Structural Integrity and Durability of High Voltage Composite (Non-Ceramic) Insulators

M. Kumosa¹

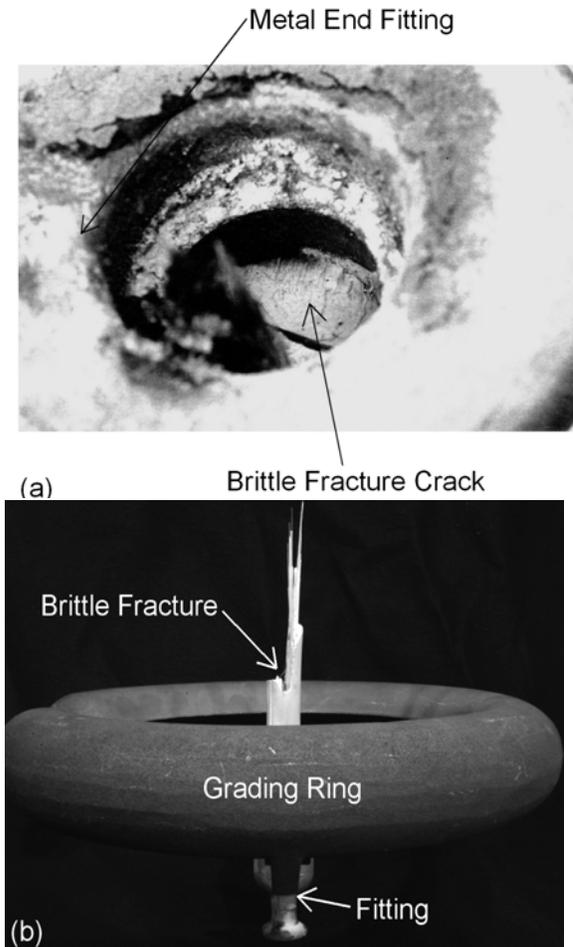
In brittle fracture, large cracks are formed inside the GRP rods and run perpendicular to the long axis of the insulators (Fig. 2). The cracks can be as large as 80% of the rod cross section, as reported by Kumosa, Shankara Narayan, Qiu and Bansal (1997) and Liang and Dai (2006). The failure process starts on the surfaces of the GRP rods by the initiation of stress corrosion C-type flows in individual E-glass fibers [Hull, Kumosa and Price (1985)] leading to their fractures (Fig. 3). Then, the failure process slowly accelerates causing more stress corrosion fiber failures. The final stage of the process is a catastrophic mechanical failure of the entire rod. The brittle fracture failure process is caused by a combined effect of electrical, mechanical and environmental fields [Kumosa, Kumosa and Armentrout (2004b)]. Due to the complexity of the problem, several different analyses are required as part of the failure investigation. Brittle fractures can only be determined

Figure 2: Examples of brittle fracture failures of 500kV suspension insulators; (a) failure inside the fitting and (b) failure above the hardware.

Brittle fracture can occur either inside (Fig. 2a) or just outside (Fig. 2b) of the energized end fittings [Kumosa, Shankara Narayan, Qiu and

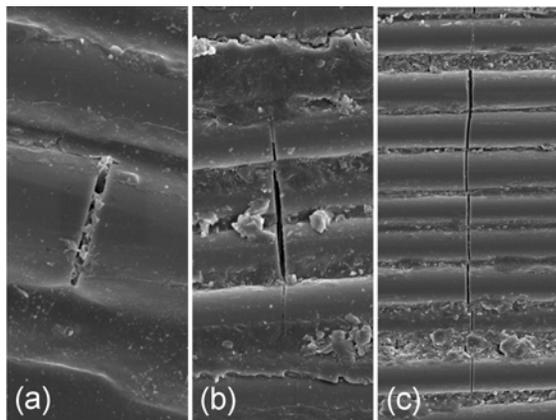
Figure 3: Initial stages of SCC and brittle fracture.

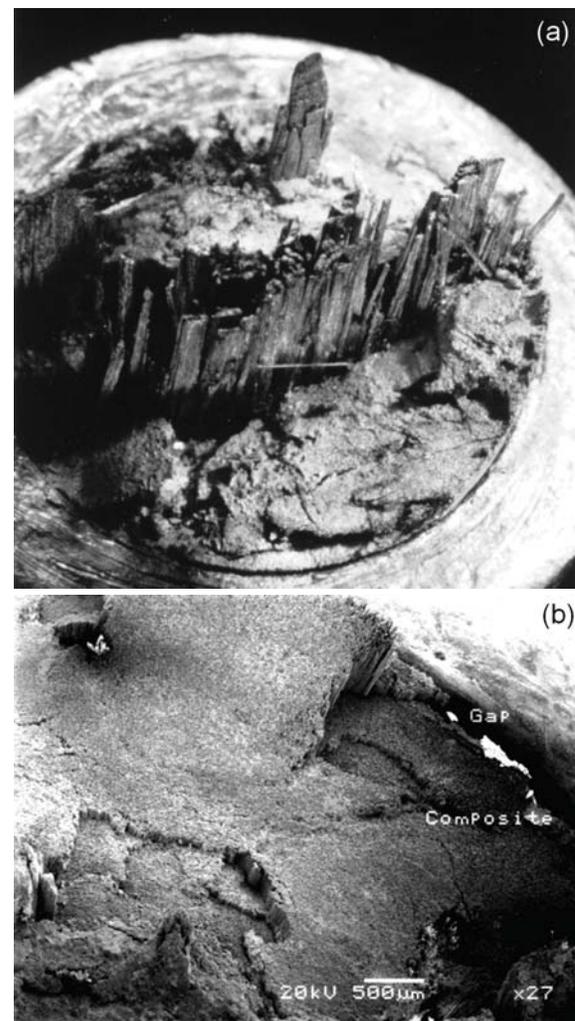
almost perpendicular to the long axis of the rod (Fig. 4). In this case, the macro-fracture features will be almost indistinguishable from the fracture features caused by brittle fracture. This type of failure can occur at either end fitting. If crimping deformations are large, the loads at rod fracture can be quite low [Kumosa Armentrout, Kumosa, Han and Carpenter (2002)]. The only way to distinguish the purely mechanical failures by overcrimping from brittle fractures is by performing a detailed microscopic analysis of the rod's fracture surface.

Figure 4: Failure characteristics of overcrimped 115kV insulator; (a) macro-damage zone and (b) composite fracture surface.

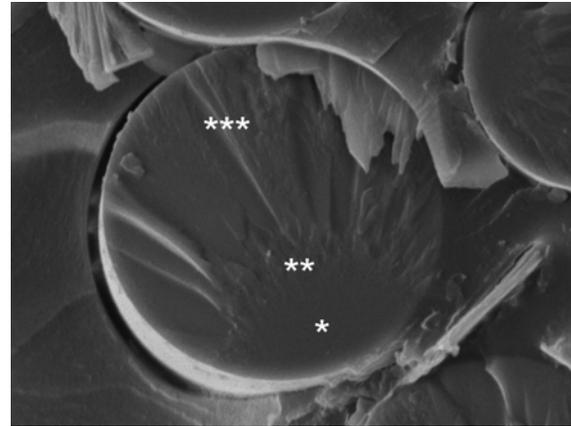
The zones shown in Fig. 5 are usually damaged during a corrosion process. This process is called post failure damage [Hull, Kumosa and

Figure 5: Mirror (*), mist (**) and hackle (***) zones on the fracture surface of E-glass fiber exposed to nitric acid.

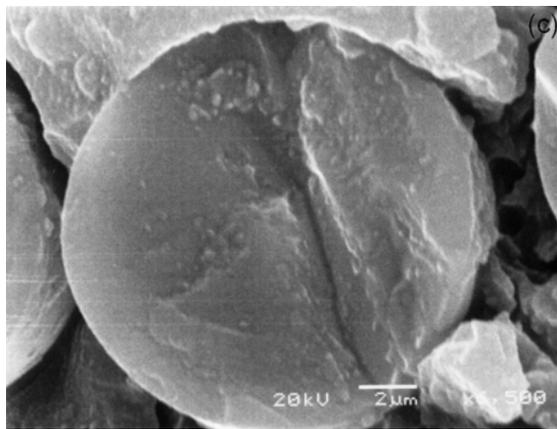
Figure 6: Typical example of fractured fiber caused purely by mechanical loads.

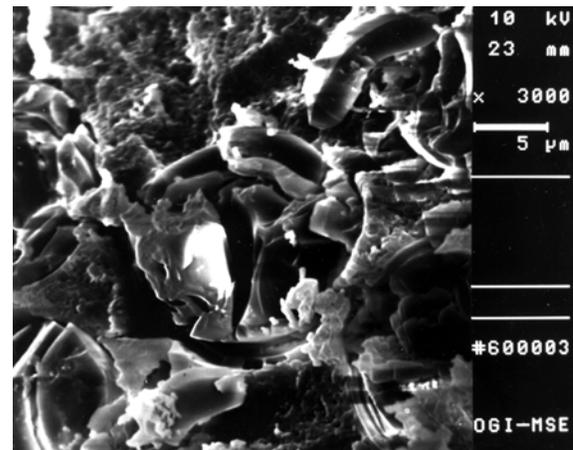
Figure 7: Post failure damage on the fracture surface of E-glass fiber exposed to oxalic acid.

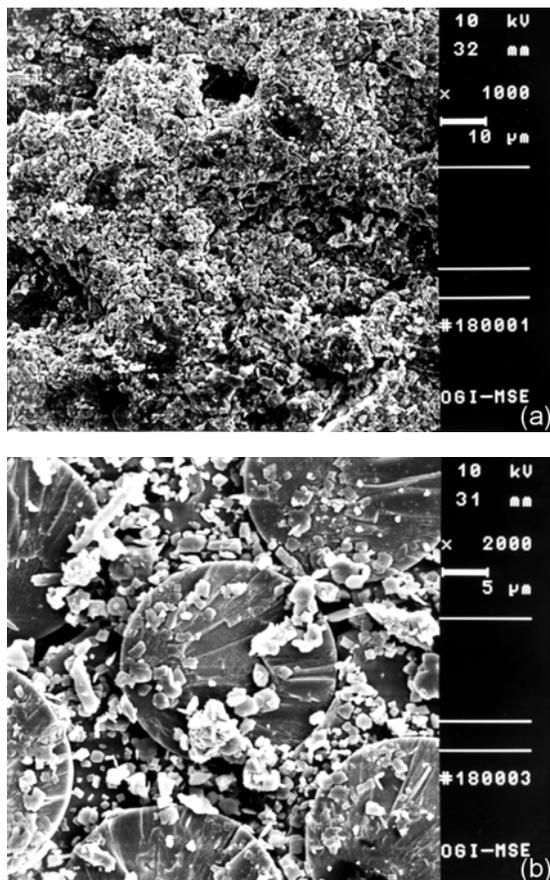
Figure 8: Examples of surface deposits on brittle fractures of composite insulators.

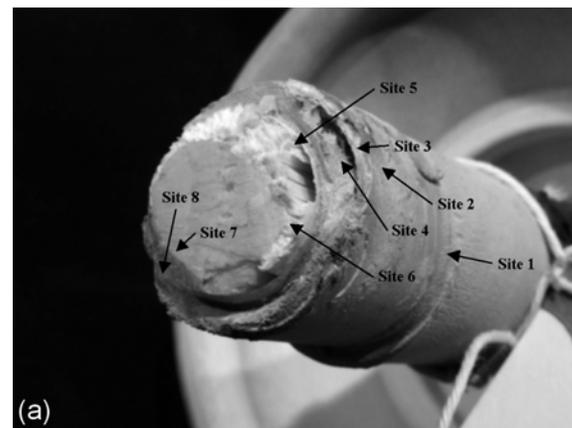
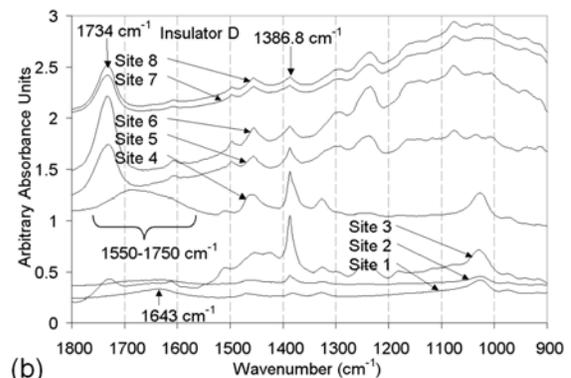
Figure 9: FTIR analysis of failed by brittle fracture suspension composite insulator; (a) failure morphology with site locations for FTIR and (b) FTIR spectra for the sites in Fig. 9a. Band at 1386.8cm^{-1} indicates presence of nitrates.

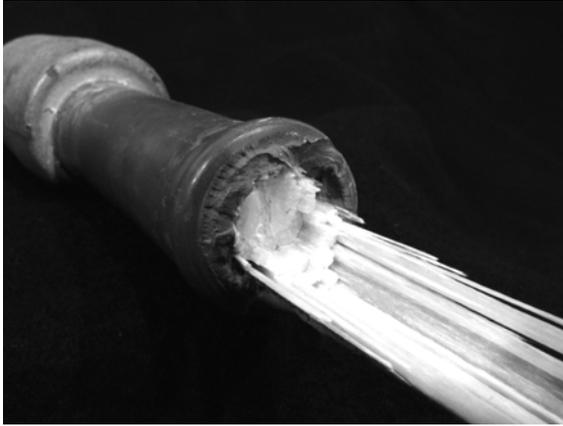
The failures occurred in 1990/1991 on a 345 kV line. Fourteen brittle fracture failures occurred resulting in the drop of the conductor (see Fig. 10) within two years after the installation [Kumosa, Shankara Narayan, Qiu and Bansal (1997)

Figure 10: 345 kV suspension insulator failed in-service by brittle fracture.

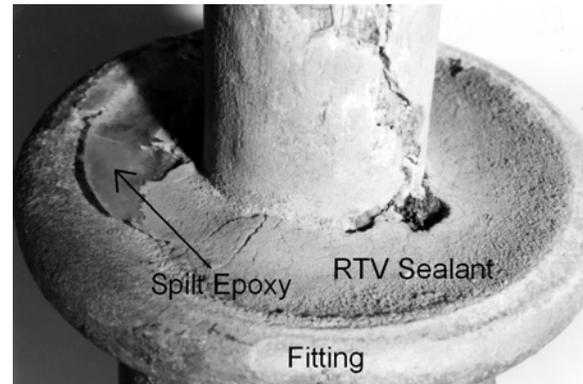
Figure 12: Spilt epoxy on the upper surface of the hardware of 500kV suspension composite insulator.

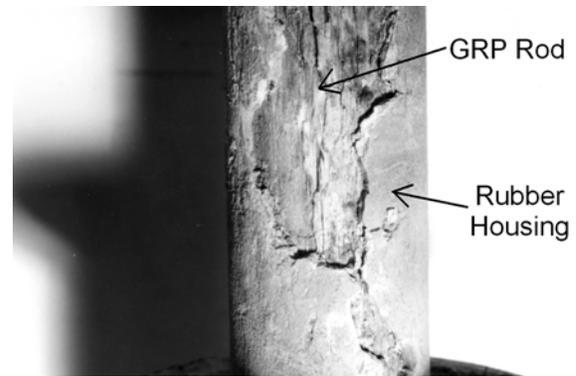
wards the external surface of a composite insulator (see Fig. 14). This could explain the origin of the damage to the housing presented in Fig. 13. It could also suggest that when such cracks are present, large amounts of water will penetrate the housing through those cracks, further accelerating the damage process in the housing. However, if a large quantity of water is present inside an insulator, nitric acid forming at the rubber housing interface will not be concentrated high enough. As a result, the critical chemical conditions for brittle fracture (acid concentration) will not be satisfied. It has been shown that the critical pH for SCC in nitric acid for a polyester type composite with E-glass fibers is somewhere between 3 and 3.5 and between 2.5 and 3 for an epoxy based composite [Kumosa, Kumosa and Armentrout (2004b)].

Figure 13: Damaged rubber housing in 500 kV composite insulator near its hot end.

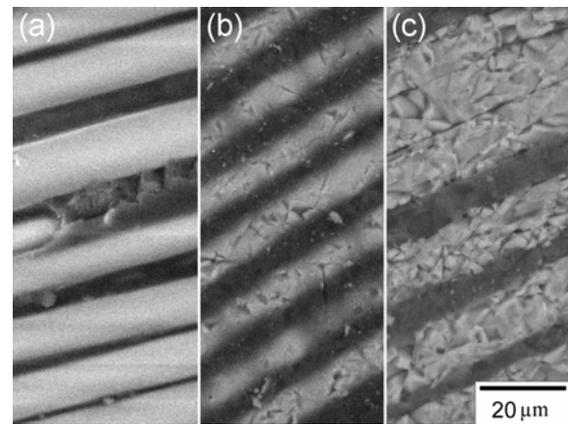
formed sandblasting of their composite rods to increase adhesion between the rods and the rubber housing (see Fig. 15) [Kumosa, Armentrout and Kumosa (2002)]. During sandblasting the surface of the rods can be severely damaged. This damage is usually created in the glass fibers left on the composite surface. The initial assumption made by us was that sandblasting could have an extremely negative effect on the resistance of the GRP rods to brittle fracture. It was found however that low/medium sandblasting could actually improve slightly the resistance of the composites to SCC in nitric acid. This was attributed to the relaxation of mechanical residual stresses on the surface of the composites due to sandblasting. This clearly indicates that not all types of damage to the composites can negatively affect their resistance to brittle fracture.

Figure 15: Surface damage in E-glass fibers caused by sandblasting; (a) as supplied, (b) after low sandblasting and (c) after medium sandblasting
