Non-Destructive Assessment of the Historic World War Memorial Baseball Stadium, Greensboro, North Carolina

Salah Amer¹, Wonchang Choi², Miguel Picornell³ and Sameer Hamoush³

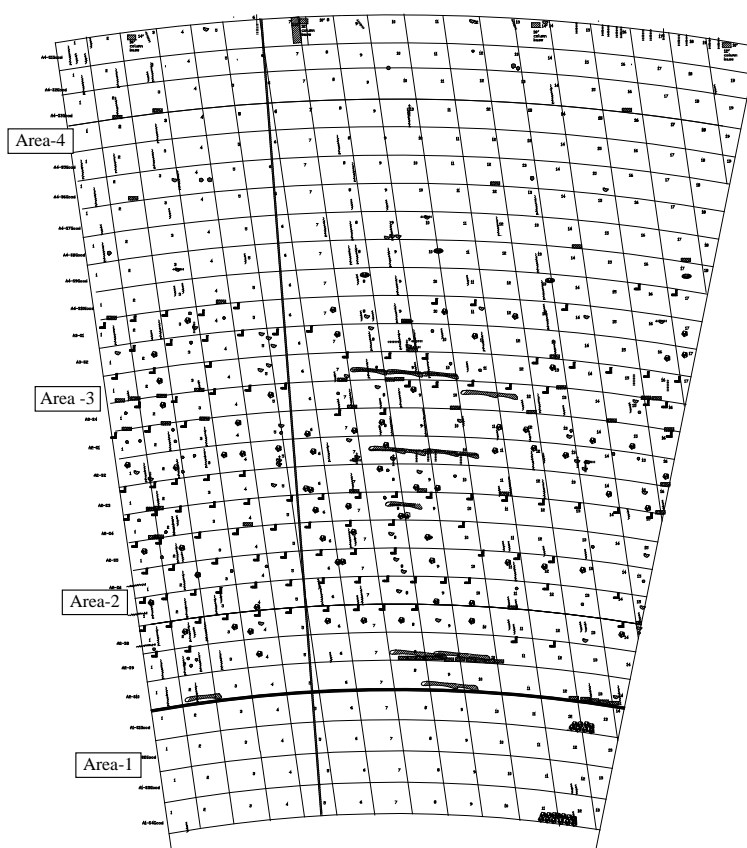
Figure 3: Seating Area Visual test.

During the visual inspection, the cracks types and type of deteriorations were identified by design symbols inside organized scheme of work as shown in Figure 2. The investigated areas were divided to grids with a spacing of one yard for easy reading defining the location of concrete delaminating, the figure shows the pictures of several delaminating pictures and its symbols and the symbols were sited on the grid corresponding to the actual location. Figure 3 shows the detailed visual test for the seating slab where Figure 4 shows the detailed visual test for the left façade tower. The two figures show that the most affected areas in seating slab are Area -2 and Area-3 as they are the most exposed reinforced concrete members to environmental factors. The concrete delaminating in the façade tower is more extensive near the top and more cracks concentrated existence around the bottom

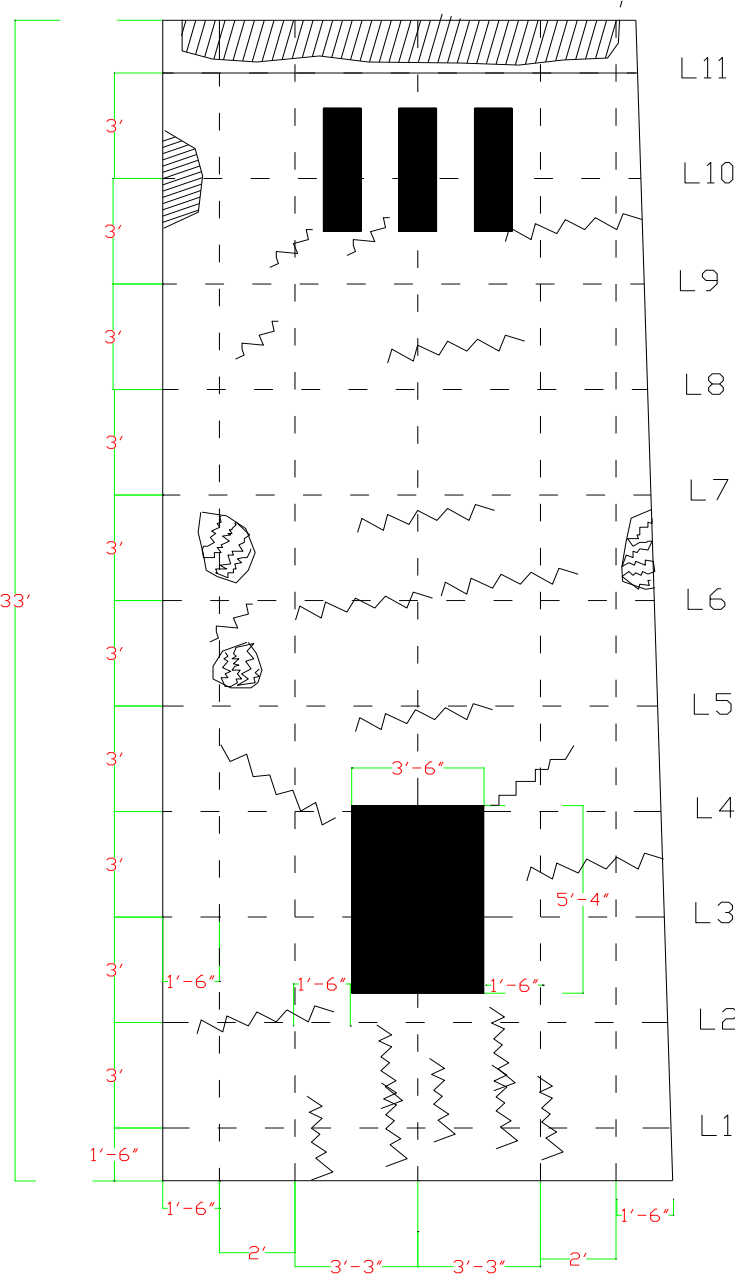
Figure 4: Visual test for façade tower.

window opening, and it was noticed that most cracks in the façade exist in the decorative cover.

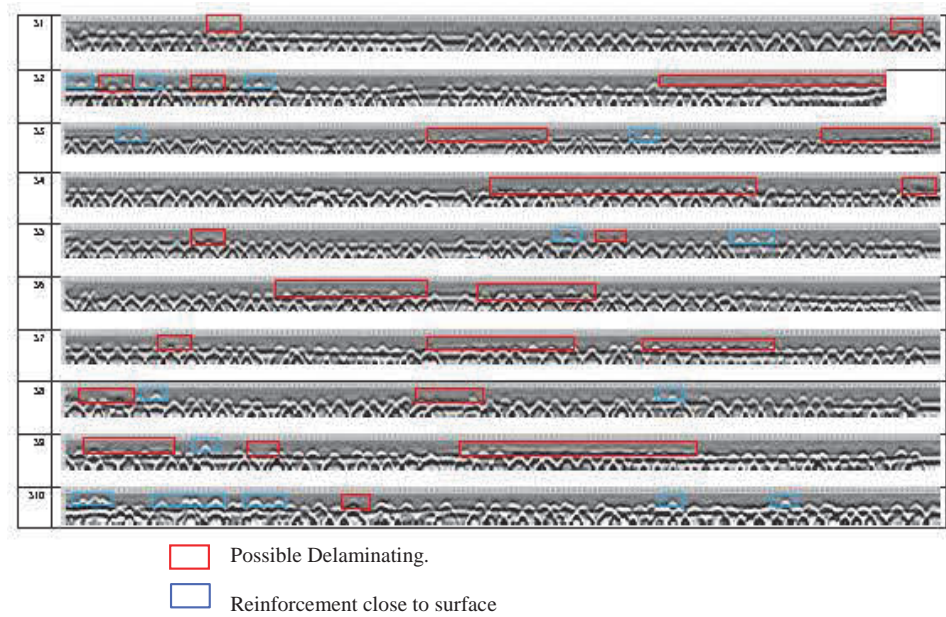
Figure 6: GPR Results for Area 4 Left Side.

axis and every one yard on the perpendicular axis to show the delaminating area inside concrete and the reinforcement bars, as well as the scanning picture shows the concrete cover to reinforcement, in **Figure 6** shows a sample of a slab scanning with details for the left side seating slab of area- 4 of as the red rectangular boxes show the areas that affected by concrete delaminating or deterioration and the chamfered blue rectangular boxes show the areas that contain the reinforcement bars with no enough concrete cover

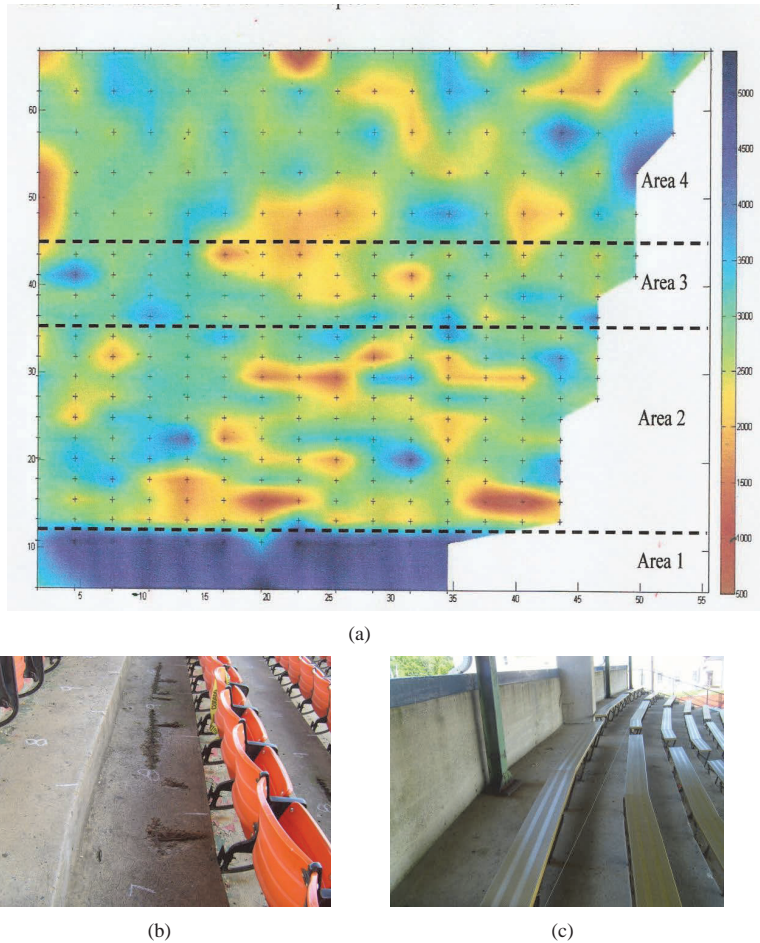
Figure 8: a- Seating Slab SPA Results Image (Red are Weak Areas) b and c are the damage picture in area 2 and area 4 respectively .

The test was run on a point every one yard for every seating slab step and on a similar grid X and Y on the façade wall. The collected data by SPA and the grid location, the MATLAB software were used to create an image for concrete strength in seating slabs and the façade wall as shown in Fig. (8) With corresponding damage pictures for area 2 and area 4, in Figure 9. and Figure 10. a simulation for SPA test for the tower wall and the corresponding damage pictures respectively. some core samples 3.0" x 6.0" were taken from selected locations and tested in the laboratory to support and calibrate the previous tests.

1. Structure in the Section 1 exhibits numerous areas of concrete spalling, delaminating, and cracking as well as the reinforcing steel corrosion especially in area 2 and area 3.
2. As seen in Figure 8 and Figure 9, the condition of the concrete in the stadium can be categorized into three cases:
Case-a, sound concrete area, can be found in the area indexed by blue color.
Case-b, minor damaged area, can be found in the area indexed in yellow and green color.
Case-c, excessive damaged area, can be found in the area indexed in orange and red color.
3. Even there is significant damage in some of surveyed areas so far, it can be concluded that the structure can be repaired.

However, before making the final decision for repair of the structure, it is recommended that a complete nondestructive survey needs to be extended to cover all

the areas expected to be repaired. The purpose of this survey is to provide tools to assess the extent of the damage in order to reduce the cost of unnecessary repairs.

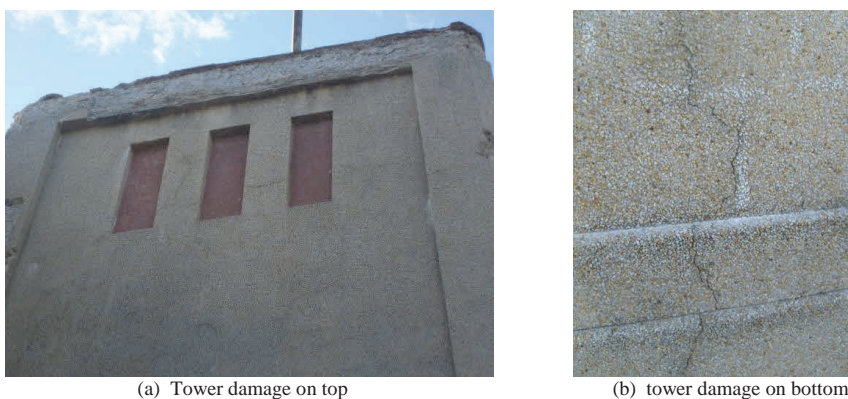
Figure 10: The Façade Tower Damage.
