Analysis of the Mechanisms Underpinning Rainstorm-Induced Landslides

Shaojie Feng*, Leipeng Liu, Chen Gao and Hang Hu

School of Civil Engineering, North China University of Technology, Beijing, 100144, China

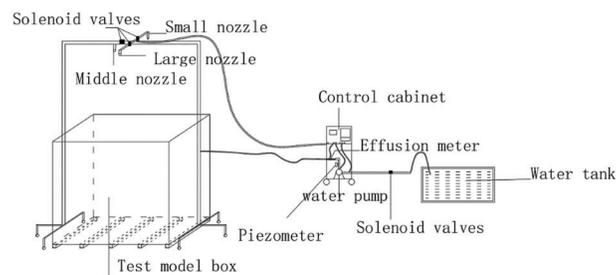
Figure 1: Diagram of rainfall device

As can be seen in [Fig. 1](#), the test bench consisted of a test model box, a rainfall device, a monitoring system, a console and a water tank. The test model box was designed based on the size of the test model, with the length, width and height of 2.0, 1.5, and 1.5 m, respectively. While the three sides of the box were made of organic glass, the bottom was a steel plate with drainage holes. This made it more feasible for the researcher to observe the process of rainwater infiltration and landslide development. Additionally, while the test box was welded by angle steel, glass adhesive was used to seal the joints. Yet, the slurry generated during the test could be discharged through the door of the test box.

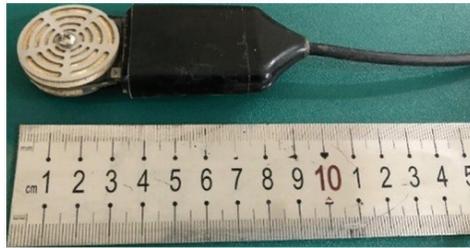
Figure 2: TEROS 21 matrix suction sensor

To acquire point cloud data, the deformation was monitored using a Z+F IMAGE \circ R5016 3D laser scanner. Moreover, as shown in [Fig. 2](#), TEROS 21 sensor was used to monitor the matric suction. More precisely, with a range of -2000 kPa to -9 kPa and an accuracy of 0.1 kPa, the surrounding moisture of the soil was calculated using the moisture release curve of the internal porous material. Furthermore, as can be observed in [Fig. 3](#), the content of the soil moisture was measured using the CSF 11 soil moisture

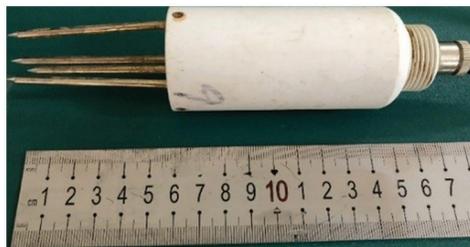
Figure 3: CSF 11 soil moisture sensor

sensor. This was done through generating and receiving signals by an internal crystal oscillator with the measurement and accuracy of 0%~60%, and $\pm 2\%$, respectively.

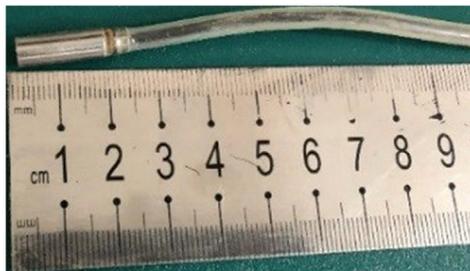
Figure 4: Pore water pressure sensor

Fig. 4 displays the HC-25 pore water pressure sensor. When under stress, the Wheatstone bridge inside the sensor loses its balance and, as a result, sends an electrical signal proportional to the pressure. The measuring range and the accuracy of the sensor were 0~25 kPa and 0.2% F.S, respectively. Furthermore, as shown in Fig. 5, the pressure of the soil was monitored using a HC-16 miniature stress sensor, with the range and accuracy of 0~100 kPa and 0.3% F.S, respectively.

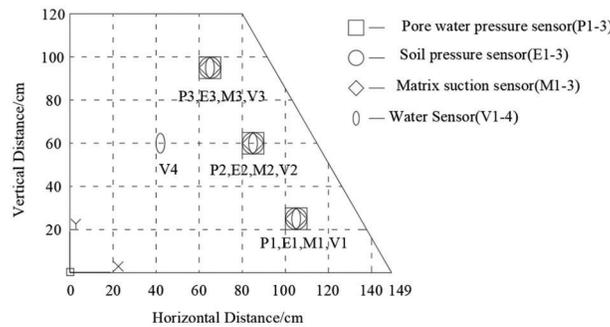
Figure 6: T3 group of sensors embedded position profile

The sensor layout is shown in Fig. 6. Three groups of sensors were embedded in this experiment, the frequency of data acquisition of which was 1 min/time. While the first group of sensors was buried at a depth of 40 cm, the second and the third were buried at 50 and 25 cm, respectively.

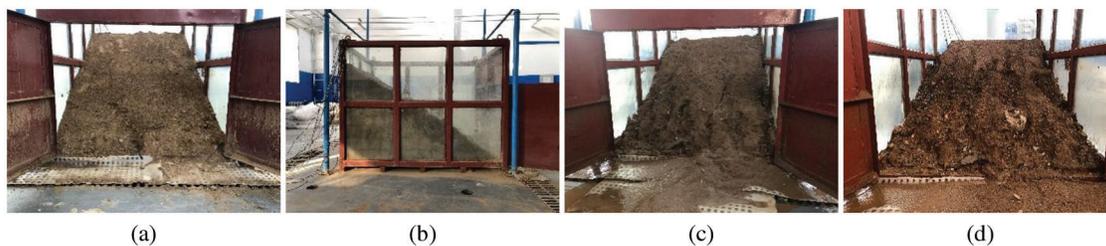
Fig. 7 displays the process of landslide development in T1 test. As can be observed, the wetting front deeply penetrated into the slope, causing the soil color to be deepened in the early stage of the rainfall. Next, the shallow erosion appeared on the surface of the slope body. As can be seen in Fig. 7c, with an increase in the rainfall time, the erosion ditch was gradually formed and, then, expanded all over the slope. The erosion ditch stopped after developing to a certain depth. According to the above landslide development process, the failure mode can be argued to be the erosion-induced local shallow sliding failure.

Figure 7: T1 development process of landslide; (a) prior to the rainfall; (b) penetration of the wetting front into the slope; (c) appearance of the erosion ditch; (d) failure of the slope

The monitoring data obtained from the first two days of T1, T2 and T3 tests were selected for analysis. With the intensity of 70–140 mm/h, the rainfalls of the first two days of the tests were almost the same. Figs. 7d, 8b and 9c display the influence of the rainfall on the failure modes of three groups of slopes. After comparative analysis, significantly different modes of failure were detected. This is to say that while the failure of the 30° slope belonged to the erosion-slip failure, that of the 60° slope belonged to the comprehensive failure of shallow collapse and erosion-slip. Furthermore, since the failure of 45° slope was insignificant, the failure mode was not obvious.

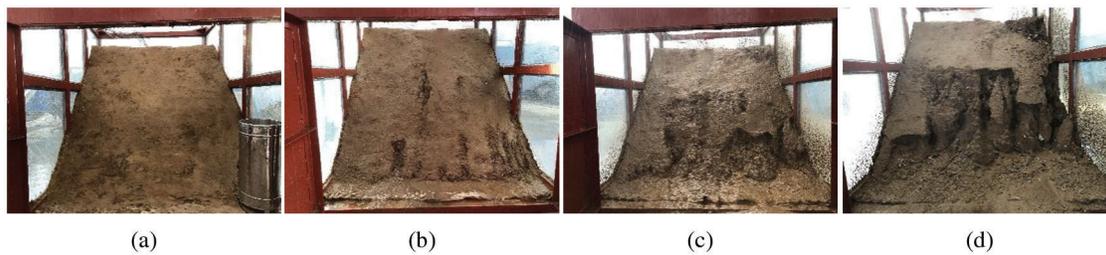
The process of landslide development in T2 test is shown in Fig. 8. In the early stage of the rainfall, the soil color deepened, the rainwater infiltrated slowly, and the loose fine soil particles on the slope were splashed. As the rain continued, a layer of mud film was formed on the slope surface. This layer hindered the total infiltration of rainwater, i.e., it was only partly infiltrated to the slope body. As can be seen in Fig. 8, the result reveals a small amount of erosion near the slope toe only, with no large displacement and no cracks in the slope.

In the T4 test, the rainfall was continuous. As can be observed in Fig. 8c, by the beginning of the rainfall, a large area of erosion appeared on the surface of the slope foot. Due to the erosion of runoff, several rills with the depths of about 15 cm extended from the toe to the slope. Afterward, based on Fig. 8d, the collapse block fell on the slope foot, and the damage continued and developed. While the local failure initially occurred at the toe of the slope, it then gradually expanded and finally led to the global failure. Hence, the failure mode of landslide is multi-stage backward landslide.

Figure 8: T2 and T4 development processes of landslide; (a) prior to the rainfall; (b) appearance of the erosion ditch; (c) failure of the slope toe; (d) failure of the slope body

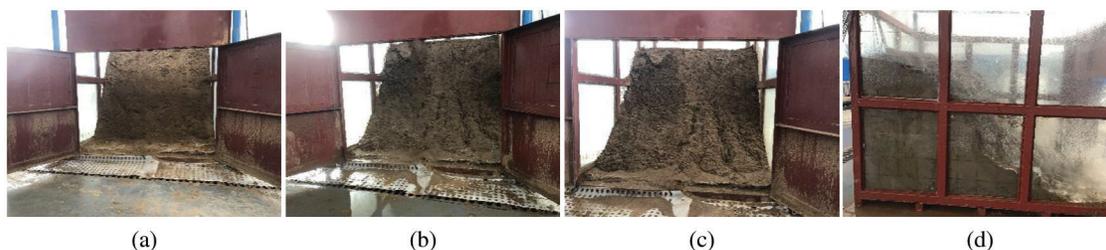
Fig. 9 shows the process of the landslide development in T3 test. As can be observed, water accumulated at the toe of the slope and the soil softened at the beginning of the test. As the rainfall continued, shallow landslide occurred at the slope toe. Subsequently, soil sliding developed from the bottom to the top, and eventually the whole slope surface suffered the shallow sliding failure, which, accordingly, can be argued to be the comprehensive failure of shallow sliding and erosion sliding.

Figure 9: Development process of landslide for test T3; (a) prior to the rainfall; (b) appearance of the erosion ditch; (c) erosion ditch deepens and enlarges; (d) failure of the slope body

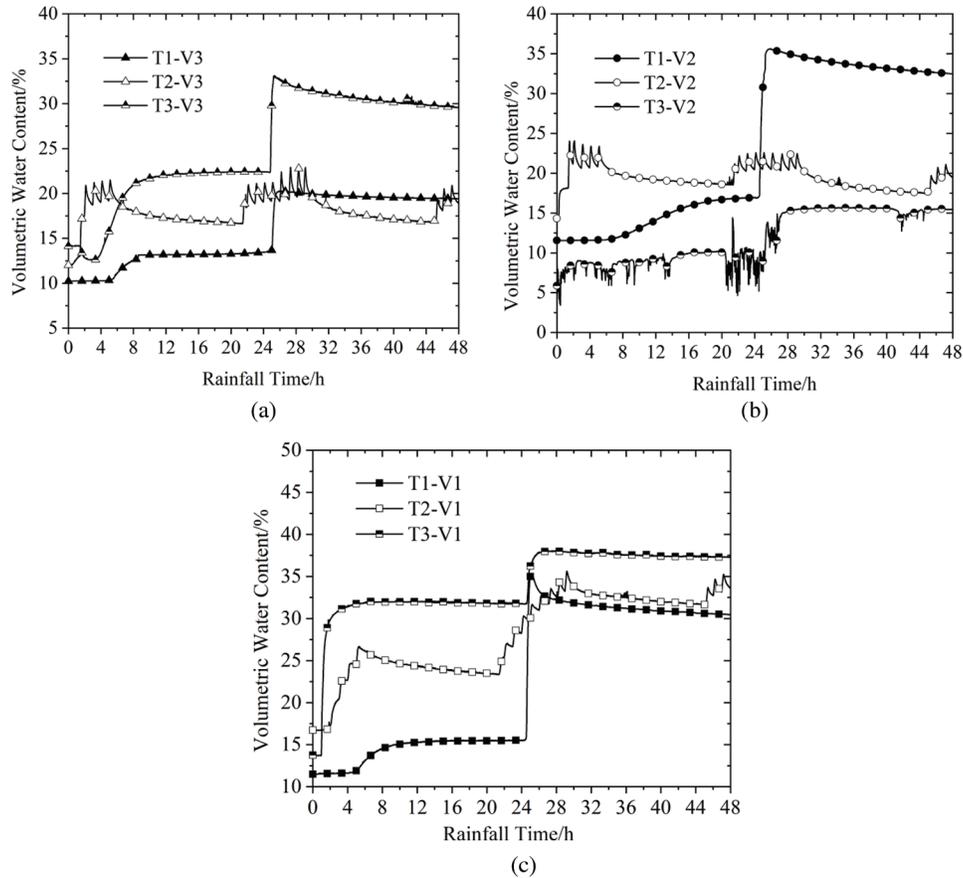
Fig. 10 shows the change in volumetric water content at the measuring points of the three groups of tests. The difference between the peak value and the initial value of the measuring point is defined as the maximum increment. The maximum increment of volumetric water content at the foot of the slope was close to that of the three test groups. Moreover, the maximum increment of volumetric water content under 30° was found to be significantly greater than that of the other two experimental conditions in the middle and top of the slope. In other words, the large rainfall area of the gentle slope facilitates the infiltration of rainwater. Rather than flowing to the foot, the infiltrated water flows into the depth of the slope through the runoff channel. Hence, the maximum increment of the foot of the slope is close to that of the steep slope.

Figure 10: Variation in the volumetric water content at each measuring point of T1, T2 and T3 slopes; (a) top of the slope; (b) middle of the slope; (c) toe of the slope

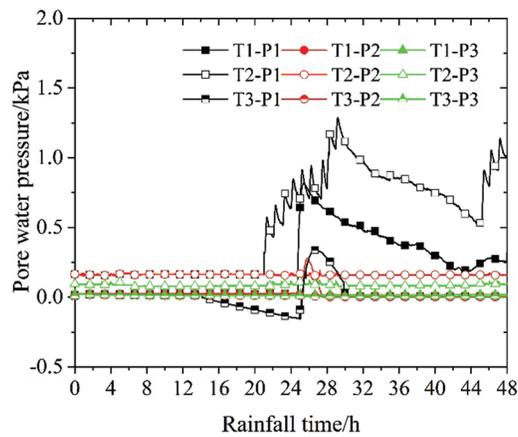
Fig. 11 shows the change in the pressure of the pore water in the three groups of experimental conditions. While no pore water pressure was detected in the middle and at the top of the slope, the toe of the slope at 45° demonstrated the highest level of pressure. This was followed by the 30° and 60° of the experimental

conditions. Therefore, no obvious relationship was found between the peak pore water pressure and the slope angle.

Figure 11: Variation of pore water pressure with time

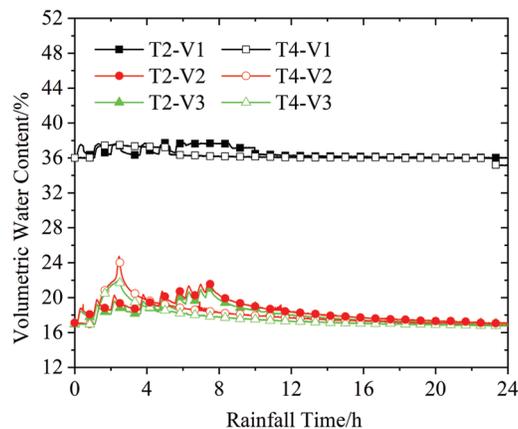
Figs. 12 and 13 demonstrate the variations in the volumetric water content and pore water pressure in the two rainfall conditions. Under the continuous rainfall, the peak volumetric water content was slightly larger than that of the intermittent rainfall at the middle and top of the slope. Moreover, with close peak values, the soil at the foot of the slope was saturated. In addition, the peak value of pore water pressure at the foot of the slope was slightly larger under continuous rainfall than the intermittent one. With the pore pressure of 0, the middle and the top of the slope were not saturated in either of the conditions. Furthermore, since the beginning of the rainfall, the volumes of the moisture content were observed to become stable after 8 and 12 h for the continuous and intermittent rainfalls, respectively.

Figure 12: Variation of volumetric water content at each measuring point of T2 and T4 test slopes

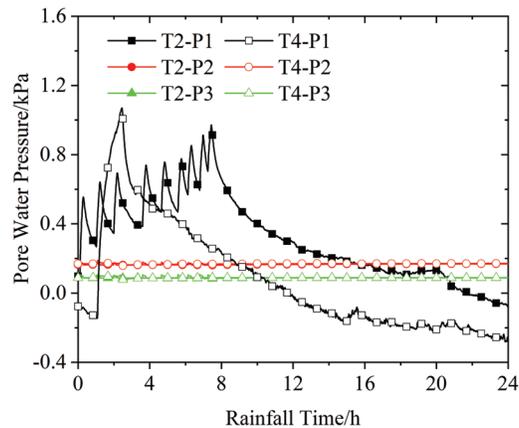
Figure 13: Variation of pore water pressure at each measuring point of T2 and T4 test slopes

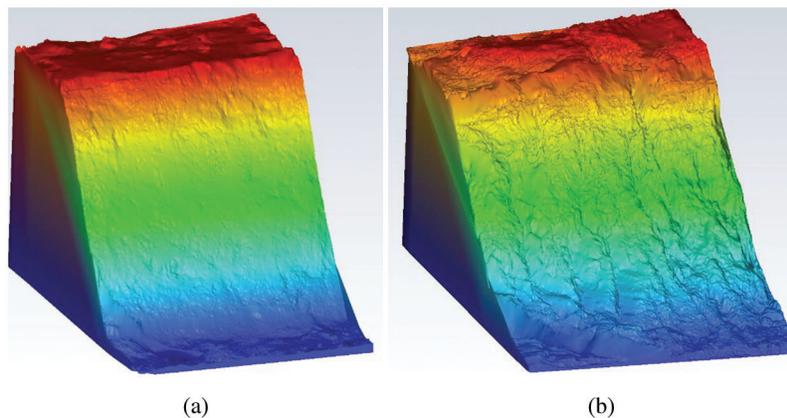
Using the 3D laser scanner, the slope model was scanned for several times before and after the test, the purpose of which was to generate an effective 3D model of elevation. To analyze the slope deformation and failure characteristics, the collected data was further processed using the JRC and 3DReshaper software. Fig. 14 shows the three-dimensional laser scanning maps of T3 test slope before and after the rainfall. The figures are obtained by assigning colors to different elevations of point cloud data. Furthermore, Fig. 14a is the scanned image of the 60° slope model before the rainfall. As can be seen, the slope has a

relatively smooth surface, with a basically straight shoulder. As indicated by Fig. 14b, with only small erosion pits and a small amount of accumulation body at the toe, the soil at the slope shoulder was still relatively intact after a certain level of rainfall. Accordingly, this is an indication of the appropriate capability of the 3D laser scanner in reproducing the occurrence and development of landslides.

Figure 14: Three-dimensional scanning pictures of T3 test; (a) prior to the rainfall (b) after the rainfall

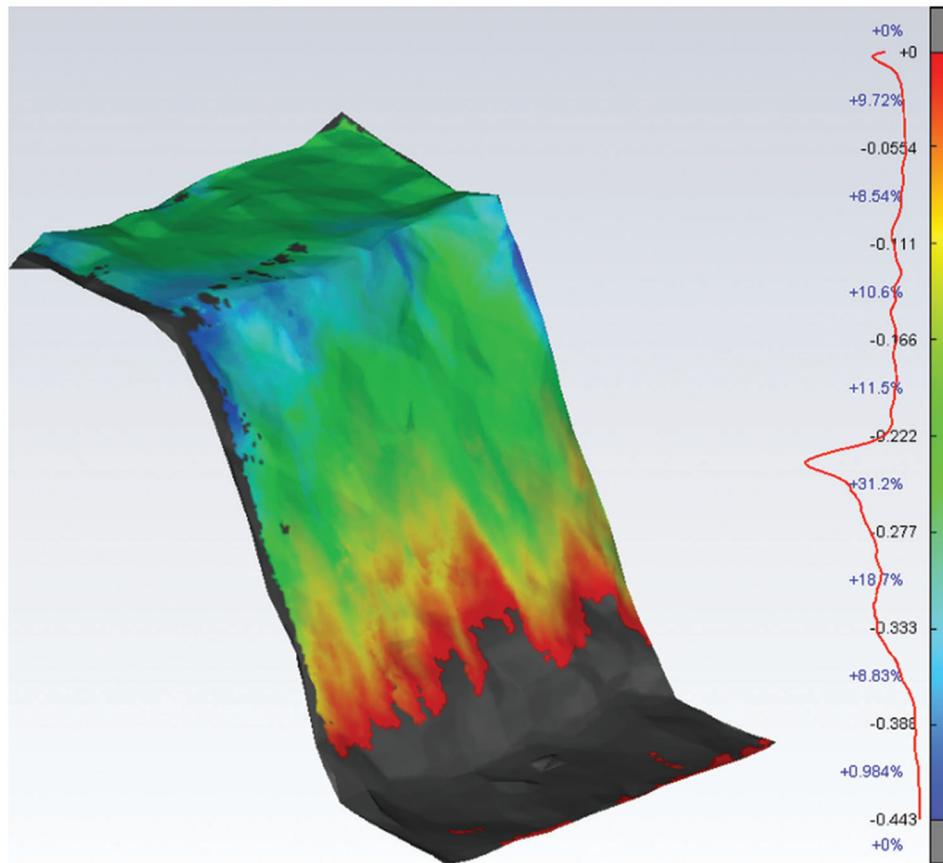
Figure 15: T3 test slope deformation figure

Fig. 15 demonstrates the overall slope deformation map of the T3 test. The map is generated through a comparison of the point cloud data of the same part of the slope model before and after certain level of rainfall. The red line in Fig. 15 represents the deformation degree of the corresponding elevation of the slope. While the maximum deformation of T3 slope occurred in the middle of the slope, relatively small deformation at the shoulder and the toe was observed. Using the 3D laser scanning technology, the point cloud data of the slope was instantly collected and the 3D model was constructed. The slope deformation was measured through a comparison of the 3D model before and after the rainfall. Consequently, efficient, accurate, and relatively simple monitoring results were obtained for slope monitoring. Hence, the practicality of the 3D laser scanning technology is corroborated.
