# Structural Health Monitoring of Concrete Bridges in Guilan Province Based on a Visual Inspection Method

**Abstract:** Iran is located in a seismic prone region with several earthquakes occurring annually causing extensive damage to structures and infrastructure. Guilan province is located in the northern part of the country, exhibiting a large population, moderate climate and extensive river system. This region experiences high humidity, several active faults and high seismic hazard potential. This highlights the importance of an active and extensive maintenance and rehabilitation program for the bridges in this region. Structural Health Monitoring (SHM) is an engineering tool used to control changing conditions of infrastructure providing useful information for management, decision making and in certain circumstances code revision. This paper proposes a method for SHM of bridges. In total, 123 concrete bridges were assessed based on this visual inspection; with statistical analysis of results carried out on decks, piles, abutments, restraints and river engineering which effectively addressed the deficiencies in bridges maintenance. Finally some practical solutions are suggested

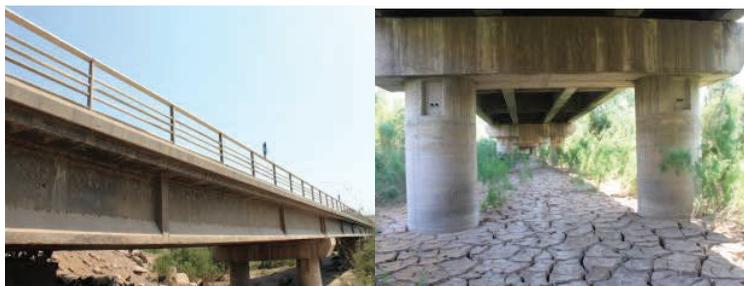
Figure 1: Bala Bala bridge – Site of the liquifaction that occurred during the Manjil earthquake (1990).

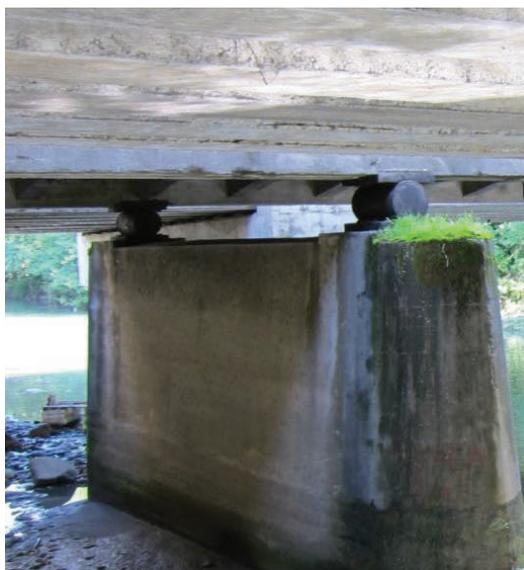
Figure 9 presents average SHM scores of restraints for each road hierarchy. The SHM of restraints in bridges satisfied the limitation. The use of new technologies and materials (neoprene) help to absorb shock and vibration efficiently. In older bridges, some roller restraints were observed. In all cases, the bridges without neoprene restraints scored lower than those with neoprene. Neoprene is a very effective material at transferring forces (especially seismic activity), to the main bridge structure, ensuring the safety and integrity of whole structure.

Figure 10a: Type of roller restraints used in older concrete bridges.

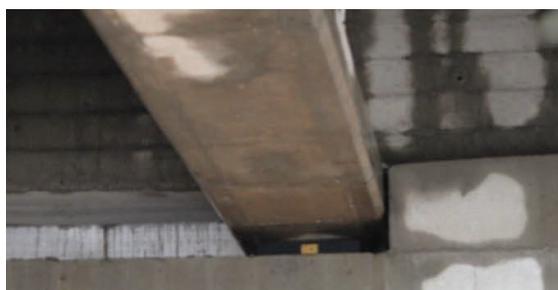
Figure 10b: Type of new restraint in concrete bridge.
