Damage Detection of Cyclically Loaded Concrete Shear Wall using EMI Technique

A. Likhith Reddy¹, Shirleen Charles¹, C. Bharathi Priya², G.V. Rama Rao²,
N. Gopalakrishnan^{3,4} and A. Rama Mohan Rao³

Abstract: Details of the investigations on an unexplored application of Electro Mechanical Impedance (EMI) technique using smart piezoelectric (PZT) sensors for damage detection of concrete shear wall structures under crack opening and closing is presented in this paper. The behavior and the ability of this method to detect damages, in a heterogeneous quasi-brittle material is studied for its effective utilization in structural health monitoring. The paper discusses the experimental investigations conducted on a concrete shear wall using PZT patches. Conductance data is acquired at different applied lateral displacements of shear wall. Damage index is calculated using Root Mean Square Deviation (RMSD), Mean Absolute Percentage Deviation (MAPD) and Correlation Coefficient (CC) computed between pristine and damaged states. It is found that compared to a metallic specimen, concrete specimens do not show a large variation in these damage metrics, due to reduced modal density and high damp

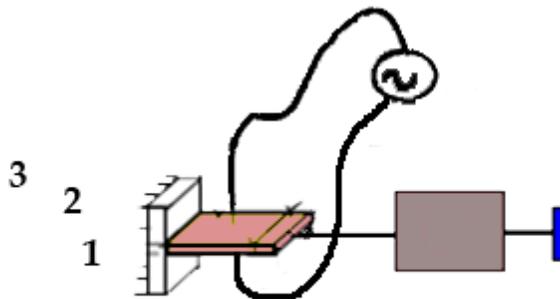
Figure 2: Model of the host structure with mechanical impedance Z_s connected to the PZT patch.

The electromechanical admittance consists of the real and imaginary part which depends on the properties of PZT and structure. This two dimensional governing equation is expanded by Bhalla and Soh (2004), and is given in Eq. 3.

$$\bar{Y} = G + B_j = \omega j \frac{l^2}{h} \left[\bar{\epsilon}_{33}^T - \frac{2d_{31}^2 \bar{Y}^E}{(1-\nu)} + \frac{2d_{31}^2 \bar{Y}^E}{(1-\nu)} \left(\frac{Z_{a,eff}}{Z_{s,eff} + Z_{a,eff}} \right) \bar{T} \right] \quad (3)$$

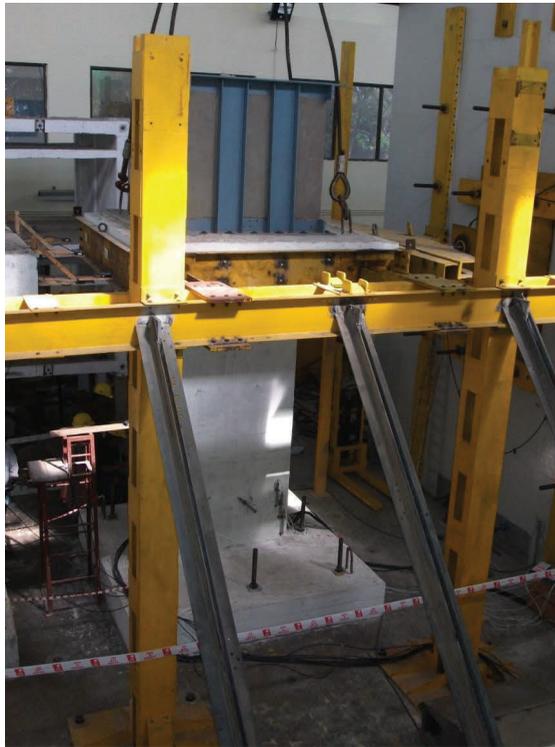
Figure 3(a): Experimental setup for the cyclic load test on shear wall.

The experimental study had been performed on a concrete shear wall which is 1:4 scale of the prototype. Fig.3(a) shows the experimental setup for the cyclic load test on shear wall. The dimensions of shear wall specimen are 3 m height, 1.56 m width and 0.2 m thickness. The shear wall is axially loaded with a super-imposed vertical load of 160 kN. Displacement controlled cyclic loading test is applied on the shear wall. The base of the shear wall is fixed and displacement is given at the top of the shear wall using a hydraulic jack. Displacement is an in-direct quantification of loading, during elastic phase of a concrete structure. Generally for quasi brittle structures and ductile structures with steeply falling hysteretic structures, displacement controlled tests are performed on the structure, so as to capture the post-peak force-displacement hysteretic characteristics. Load controlled tests are generally not preferred. Applied displacements are indicators of the increased crack width, crack length and permanent set of a structure. Cyclic loads are applied through a push-pull hydraulic jack connected by a pinned connection to the steel box encasing the top slab. Initially the load is applied as push, till the monitored displacement has reached the peak displacement. Then the un-loading is done and the shear wall is pulled in the other direction, such that the negative peak displacement of the cycle is reached. Then it is slowly un-loaded until the load is zero. This completes

one cycle. Three cycles of loading for each peak displacement of 2, 4, 6, 8, 10, 15, 20, 25, 30, 40 and 50 mm are applied on the shear wall. The experimental setup consists of an LCR meter, a notebook computer and 4 PZT patches surface bonded on the shear wall as shown in Fig 3 (b) and Fig 3(c). PZT patches are bonded to the bottom of the shear wall with epoxy resin. Baseline signatures are acquired from the four patches in the undamaged state. A displacement of 2 mm had been given to the structure by the hydraulic jack and the conductance signature for the four patches is acquired. Similarly the signatures are acquired for all cases of displacements increasing up to 60 mm. This corresponds to a lateral drift of 2% of the wall height, which is close to an incipient damage state of the wall. Crack opening and closing is clear apparent in the experimentally obtained hysteresis curves (Fig. 4). The crack closure of a previously opened-up crack is seen through the increase in stiffness of the shear wall. The trajectory of the hysteresis loop as it touches the negative Y-axis where the crack closes results in a sudden gain of strength.

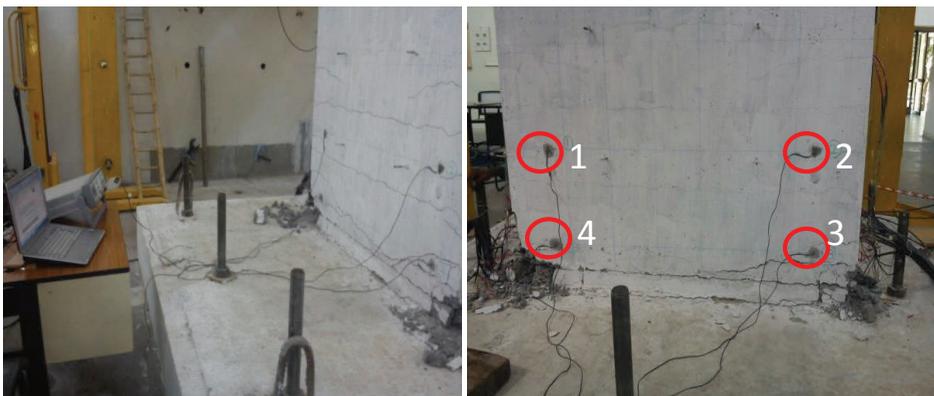
Figure 3: (b) Experimental setup and (c) Location of for PZT patches.

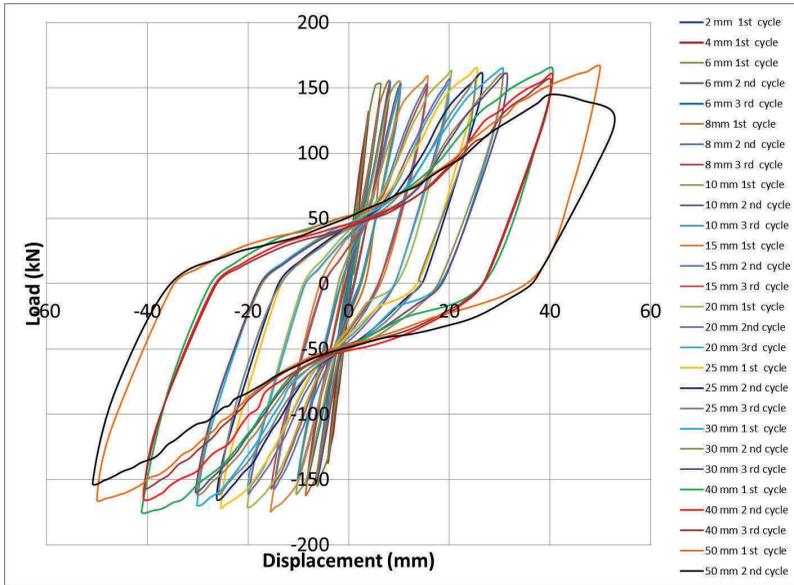
Figure 4: Hysteretic behaviour of shear wall obtained in cyclic load test depicting strength & stiffness degradation and pinching.

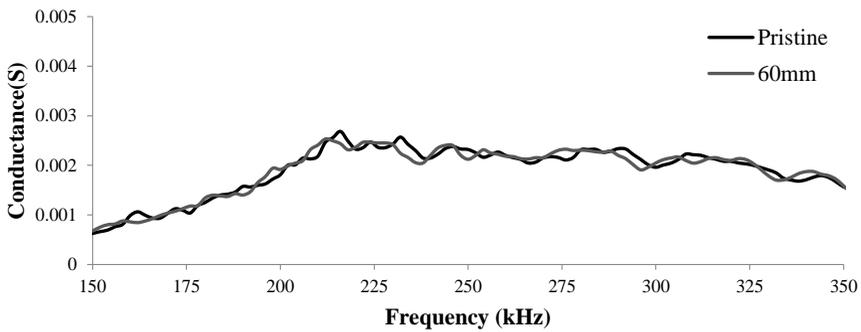
Figure 5(a): Conductance signature of patch1 for pristine and 60mm top displacement of shear wall.

Figures are plotted between the frequency and conductance for all patches. Marginal variations are observed between the conductance signatures corresponding to pristine state and the damaged state. This is due to the reduced modal density and lack of metallic ringing modes as normally seen in metallic structures. As patch 4 is near to damage, the conductance signature shows greater variation compared to patch 1 as observed from Fig 5(a) and 5(b).

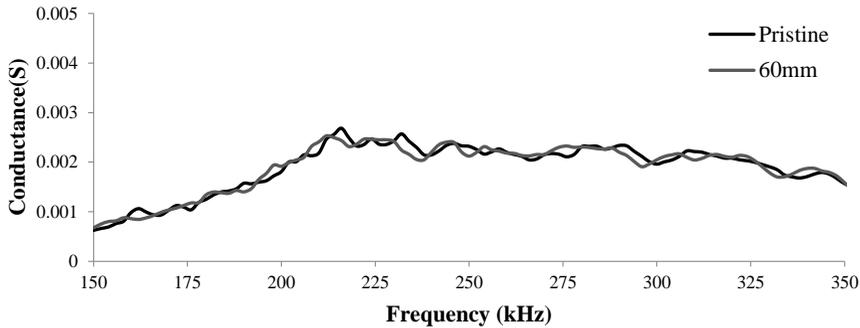
Figure 5(b): Conductance signature of patch4 for pristine and 60mm top displacement of shear wall.

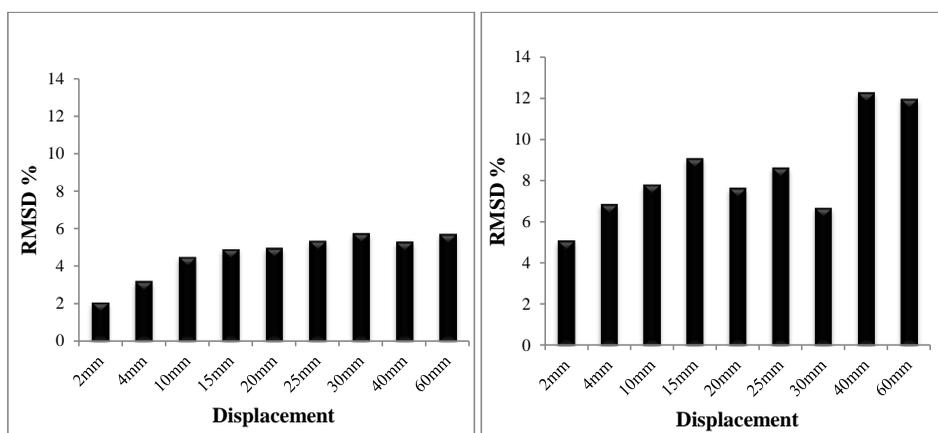
Figure 6: Displacement vs. RMSD plots for patch 1 and 4.

The RMSD plots shown in Fig.6 clearly indicate the propagation of the damage with increasing displacement which is sensed well by the PZT patches. Table 2 shows the RMSD values of all the 4 patches with increasing displacement in 200-300 KHz frequency range. As patches 3 and 4 are near to damage, the RMSD values computed between conductance signature of pristine state and subsequent damage states at 2mm, 4mm etc. are almost double the RMSD values obtained for patch 1 and are shown in Fig.6.

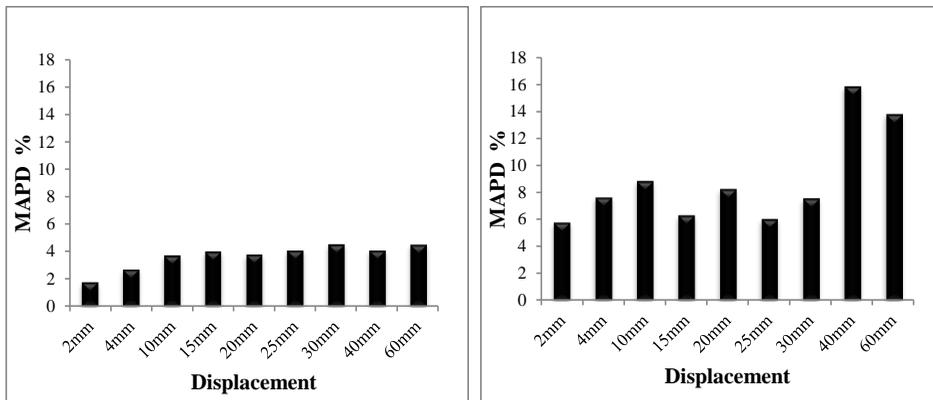
Figure 7: Displacement vs. MAPD plots for patch 1 and 4.

As patch 4 is near to damage, the MAPD values computed between conductance signature of pristine state and subsequent damage states at 2 mm, 4 mm etc. are almost double the RMSD values obtained for patch 1(Fig 7). It can be observed that MAPD and RMSD are giving similar results as expected.

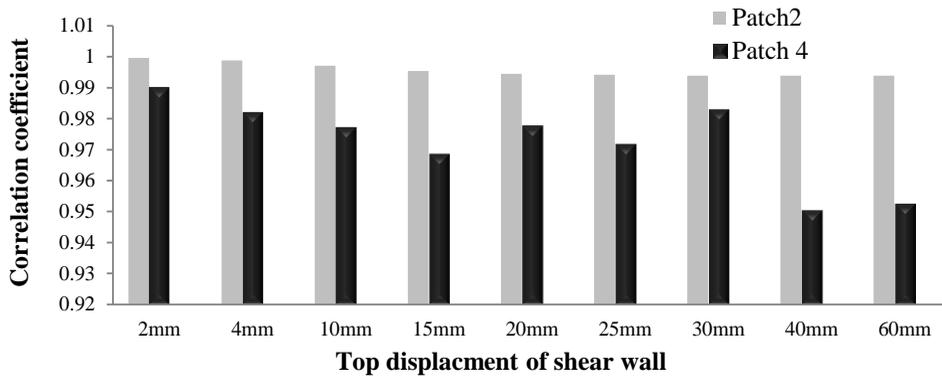
Figure 8: Displacement vs. CC plots for patch 2 and 4.

The correlation coefficient values are decreasing with increasing damage level as expected. This decrease is pronounced in case of patch 4 which is closer to major crack zone. Fig.8 shows the decreasing trend of the correlation coefficient with increasing top displacement of shear wall.

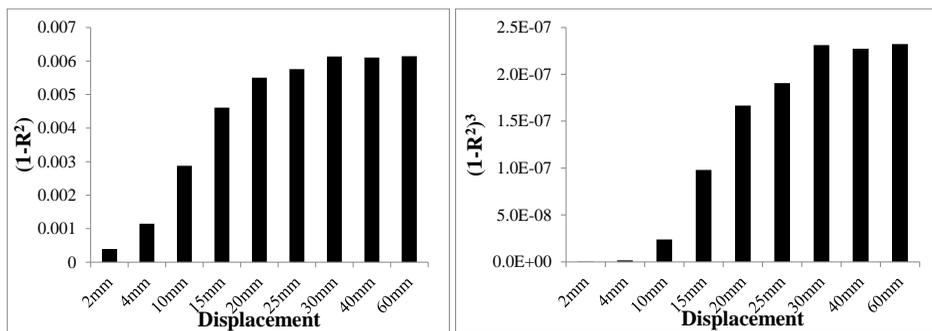
Figure 9: (1-R²) and (1-R²)³ variation with top displacement (in mm) for patch 2.

Here, R^2 is the correlation coefficient of datasets x , y . It has been found from Fig.9 that increase in the power of correlation coefficient increases the gap between the initial small displacements of shear wall and the later large displacements. Even though such a magnification of difference through higher powers is reported by

Giurguitiu (1994a), Park (2006) and other researchers, the extension to concrete structure is not adequately available. This helps in clearly identifying damage after significant permanent set has occurred in the shear wall. In case of fourth order of correlation coefficient, the damage index value of 10 mm is found to reduce drastically when significant permanent set has occurred. Hence, third power of the correlation coefficient deviation $(1-R^2)^3$ is a good damage indicator [Seunghee et al. (2011)], which tends to increase linearly with increase in the top displacement of shear wall.

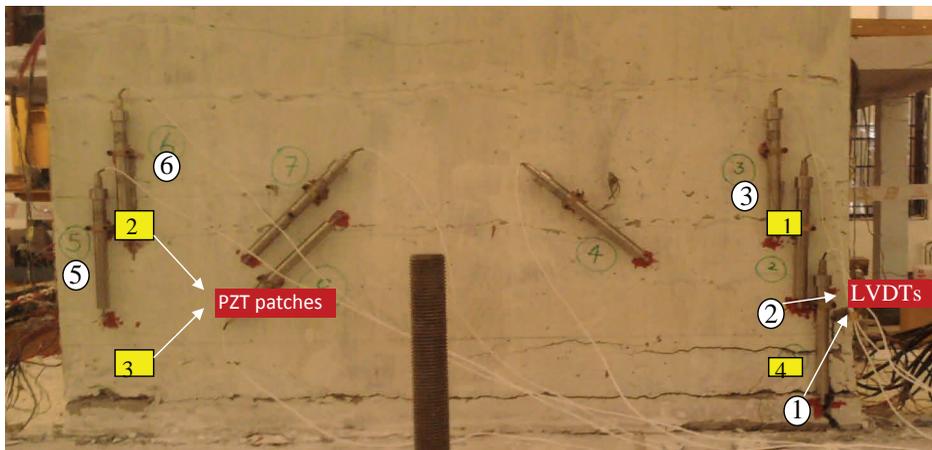
Figure 10: Position of LVDTs on the shear wall with 20mm cycle.

Increasing crack width is a measure of damage state in a structural system. Eight LVDTs are placed to capture the crack pattern. The position of LVDTs is shown in the Fig 10. Piezoelectric patches are on the opposite side of the shear wall. The crack width information from LVDTs 1, 2 5 and 6 are used to plot graphs between crack width and RMSD values. Similar figures are plotted to observe the CC variation with increasing crack width.

The LVDTs are on the front face of shear wall which are indicated by circles with

white background in Fig. 10. PZTs are located on the back face of shear wall at 20 cm and 50 cm from the bottom of the toe and 40 cm clear cover. PZT are indicated by squares with yellow background. With increasing crack width, the RMSD values are expected to increase, which can be noted from the graphs shown in Fig 11a to 18b. CC values are decreasing with increasing crack width as expected. LVDT 1 captured the major cracks showing significant crack width.

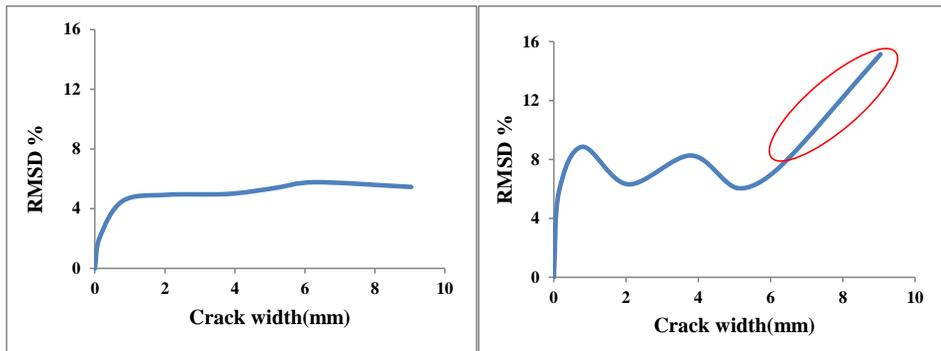
Figure 11: (a) RMSD variation of patch 1 and (b) patch 4 versus crack opening data from LVDT 1.

LVDTs 3, 4 are relatively far from major damage, when compared with LVDTs 1, 2. Sudden spurt in RMSD values and sudden fall in the correlation coefficient values as indicated in these figures can be attributed to the abrupt loss of stiffness of the shear wall at 60 mm displacement. Also, there is abrupt increase in the RMSD values for patches 3, 4 due to the same reason.

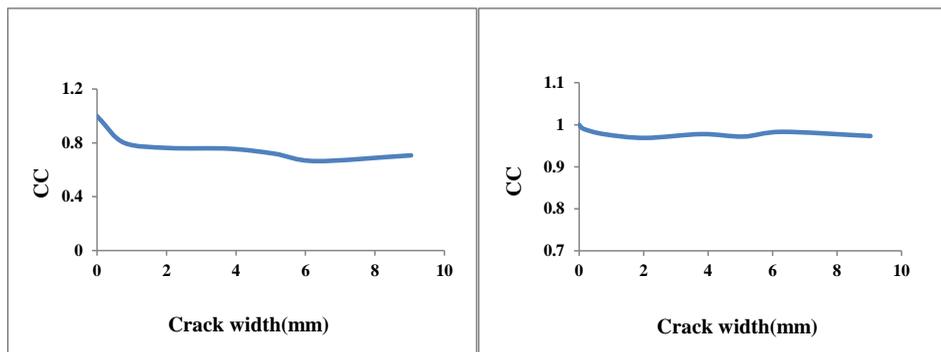
Figure 12: (a) CC variation of patch 1 and (b) patch 4 versus crack opening data from LVDT 1.

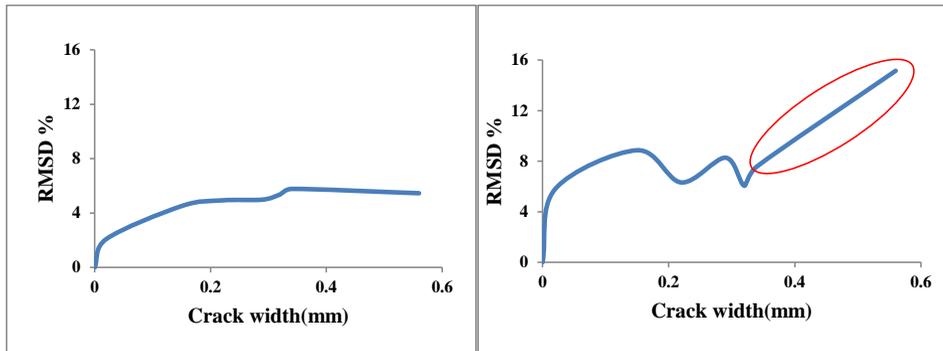
Figure 13: (a) RMSD variation of patch 1 and (b) patch 4 with crack opening data from LVDT 2.

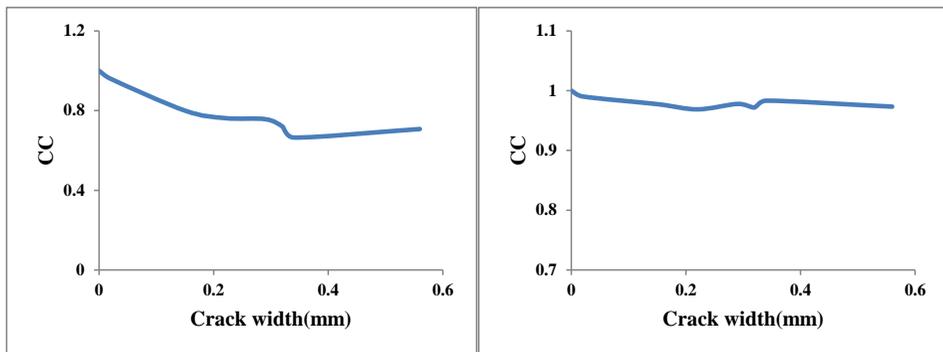
Figure 14: (a) CC variation of patch 1 and (b) patch 4 with crack opening data from LVDT 2.

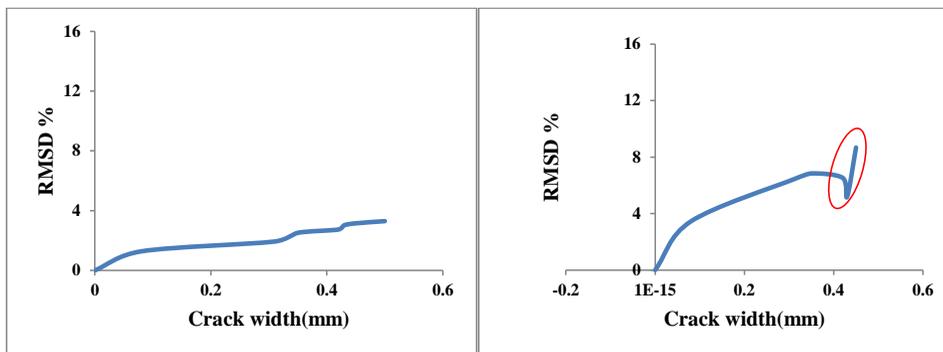
Figure 15: (a) RMSD variation of patch 2 and (b) patch 3 with crack opening data from LVDT 5.

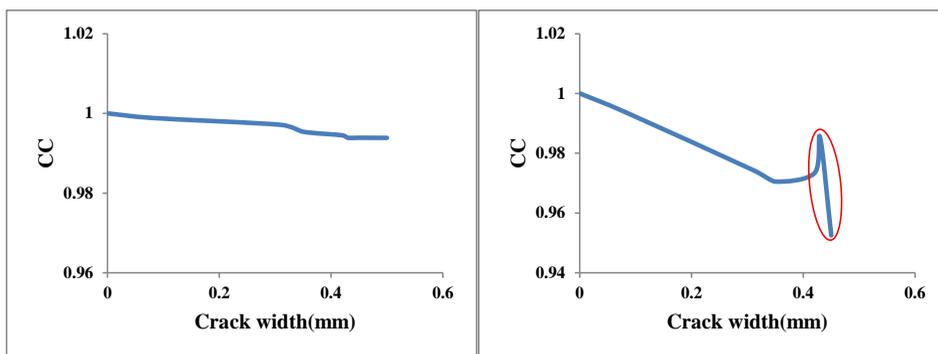
Figure 16: (a) CC variation of patch 2 and (b) patch 3 with crack opening data from LVDT 5.

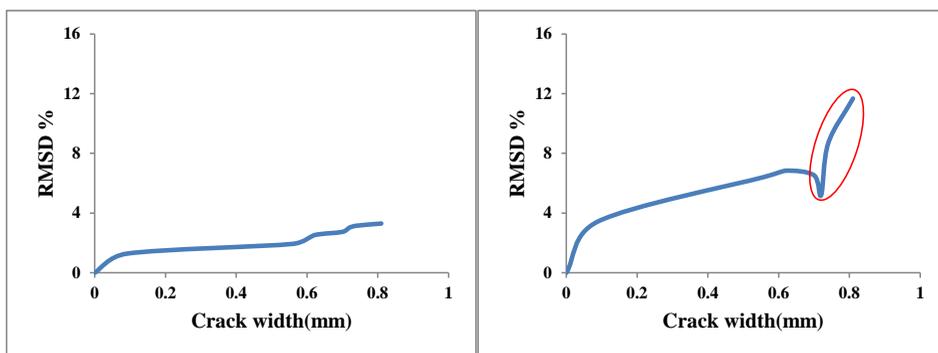
Figure 17: (a) RMSD variation of patch 2 and (b) patch 3 with crack opening data from LVDT 6.

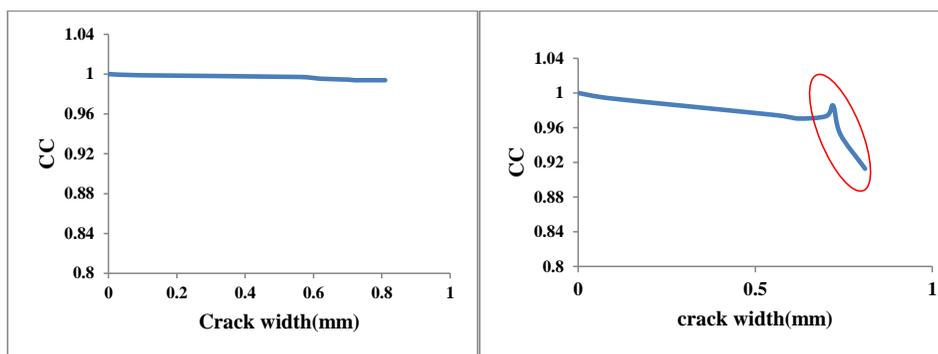
Figure 18: (a) CC variation of patch 2 and (b) patch 3 with crack opening data from LVDT 6.
