2-D Statistical Damage Detection of Concrete Structures Combining Smart Piezoelectric Materials and Scanning Laser Doppler Vibrometry

Abstract: In the present study a new structural health monitoring (SHM) technique is proposed as well as a new damage index based on 2-D error statistics. The proposed technique combines the electromechanical impedance technique (EMI) which is based on the use of piezoelectric Lead Zirconate Titanate (PZT) patches and Scanning Laser Doppler Vibrometry (SLDV) for damage detection purposes of concrete structures and early age monitoring. Typically the EMI technique utilizes the direct and inverse piezoelectric effect of a PZT patch attached to a host structure via an impedance analyzer that is used for both the actuation and sensing the response of the PZT-Host structure system. In the proposed technique the attached PZTs are actuated via a function generator and the PZT-Host structure response is obtained by a Scanning Laser Doppler Vibrometer. Spectrums of oscillation velocity of the surface of the attached PZTs vertical to the laser beam versus frequency are obtained and are evaluated for SHM purposes. This damage detection approach also includes t

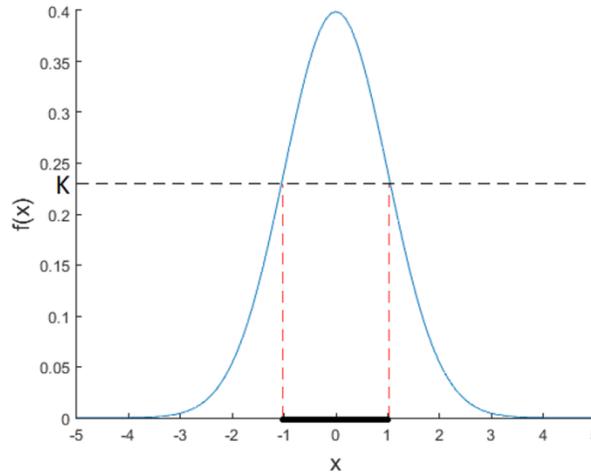
Figure 1: Locus of points where PDF is greater than K

In this case the PDF is bell shaped and symmetrical around the mean value μ . The mean value and the variance σ^2 are the two parameters that can completely characterize a normally distributed random variable. A useful evaluation of the PDF is the locus of the points where PDF is greater or equal to a specific value K . For the scalar case the locus is a line segment (Fig. 1).

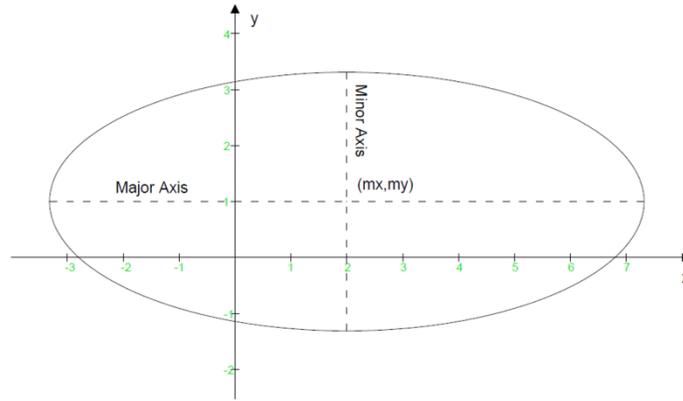
Figure 2: Locus of constant PDF with $\rho=0$, i.e. axis parallel to coordinate frame

which is an ellipse centered at (m_X, m_Y) and two axes with lengths $2\sigma_X\sqrt{K}$ and $2\sigma_Y\sqrt{K}$ for x and y respectively.

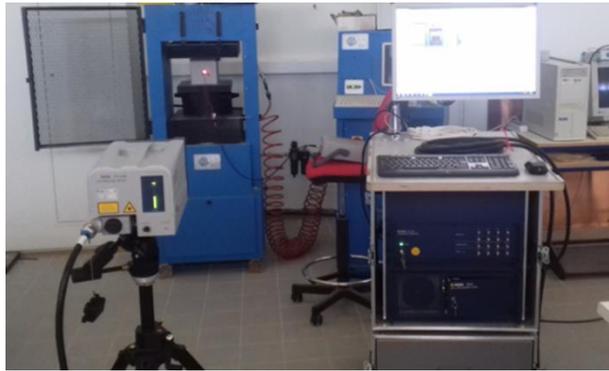
Figure 3: Compression test experimental setup. The PSV 500H Scanning Laser Doppler Vibrometer consisting of the scanning head and the control unit aiming at concrete specimen placed on the compression machine

Three sets of experiments were carried out as proof of concept of the described methodology and damage index. In all three of them the excitation of the PZTs is done via a function generator using a chirp signal with duration time of 60 msec, the interval between two chirp signals was 4 msec and the scanning frequencies were 1 to 100 kHz. The response measurements were obtained using a PSV 500H Scanning Laser Doppler Vibrometer of Polytec. The measurements were obtained in frequency domain, as the PSV 500H software uses a Fast Fourier Transform (FFT), with a sampling time of 64 msec and 6400 number of FFT lines.

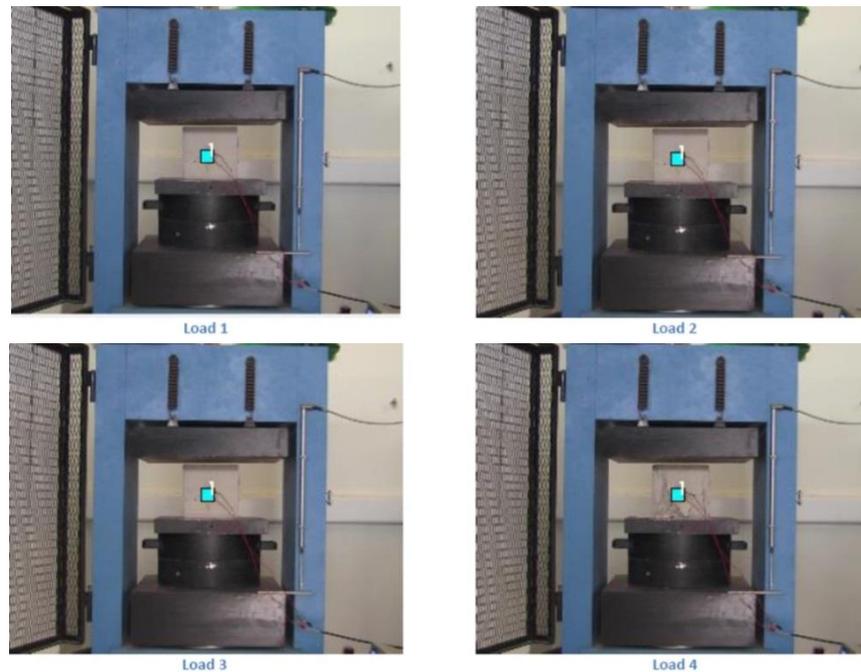
Figure 4: Experimental setup for compression test and the cubic concrete specimen at the end of each cycle

The first set of experiments was cyclic compressive uniaxial test of cubic $150 \times 150 \times 150$ mm concrete specimens made by a mixing proportion of 1:0.62:2.55:3.83 ratio by mean of cement (cement: water: fine aggregate: Coarse aggregate). Each specimen was equipped with a PIC 255 PZT attached on its surface and was subjected to different, ascending uniaxial compressive loads until failure. The specimens are denoted as C1 to C3. In specimen C1 PZT was attached with hard two component adhesive glue. In order to investigate the possibility of applying the aforementioned technique in structures with a sensitive surface or structures where the possibility of permanent attachment of the PZT is not an option, the attachment of PZTs in specimens C2 and C3 was made using a double sided adhesive tape. The first set of measurements was taken prior to any load being subjected to the specimen under test and was the baseline measurement. The following measurements cyclic ascending compressive loads with the measurements being obtained at the end of each cycle.

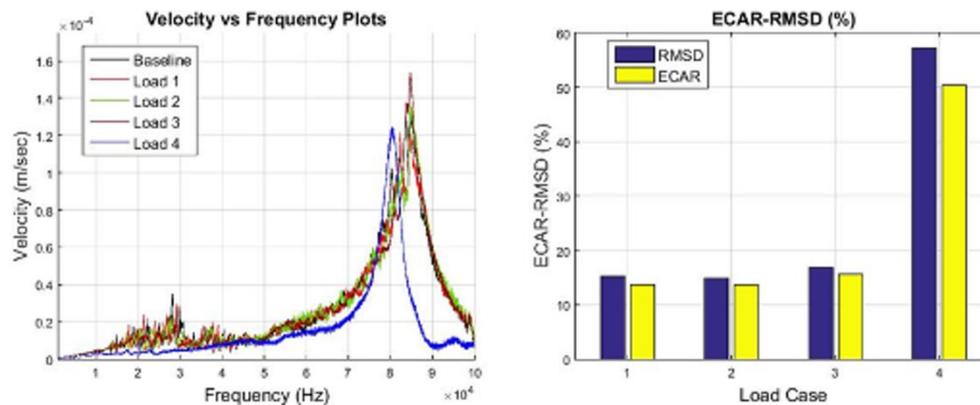
Figure 5: Velocity spectrum (left) and damage indices (right) for load cases 1-4

The covariance matrices were also calculated via Matlab 15 and are presented in Tab. 1. The velocity spectrums and the RMSD and ECAR damage indices are shown in Fig. 5.

Load 1	Load 2	Load 3	Load 4
	221.5 (kN)	305.7 (kN)	413.2 (kN)	677.4 (kN)
RMSD (%)	15.20	14.83	16.92	57.31
ECAR (%)	13.66	13.66	15.56	50.38

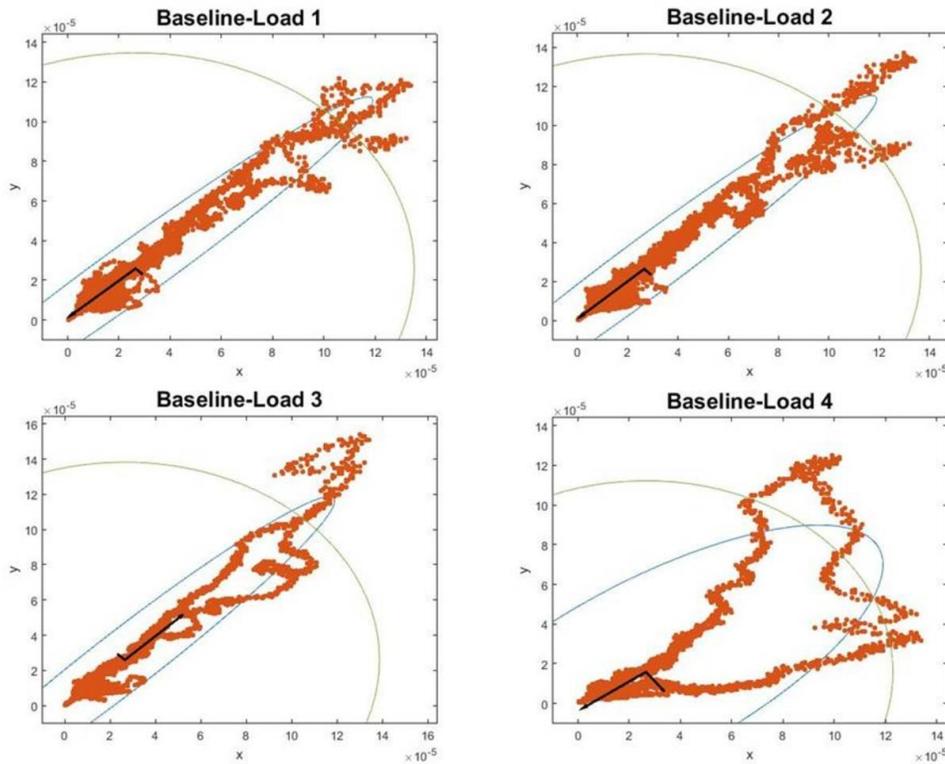
**Figure 6:** Error ellipse and error circle plots for 99.5% confidence level for Loads 1-4

As described in previous chapter, for early load levels with less damage and therefore less difference compared to the baseline measurements, the ellipse is thinner and more elongated and the area of the ellipse is therefore smaller. In this case the majority of the measurement values are located along the axis of the largest eigenvector and the in the special case when there is no difference between the baseline and the investigated load case the ellipse degenerates to a line with the ECAR value taking the extreme value 0. In Fig. 6 the eigenvectors are shown in black color. The orientation of the ellipse is obvious and the rotation angle mentioned in Tab. 2 is the angle between the largest eigenvector and the x axis. As the damage grows bigger thus the differences in the values grow bigger resulting in a greater dispersion of the values on the plot and bigger area of the ellipse. As mentioned in the previous chapter the eigenvalues represent the spread of the data in the direction of the eigenvectors. In the special case of equal eigenvalues the dispersion of values is the same in both directions which means that the ellipse degenerates to a circle

as the two foci of the ellipse coincide. In this case the ECAR index takes the extreme value 1 which is the upper limit of the index. The differences between the load cases and all the values calculated via Matlab are represented in Fig. 6.

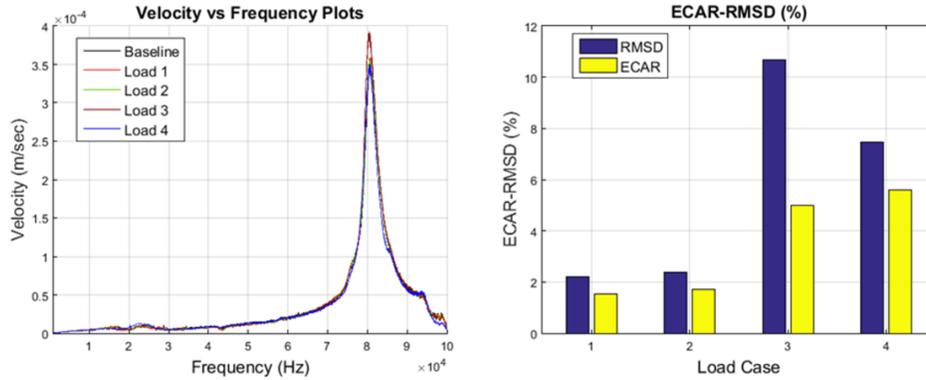
Figure 7: Velocity spectrum (left) and damage indices (right) for load cases 1-4

Load 1	Load 2	Load 3	Load 4
	224.6 (kN)	407.6 (kN)	618.4 (kN)	595.4 (kN)
RMSD (%)	2.18	2.39	10.66	7.48
ECAR (%)	1.53	1.72	5.00	5.59

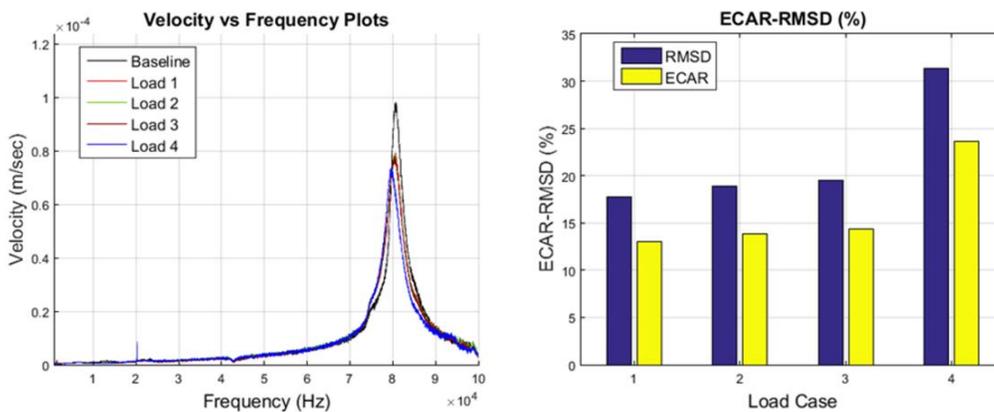
Figure 8: Velocity spectrum (left) and damage indices (right) for load cases 1-4

Load 1	Load 2	Load 3	Load 4
	224.6 (kN)	407.6 (kN)	618.4 (kN)	595.4 (kN)
RMSD (%)	17.73	18.88	19.55	31.38
ECAR (%)	13.01	13.84	14.33	23.59

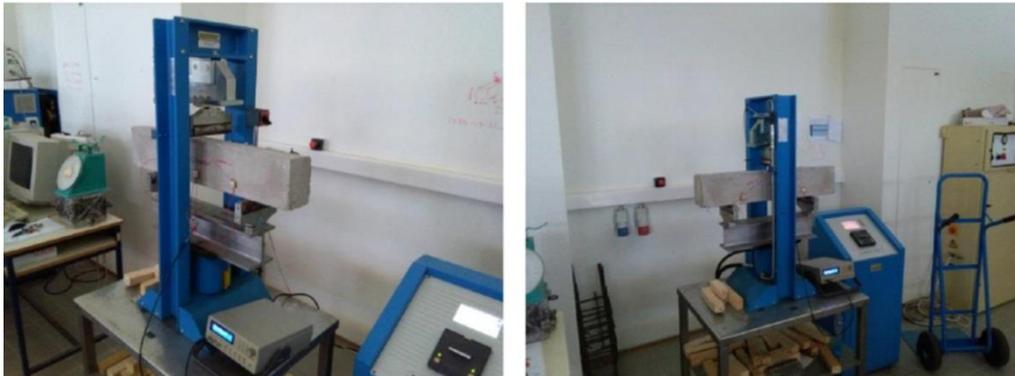
Figure 9: Experimental set up for bending test

The second set of experiments that was carried out was bending test of lightly reinforced concrete beams, sized $100 \times 150 \times 750$ mm, of the same mixing proportions as in the first set of experiments and reinforced with one steel rod with 10 mm diameter. As in the first set of experiments, the loading pattern was ascending until failure, with the measurements being made in the unloaded state. The specimens are denoted as B1 to B6. All the beams were lightly reinforced with one longitudinal steel rod of 10 mm diameter and equipped with two PZTs, located in the vicinity of the two possible shear failure routes. The objective of the experiment was to detect the shear failure due to vertical force. Due to low cohesion between the steel rod and concrete, specimens B2, B3 and B4 failed due to bending moment as shown in the following figures. Even though the specific specimens did not fail in the predicted way, they are still included in this article as the intensity and the location of the damage was successfully detected.

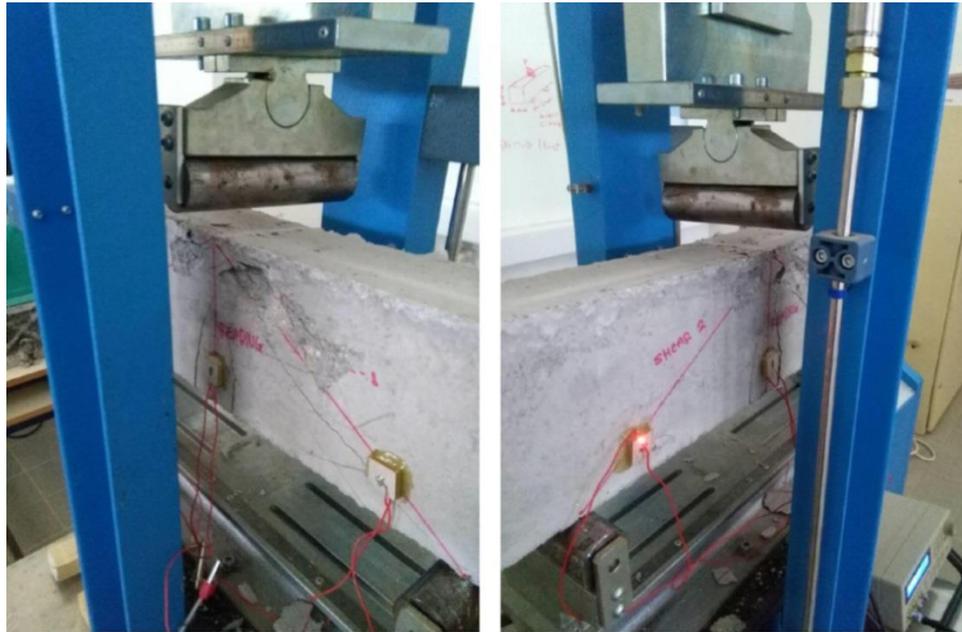
Figure 10: Shear failure pattern (Failure in the right side shear diagonal)

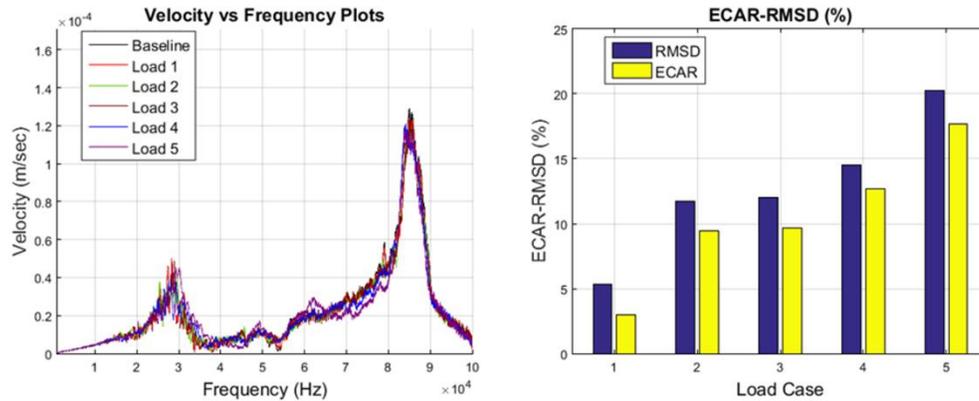
Figure 12: Velocity spectrum and damage indices for load cases 1-5 of the right PZT

PZT RIGHT		PZT LEFT	
	ECAR (%)	RMSD (%)	ECAR (%)	RMSD (%)
Load 1	3.31	3.75	2.98	5.29
Load 2	9.05	11.32	9.46	11.73
Load 3	9.28	11.47	9.69	12.03
Load 4	11.64	13.51	12.66	14.54
Load 5	26.29	32.58	17.70	20.29

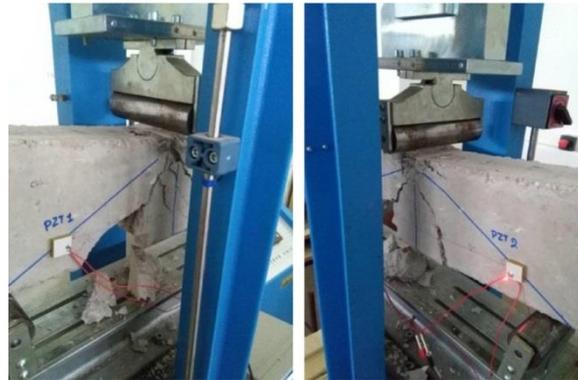
Figure 13: Failure pattern of B2

As shown in Fig. 13 the major failure occurred in the left side of the beam which was successfully detected by the indices. Due to the light reinforcement of the beam damage also occurred in the vicinity of the right PZT which occurred earlier in load case 3, explaining the spike in damage indices for the right PZT.

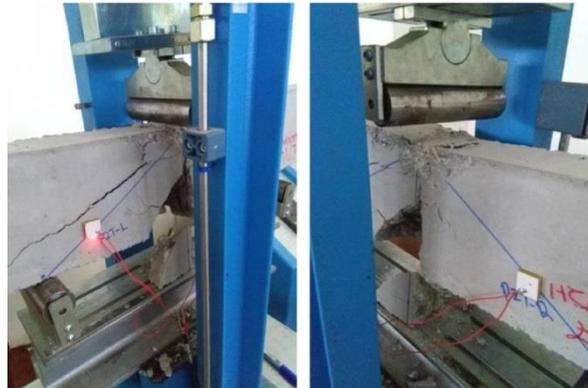
Figure 14: Failure pattern of B3

As in beam specimen B2, due to light bending reinforcement of the beam a big “tooth” shaped piece of concrete was detached as shown in Fig. 14 resulting in a big spike in both sensors damage indices, making the results inconclusive as far as the detection of the shear failure is concerned.

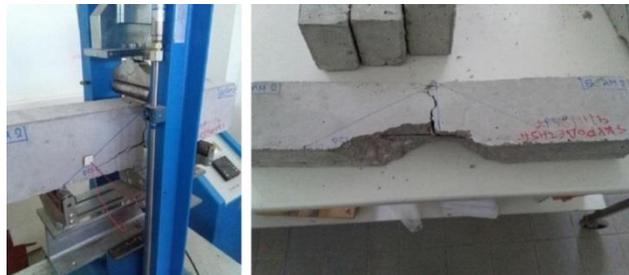
Figure 15: Failure pattern of B4

Damage occurred near both PZTs (Fig. 15) with the damage occurring in the left side being more severe as is obvious after evaluating the damage indices.

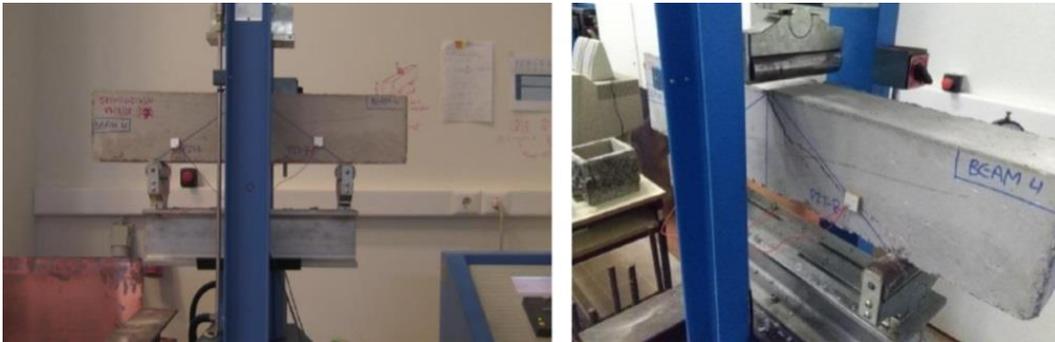
**Figure 16:** Failure pattern of B5**Table 11:** Damage indices values

Damage detection along the right hand side shear diagonal was successful in beam specimen B5.

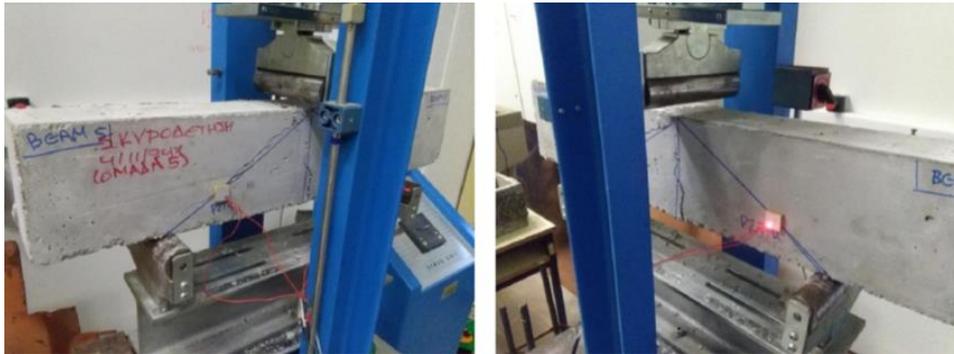
Figure 17: Failure pattern of B6

Damage detection along the left hand side shear diagonal was successful in beam specimen B6. The bending test of the specific specimen underlines one of the greater shortcomings of the RMSD damage index. A spike in RMSD values is observed in the right PZT but not in the ECAR index. RMSD index can have a great fluctuation for great differences between few values. After evaluating the velocity plots (Fig. 18), it is obvious that the plots are similar and only have great difference in the peak value. The impact on the ECAR index in this case is slight while when using the RMSD index to detect damage we get a false alarm.

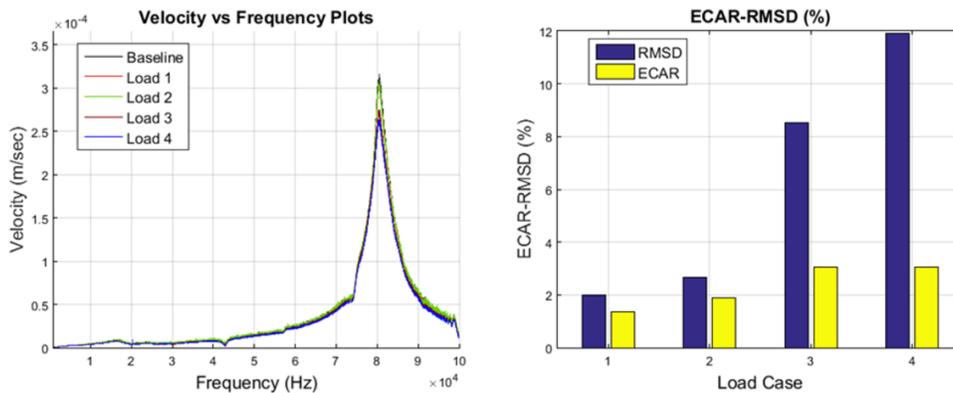
Figure 18: Velocity spectrum and damage indices for load cases 1-4 of the right PZT

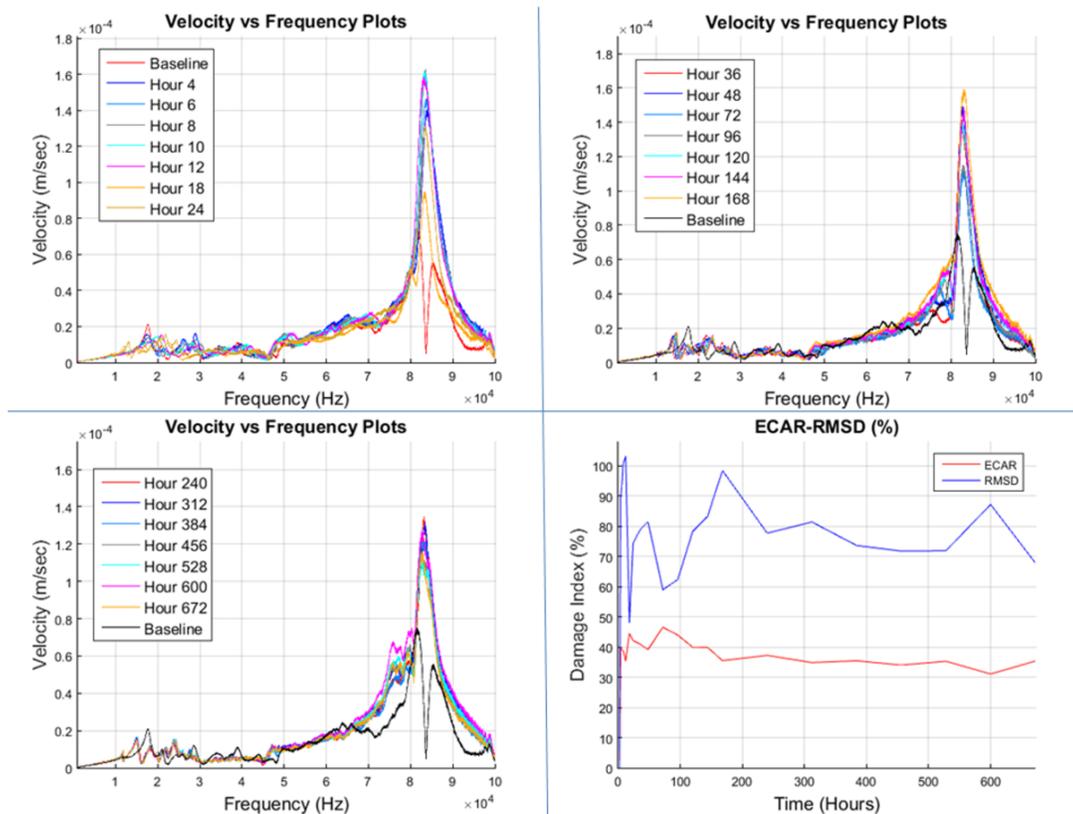
Figure 19: Velocity spectrums and damage indices

The monitoring process begun on the 15/12/2017 and the first measurement took place 2 hours after casting and was used as a reference value. The rest of the measurements were taken as shown in the table below.

Hour	2	4	6	8	10	12	18	24	36	48	72
RMSD	0.00	89.57	93.64	100.76	102.01	103.00	48.10	74.44	79.03	81.45	58.95
ECAR	0.00	39.87	39.15	38.68	37.30	35.42	44.47	42.13	40.85	39.15	46.56
Hour	96	120	144	168	240	312	384	456	528	600	672
RMSD	62.36	78.27	83.26	98.44	77.68	81.39	73.61	71.75	71.87	87.18	67.82
ECAR	43.92	39.94	39.87	35.49	37.23	34.85	35.43	34.02	35.27	31.07	35.35
