Field Load Test Based SHM System Safety Standard Determination for Rigid Frame Bridge

Continuous rigid frame bridge; rehabilitation; long-term monitoring; field load test; safety standard determination

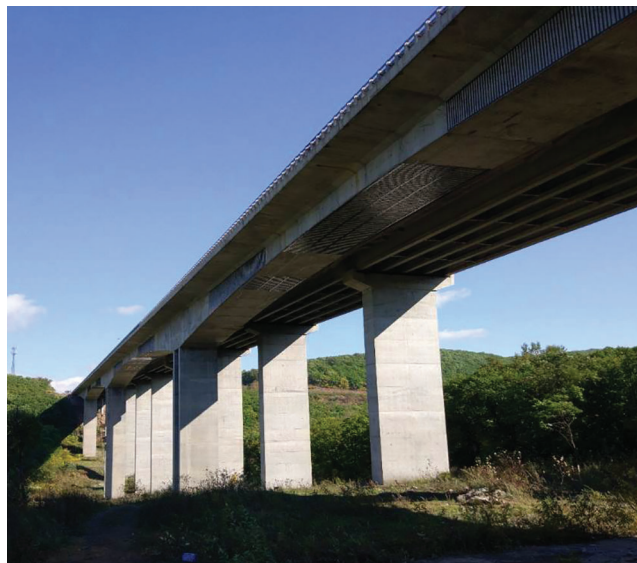
Figure 1: General view of the rehabilitated highway bridge

General view of the rehabilitated highway bridge is shown in Fig. 1. The highway bridge, which is the subject of interest in this thesis, is located in the northeast region of China. It was originally opened to traffic in December 2010. The bridge spans a total length of 549,356 mm and has a width of 24.5 m. However, the focus of the rehabilitation efforts was from north to south, specifically from Xing Mountain to the provincial border. The width of the bridge is 12 m, accommodating two traffic lanes. The span arrangement is $75\text{ m} + 3 \times 130\text{ m} + 75\text{ m}$, as shown in Fig. 2.

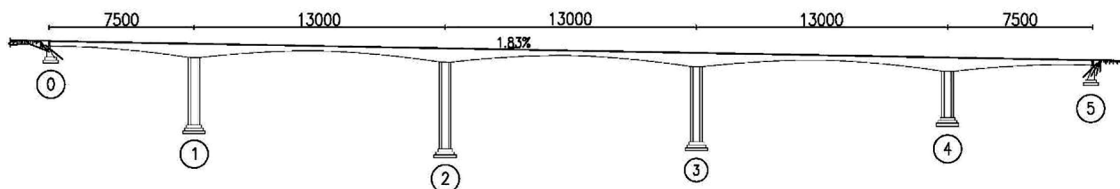
Figure 2: General view of the rehabilitated highway bridge (unit: cm)

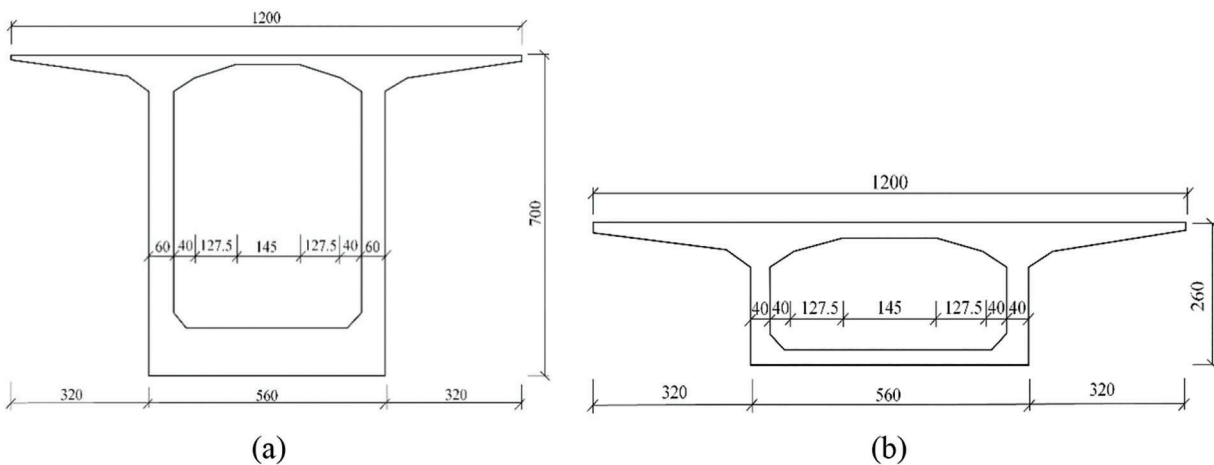
Figure 3: Cross-section view for (a) top of a pier (b) mid-span (unit: mm)

The superstructure is made up of a 5-span continuous prestressed concrete rigid frame, which includes a prominent large box girder. The box girder is single-walled; 7.0 m in height being the tallest cross-section on

top of a pier, whereas 2.5 m in height at mid-span. The bottom plate of the box girder has a width of 5.6 meters, while the bridge flange is 3.2 meters wide.

The top layer of the box girder is 0.25 m in thickness, and 0.50 m in thickness for cross-sections near a pier. The thickness of the web is 0.8 m around a pier, 0.40 m for the 81.4 m range in the middle of the span, and 0.6 m for the rest of the webs. The thickness of the bottom plate on top of a pier is 1.2 m, 1.0 m at the pier junction, and 0.25 m at mid-span.

An illustration of typical cross-sections is shown in Figs. 3a and 3b.

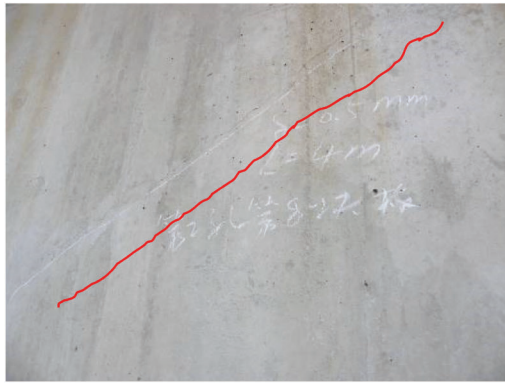
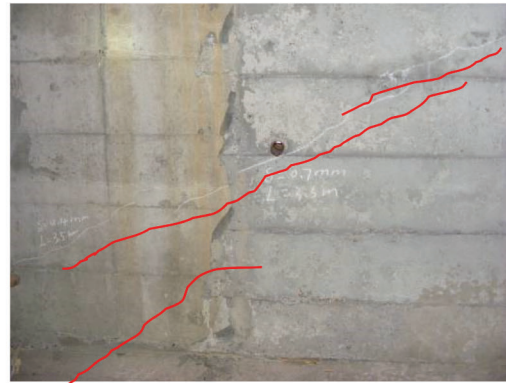
Figure 4: Cracks distribution on the web

(a) The crack observed on the exterior surface of block No. 8 ($L=4.0\text{m}$ $\delta=0.5\text{mm}$ $\alpha=45^\circ$)

(b) The oblique crack observed on the interior surface ($L=8.0\text{m}$ $\delta=0.5\text{mm}$ $\alpha=35^\circ$)

The specific continuous rigid frame box girder bridge that has been examined in this study was initially put into service for vehicular traffic in the year 2006. Nevertheless, after a mere six years of service, the bridge started to display indications of deterioration and a decrease in its ability to bear loads. Cracks were identified on the upper slab, web, and lower slab of the bridge during routine inspections conducted in 2012, 2013, and 2015, with a greater prevalence noted on the external surfaces compared to the internal surfaces. Over the passage of time, there was a noticeable increase in the length, width, and quantity of cracks. Most of the cracks measured between 0.15 to 0.4 mm in width and 0.3 to 7 m in length. In compliance with the specified codes and standards, the presence of transverse cracks in prestressed concrete beams is considered undesirable, while longitudinal cracks are permissible as long as their width does not exceed 0.2 mm. Despite this, multiple vertical cracks on the box girder were found to surpass the specified allowable limit. The distribution pattern of these cracks on the web of the box girder is illustrated in Fig. 4.

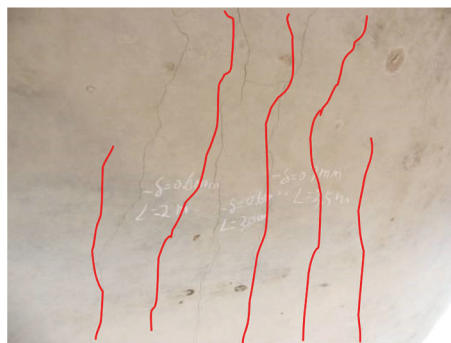
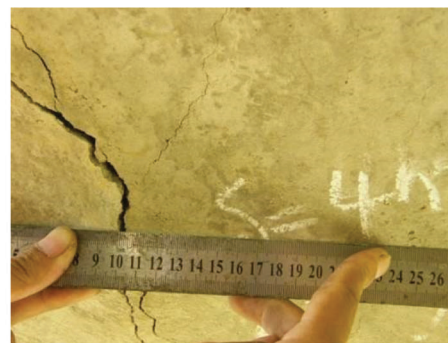
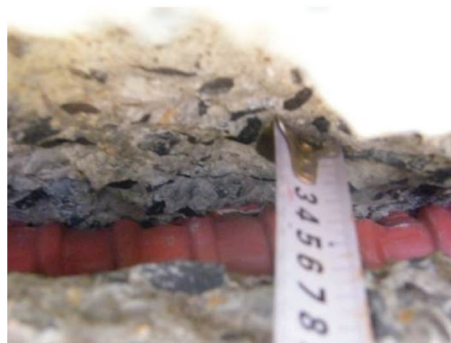
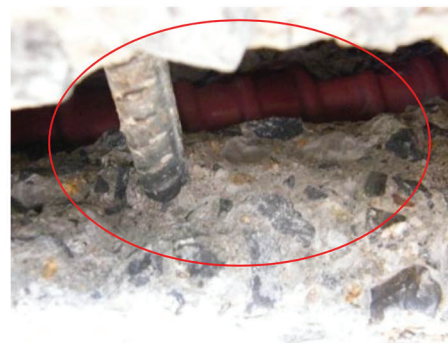
Figure 5: The cracks detected on the underside of the box girder's slab

(a) Span No.2 bottom slab cracks ($L=20.5\text{m}$ $\delta=4\text{mm}$)

(b) Span No.2 longitudinal bottom crack ($L=0.7\text{m}$ $\delta=0.6\text{mm}$)

(c) Span No. 2 longitudinal crack corrugate pipe deterioration

(d) Span No.2 Longitudinal crack hollow section

During the 2013 inspection, on the exterior surface of the bottom slab of span No. 2 in the fold section, five longitudinal cracks were detected. These cracks had lengths ranging from 2 to 7 m and widths ranging from 0.6 to 4 mm. During the 2015 inspection, a total of nine longitudinal cracks were identified on the bottom slab of the fold section. Out of these, four cracks were observed on the bottom slab of span No. 3, while seven cracks were found in span No. 2. The bottom slab of span No. 2 exhibited the most severe condition, with cracks reaching a maximum width of 4 mm and a depth of 3 mm, leading to concrete separation. After removing loose concrete around the cracks, it was discovered that the affected area had become hollow and the corrugated pipe had suffered minor damage. Damages are shown in Fig. 5.

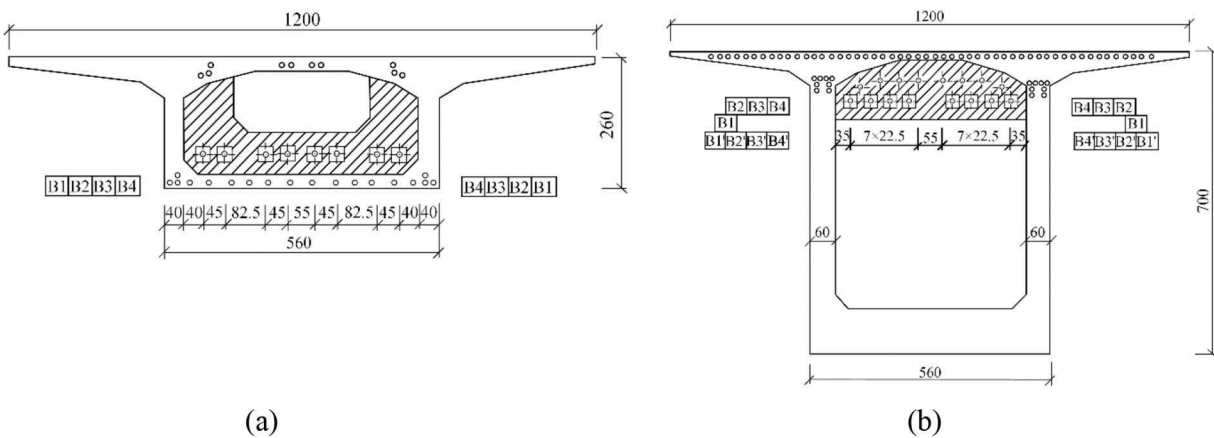
Figure 6: Cross section view of external prestressing

The inner surface of the box girder serves as the anchor point for the external prestressing strands, with a total of 8 external tendons for each span. Detailed arrangements are shown in Figs. 6 and 7.

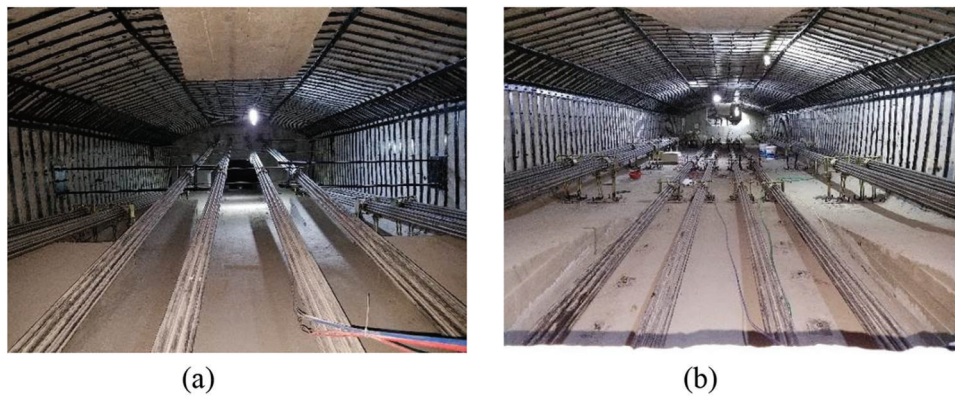
Figure 7: On-site installation of external prestressing tendon

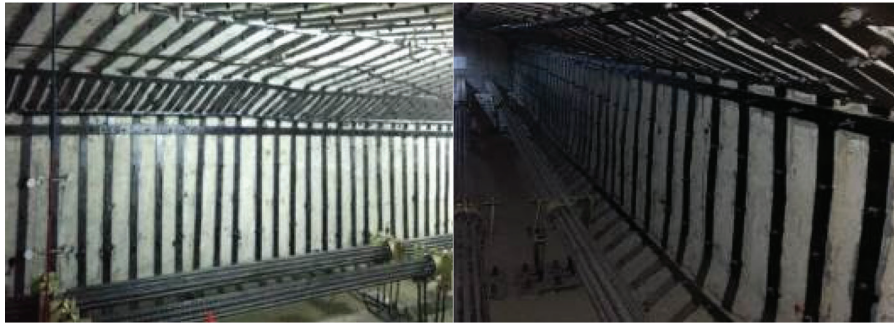
Figure 8: Steel plates on the interior of the girder web

Reinforcement stirrups of the diaphragms are of diameter $\Phi 10$, which are not sufficient in restricting crack growth. To restrict the diagonal cross-section strength, steel plates of grade Q235C were affixed to sections 6~14 within the girder and sections 6~10 on the exterior of the girder. These steel plates measure 60 mm in width and 6 mm in thickness, with the length determined by the height of the web. The plates are spaced at 150 mm intervals on the inside and 200 mm intervals on the outside. The anti-corrosive coating used zinc-rich primer plus coal tar epoxy coating. Two layers of zinc-rich primer, each of 35 μm , and two layers of coal tar epoxy coating, 80 and 120 μm . The total thickness of the steel plate is 200 μm as shown in Fig. 8. For severe diagonal cracks that existed, they should be glued before the steel plates pasting.

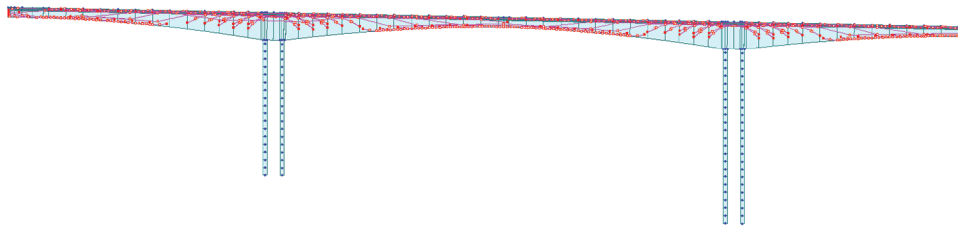
Figure 9: MIDAS external tendon model

Midas/Civil software was utilized for finite element modeling of the entire bridge structure. The element type is beam element. The model comprises the structure consists of 300 elements and has a total of 325 nodes. Specifically, the bridge deck is characterized by 154 elements and 155 nodes, whereas the piers feature 146 elements and 170 nodes. The boundary condition of the bottom of the flexible pier is consolidation, and the boundary condition of the two ends of the beam is horizontal sliding. The main beam and pier share a joint. The model is established according to the construction stage, and the effect of shrinkage and creep in 12 years after construction is considered. On this basis, the post-tensioning prestressing model is established. The piers and bridge deck are firmly interconnected. The bridge abutments are vertically supported, providing vertical stability. For the calculation, design parameters based on grade A prestressing structure standards were employed. The safety standard adhered to is level 1, which is the highest safety level. The structural components of the bridge are cast *in-situ*. The bridge itself is a prestressed concrete continuous rigid frame box girder, comprising spans of 75 m, followed by three spans of 130 m each, and another 75 m span. The depicted Fig. 9 demonstrates the Finite Element model, which consists of 61 construction stages and enables the simulation of various important rehabilitation procedures, such as on-site cantilever concrete casting.

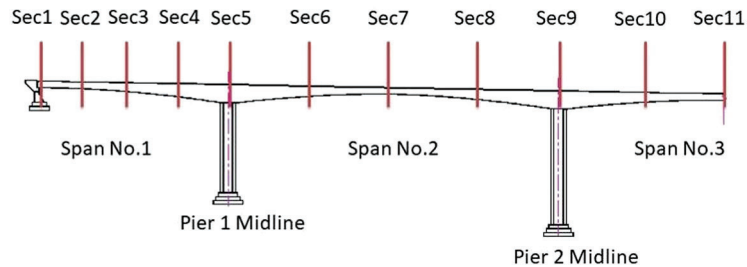
Figure 10: Key sections of the analytical model

quarter-span, half-span, and three-quarter span intervals. For ease of reference, these key sections are named as Sec1, Sec2, Sec3, and so on up to Sec21. However, since the bridge structure exhibits global symmetry, the analysis will focus solely on Sec1 to Sec11, as they encompass the necessary representative sections. Key sections are shown in Fig. 10.

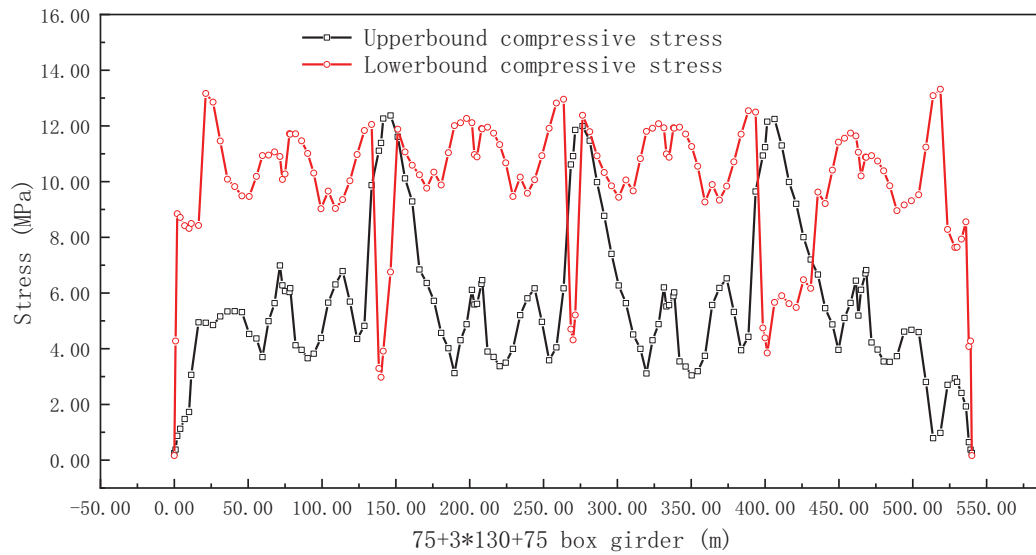
Figure 11: Maximum and minimum compressive stress

Based on Table 1 and Figs. 11–13, all cross-sections of the bridge structure were found to be under a compressive state. The maximum compressive stress in each span is concentrated near the mid-spans, and the maximum compressive stress in the lower bound occurs within the quarter-span to the pier region. Alternatively, the highest tensile stress in each span is found at or close to the quarter or three-quarter cross-sections.

The maximum compressive stresses observed in the key section at the midspan are 11.39 MPa for the upper bound and 10.89 MPa for the lower bound. These values are lower than the threshold requirement of $0.5 f_{ck} = 16.2$ MPa stipulated in the JTGD62-2004 code for structural components of type A. Furthermore, the maximum principal compressive stress observed in the key section at the midspan is 11.62 MPa, which is less than the $0.6 f_{ck} = 19.44$ MPa prescribed by the JTGD62-2004 code. Regarding tensile stress, the maximum value observed near the quarter span is -1.07 MPa, which is also lower than the $0.5 f_{ck} = 1.33$ MPa specified in the JTGD62-2004 code.

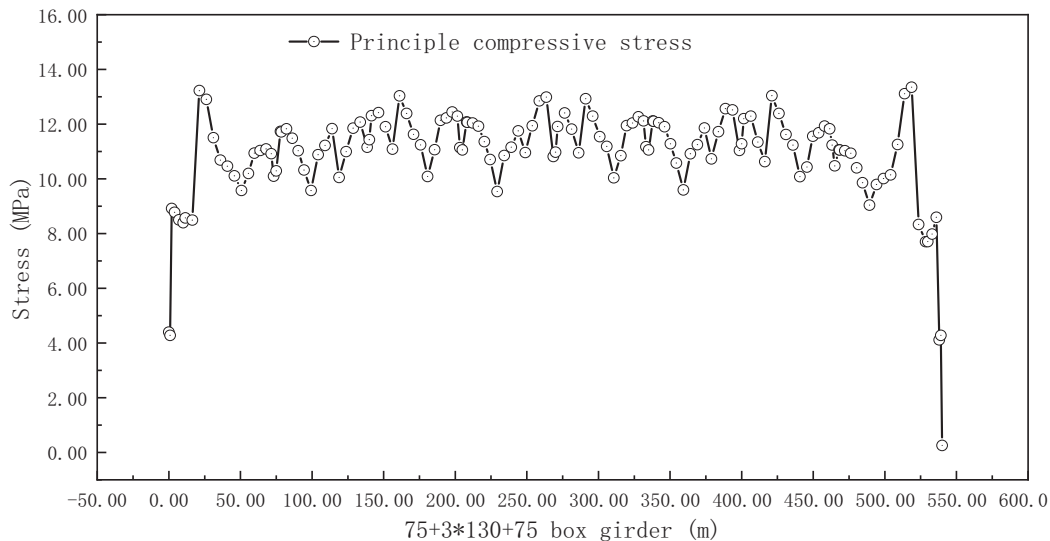
Figure 12: Compressive stress derived from the box girder principle

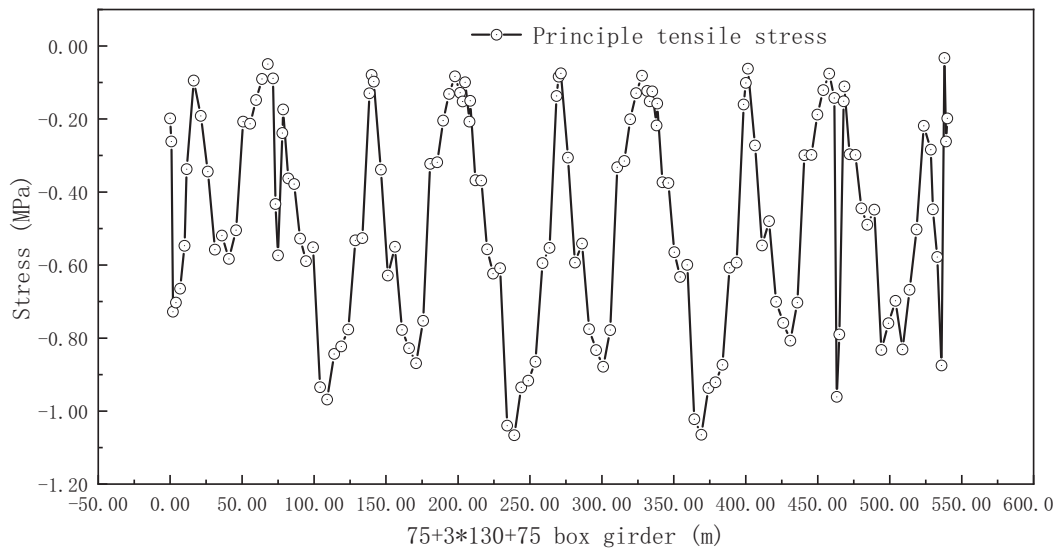
Figure 13: Tensile stress derived from the box girder principle

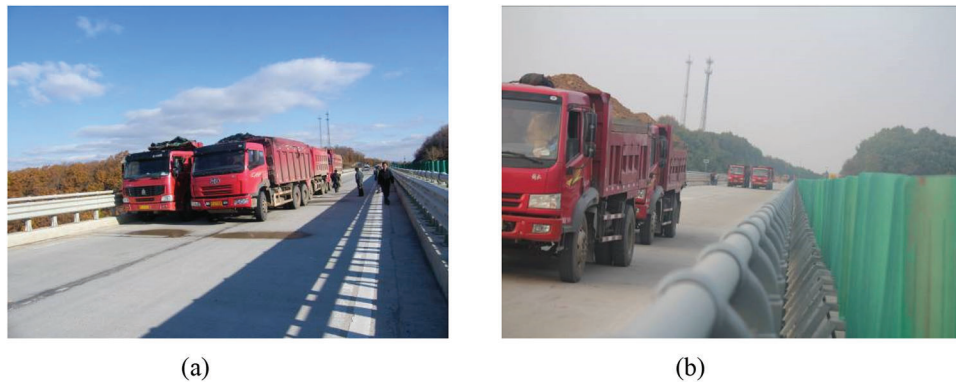
Figure 14: Eccentric loading of load test: (a) before strengthening; (b) after strengthening

The 5-span bridge, with spans measuring $75\text{ m} + 3 \times 130\text{ m} + 75\text{ m}$, was originally designed to accommodate a live load of 360 kN. The design specification was developed in accordance with the Chinese design code JTG 021-1985, which corresponds to the AASHTO HS15 loading requirement stipulated in the American bridge design code. To evaluate the structural performance of the bridge, static loading tests were carried out before and after the reinforcement measures were implemented. Fig. 14 presents a visual depiction of these tests. In order to simulate the maximum bending moment effect and ensure the effectiveness of the test, 8 heavy vehicles are determined to be used as the test load. The test loads are 352.2, 362.0, 334.5, 371.6, 342.8, 330.1, 351.4, and 371.3 kN, respectively. The grade I load of the highway is simulated by changing the longitudinal position on the bridge floor to ensure the test load efficiency. The diagram of medium load and off-load loading is shown in Fig. 15.

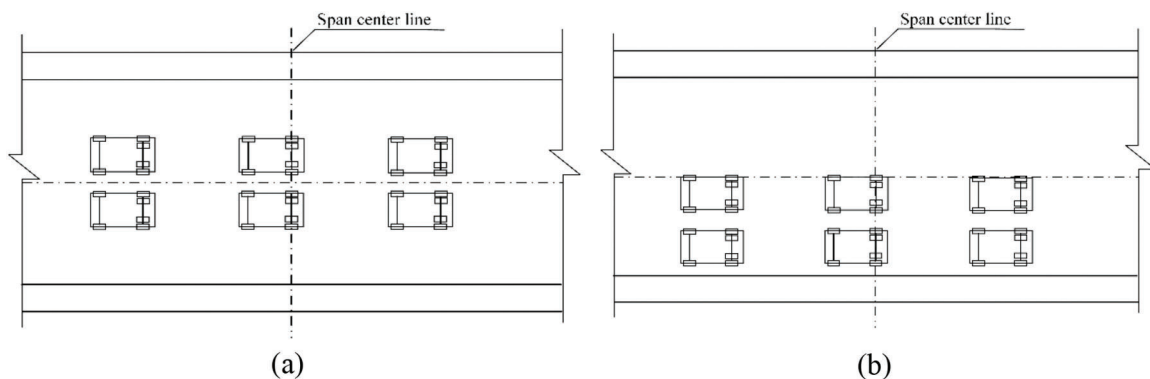
Figure 15: Loading diagram: (a) symmetric loading; (b) eccentric loading

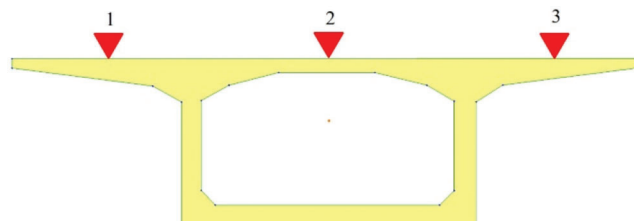
Figure 16: A cross-sectional perspective illustrating the positions of deflection measurements

The deflection value serves as an indicator of the structural integrity and resilience of a bridge. It is an essential parameter that is carefully monitored during load testing. To accurately capture the deflection behavior, measurement points are strategically located at positions where the theoretical maximum bending moment is expected to occur. Fig. 16 illustrates the placement of deflection measurement points, labeled as 1, 2, and 3, on the upper surface of the girders.

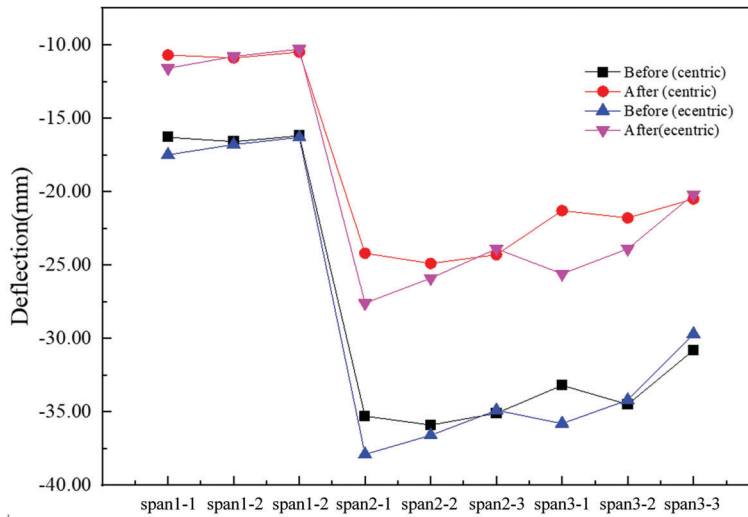
Figure 17: Graph showing the measured vertical displacement curve

The findings regarding vertical shift, obtained through measurements, are presented in Fig. 17, depicting the conditions before and after the strengthening process. The measured deflection values after the

rehabilitation of the bridge are all lower compared to the values recorded before the strengthening. In particular, the maximum displacement has decreased to 27.6 mm, a significant improvement from the initial value of 37.9 mm, representing a 27% reduction. The bearing capacity of each span has also shown improvement. Span No. 1 has experienced an 18.2% increase in its bearing capacity, while span No. 2 has seen a 17.5% increase, and span No. 3 has shown a 19.7% improvement. These results highlight the effectiveness of external prestressing in enhancing structural performance. However, it is important to note that the actual progress achieved is slightly lower than the theoretical calculated progress due to prestress loss that occurred during the construction process.

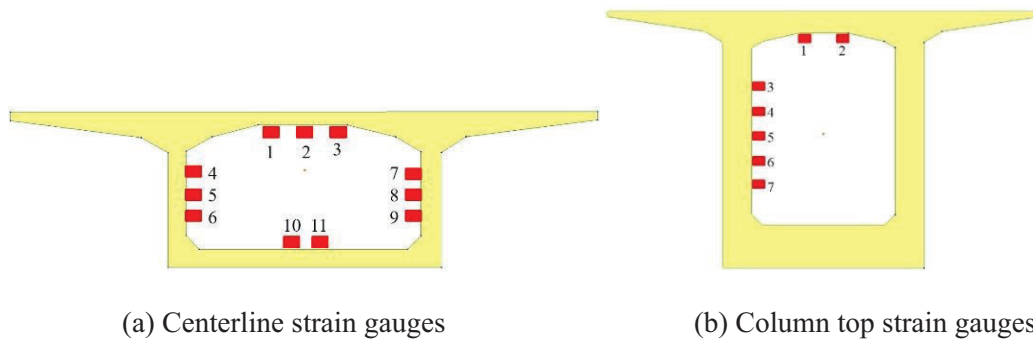
Figure 18: Strain measurement points during load testing

In order to account for the variation within the realm of structural mechanics between the midspan and sections near the piers, Fig. 18a displays the positioning of strain monitoring locations at the mid-span cross-section, while Fig. 18b illustrates the strain measurement points at the top of the pier.

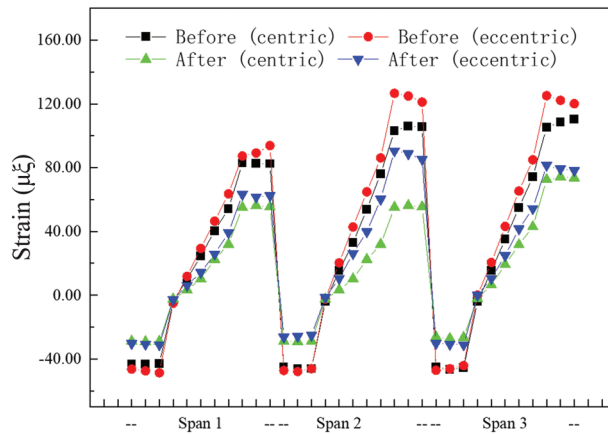
Figure 19: Recorded strain measurements for span 1~3

The deformation data collected from static loading tests are compared to the results obtained from previous static loading tests conducted prior to the rehabilitation process. The results for spans 1~3 are presented in Fig. 19, while the results for pier 2 are illustrated in Fig. 20.

After the strengthening of span 1, the recorded strain values for each load case exhibited consistently improved results. The strain validation factor, varying from 0.66 to 0.75, signified an enhancement in the structural rigidity. The load carrying capacity exhibited an average increase of 28%, along with an average 27% increase in the verification coefficient. Likewise, for span 2, the strain validation coefficient

varied from 0.57 to 0.79, with an average 26% increase in load carrying capacity and an accompanying average 27% rise in the verification coefficient. In span 3, the verification coefficient ranged from 0.57 to 0.76. Under center-loaded at midspan, there was an average 27% increase in strain, matched by an average 27% increase in the verification coefficient. In contrast, under eccentric loading, there was an average strain improvement of 23%, accompanied by an average increase of 24% in the verification coefficient. These results highlight the positive impact of the strengthening measures on the bridge's performance and structural behavior.

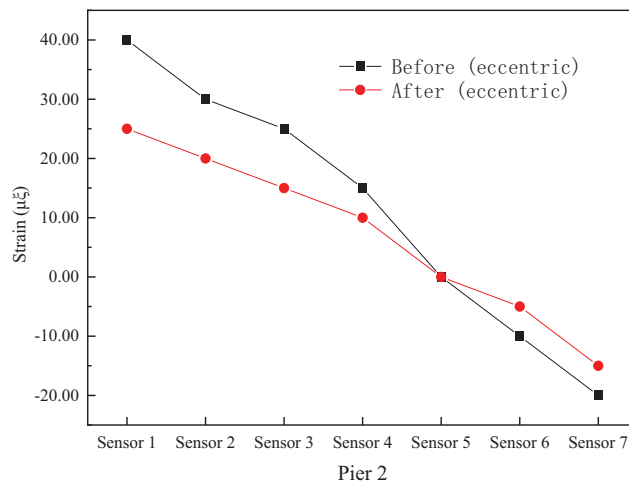
Figure 20: Measured strain data for pier 2

At pier 2, as shown in Fig. 20, The load carrying capacity demonstrated an average increase of 15% following the strengthening measures, while the verification coefficient experienced an average improvement of 18%.
