A Review of Infrared Thermography Applications for Civil Infrastructure

Prabal Shrestha¹, Onur Avci^{1,*}, Sahabeddin Rifai¹, Feras Ablal¹, Michael Seek², Karl Barth¹ and Udaya Halabe³

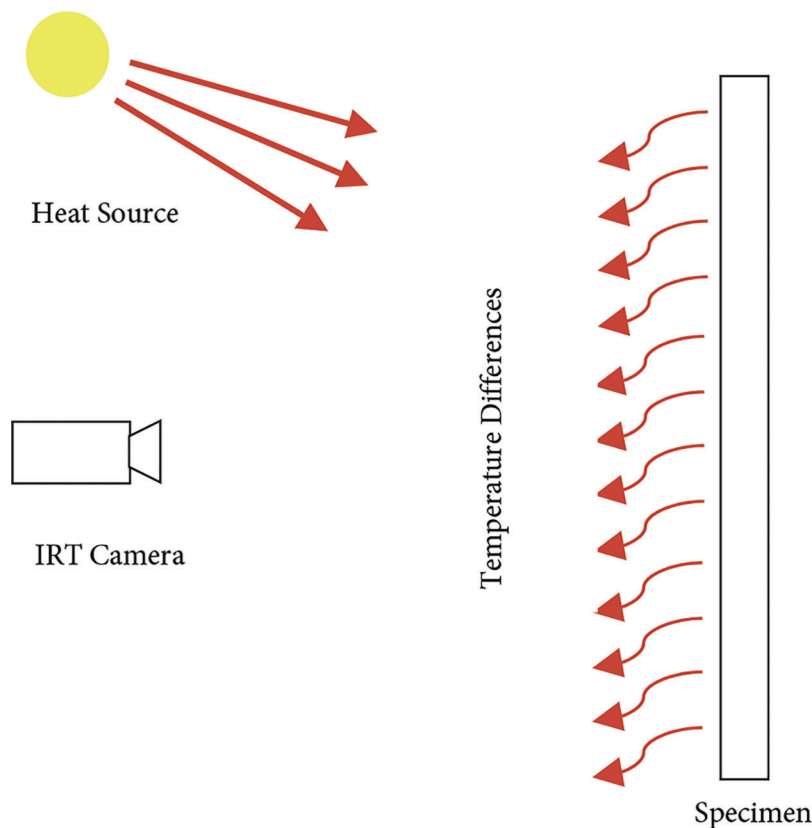
Figure 5: Typical equipment arrangement for bridge deck infrared thermography. Reprinted from Reference [34]

The main idea of IRT for reinforced concrete bridge evaluation is that defects, delaminations, and subsurface voids intervene with the transfer of heat through and along the concrete. They also appear with different temperature signatures and thermal values on the thermal images relative to the area of sound concrete throughout the concrete [33]. Detecting the defective region in the surface temperature profile makes it possible to identify subsurface defects in concrete. When external sources of heat, such as the sun, heat up the surface of concrete or any test object, it emits radiation in the IR range of the electromagnetic spectrum, which is ultimately detected using a thermographic camera [34]. This allows the investigator to obtain thermographic images called thermograms, which are used to identify the mentioned abnormal regions on the concrete surface. A typical arrangement of a heat source and IRT camera to record thermograms for concrete surfaces is depicted in Fig. 5.

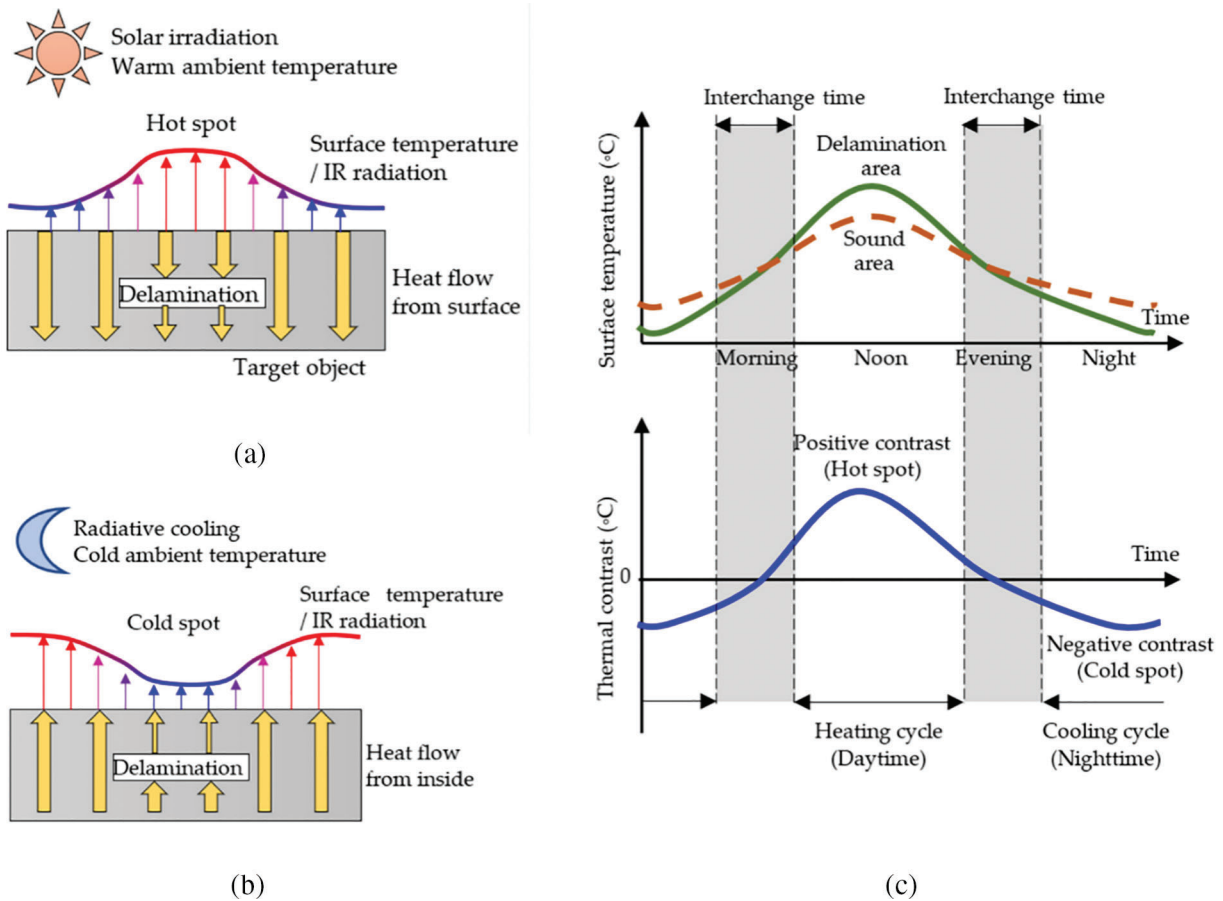
Figure 6: Heat flow during the (a) heating cycle daytime, (b) the cooling cycle nighttime; (c) daily changes of surface temperatures and thermal contrast. Reprinted from Reference [21]

radiant energy gets emitted out of the concrete, which initially absorbs the heat. Air voids and delaminations underneath the surface of the concrete will naturally try to resist the heat transfer and warm up concrete regions above them quicker than sound concrete surrounding them, making the delaminations appear as hot spots on the thermal IR image. On the contrary, during the night, when the ambient temperature decreases, the area of sound concrete around the air voids and delaminations ends up losing heat at a much lower rate compared to the delaminations [21,35] (Fig. 6). The delaminations appear as cold spots on the thermograms [33]. This mechanism is illustrated in Fig. 7.

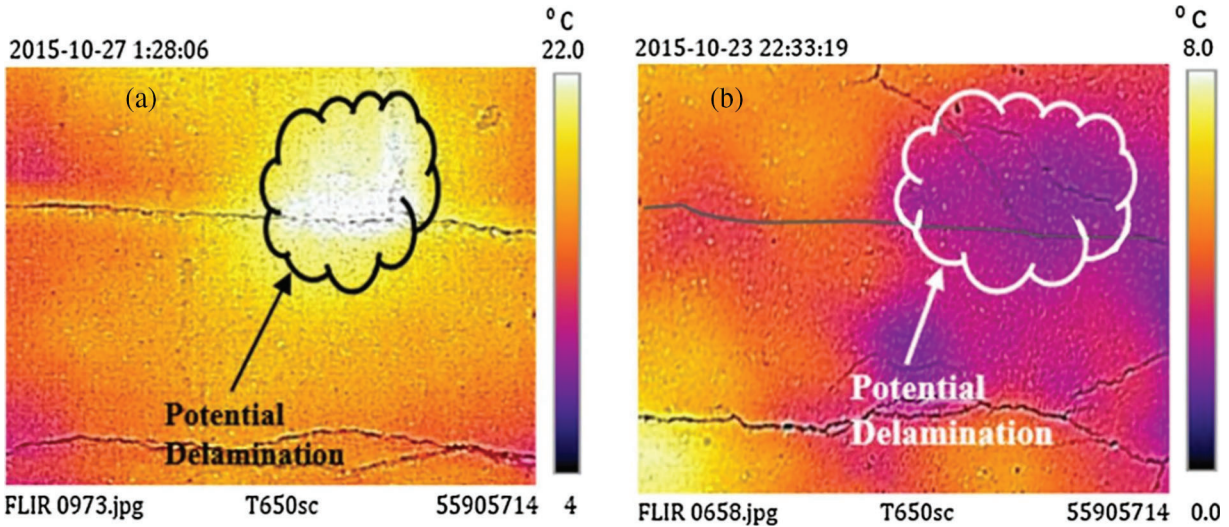
Figure 7: Examples of typical thermograms with potential delaminations, (a) daytime heating, and (b) nighttime cooling. Reprinted from Reference [9]

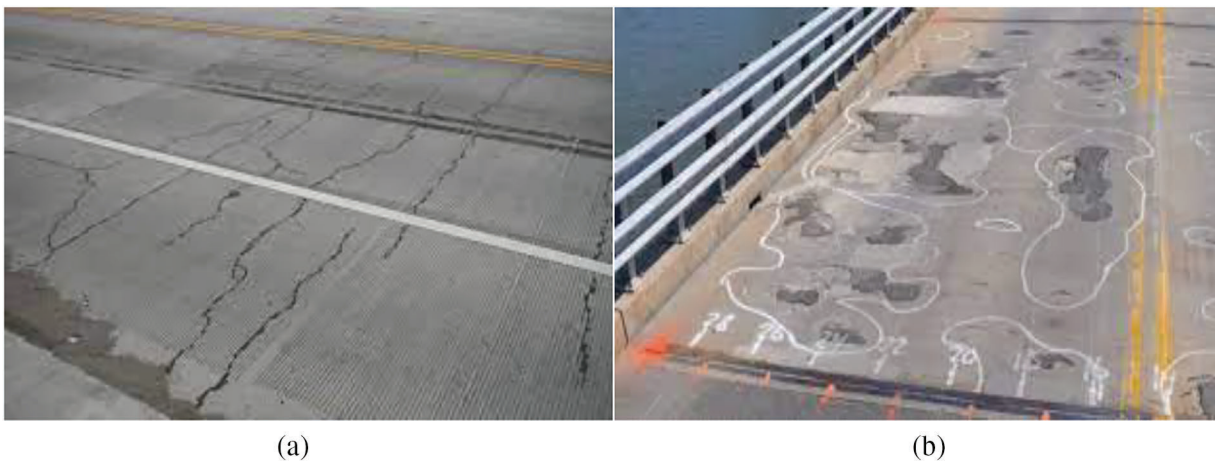
Figure 8: (a) RC deck with cracks, (b) spalling and potential delaminations. Reprinted from Reference [6]

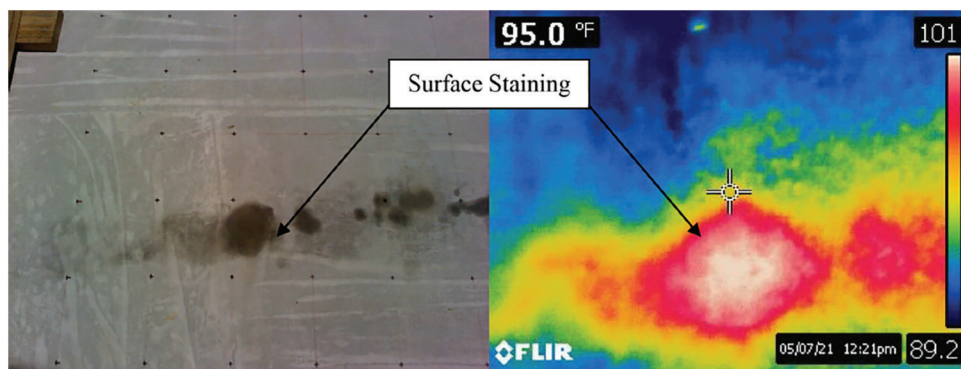
Figure 9: Hot spot caused due to oil stain on deck surface. Reprinted from Reference [32]

The ASTM D4788 standard also recommends good testing conditions for bridge decks, such as continuous sunshine for at least 3 h, clean and unspoiled surfaces, and a dry bridge for at least 24 h before testing [40,42]. Coleman et al. [32] found that their IRT could not detect several defects on their bridge deck specimen because the surface was not dry enough before testing. Despite otherwise favorable conditions, they observed that water (rain, dew, etc.) on deck can inhibit long-lasting effects on its temperature profile. In their study, the authors also observed a large hotspot on their thermograms, which turned out to be a large surface stain (Fig. 9) that leaked from a simulated delamination composed of oil and sand. The authors suggest that since the surface of the deck was darkened by the oil stain, it caused a change in the localized emissivity of the surface, resulting in the subsequent hot spot.

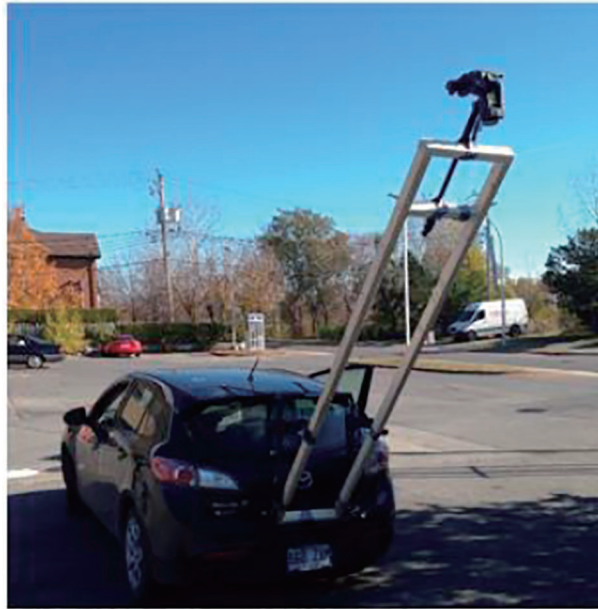
Figure 10: FLIR T650sc IR camera and vehicle-mounted setup. Reprinted from Reference [6]

An example of an IR camera is shown in Fig. 10. The shown camera is an advanced infrared thermal camera system, FLIR T650sc, utilized by Omar et al. [6] during their study on an in-service reinforced concrete bridge in Quebec, Canada. The IR camera has an uncooled microbolometer detector with a 5 MP built-in digital camera and displays thermal images with a 640×480 pixels resolution. For their IRT survey, the authors mounted the IR camera on a vehicle 8.5 ft from the ground surface facing straight-down towards the concrete deck surface. A 13.1 mm focal lens was used, which allowed a field of view (FOV) of 7×3.5 ft. to be achieved for each image and to survey each single lane of the bridge with only two predetermined paths. The IR cameras can be handheld, mounted on vehicles (as shown in Fig. 10) or carts, or even attached to drones to enhance even more contactless survey technology.

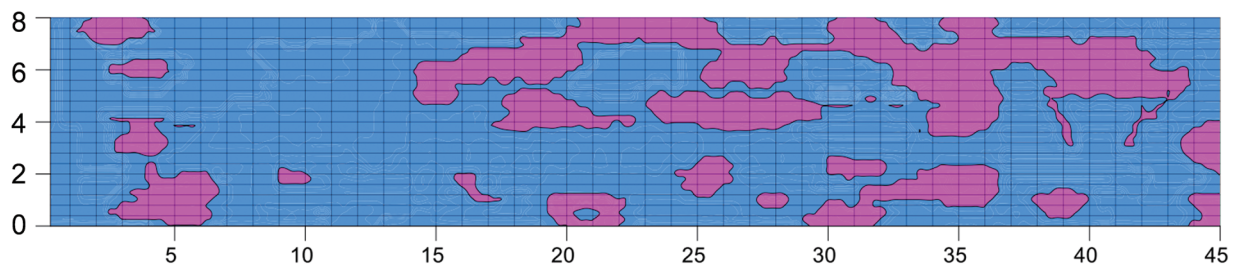
Figure 11: Map of surveyed bridge deck delaminated areas. Reprinted from Reference [6]

After capturing all the images, the authors enhanced the IR images using software such as FLIR Tools+ and ResearchIR to improve the images' quality. Pre-processing was also needed to conduct further analysis and to accurately identify the delaminated areas from the features of the deck surface like discoloration, oil stains, sand, and rust deposits that appear in the IR images, which are not relevant to the subsurface conditions. The authors also created a montage thermogram of the whole bridge deck from small individual images. A MATLAB code was written first to select a window from each image. Then selected windows were then extracted and stitched together in a successive order. Further codes were created to identify the temperature of each pixel and arrange them in a systematic order. Key specific thermal contrasts were then calculated from the temperature values of the mosaicked thermogram using a set threshold value of 1°C , which allowed the authors to highlight pixels with a higher temperature. Finally, all the temperature values were grouped into a condition map using commercial mapping software to construct a high-contrast image, which, as per the authors, accurately delineated the location of subsurface defects. The total percentage of the delaminated area was determined at the end by computing the total percentage of pixels with a higher temperature differential across the thermogram. The final image is shown in Fig. 11.

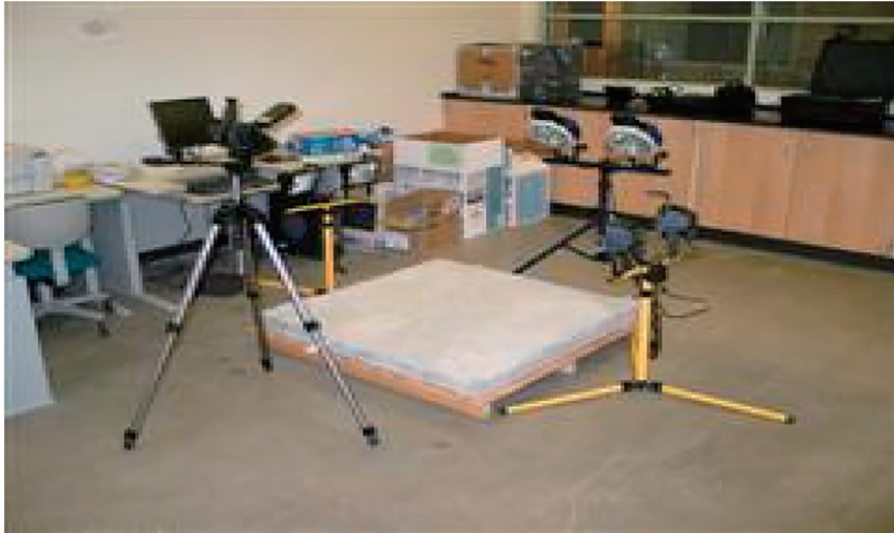
Figure 14: Active IRT experimental setup for defect detection in a concrete slab specimen. Reprinted from Reference [50]

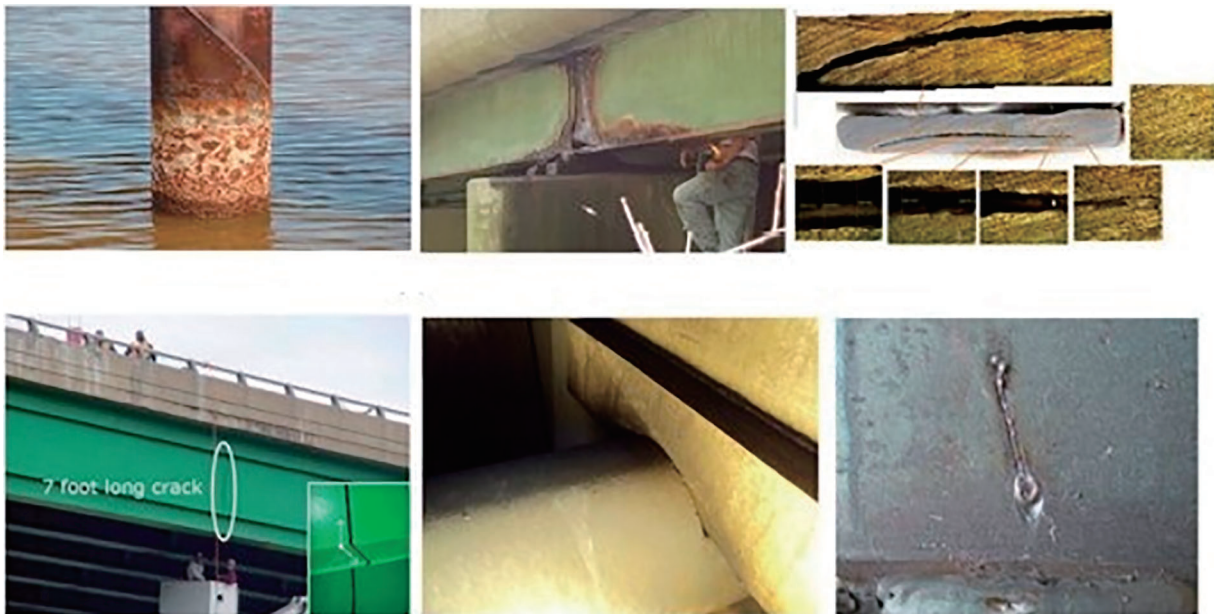
Figure 15: Common deficiencies in steel bridges. Reprinted from Reference [27]

wear, etc. (Figs. 15 and 16). Most of these sorts of damages are only detected visually at their advanced stages. Such modes of deterioration significantly affect the overall health and strength of the structure, which can lead to disastrous failures [23]. Therefore, there is a need for timely and proper structural assessment of steel structures and the material in general. Several NDE methods can be employed for this, among which IRT has proven to be an adequate method. Some of the ways it has been used in the field and laboratory are discussed in the section.

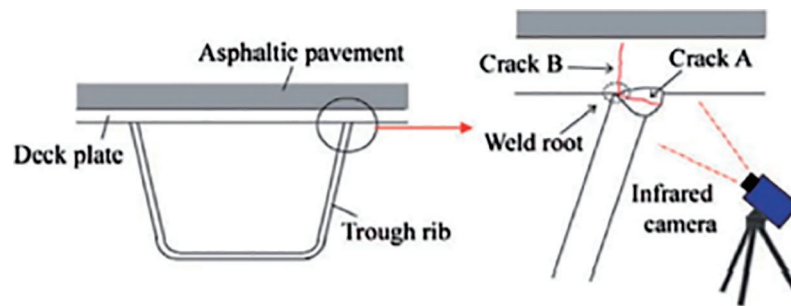
Figure 16: Schematic representation of fatigue cracks and IRT inspection. Reprinted from Reference [27]

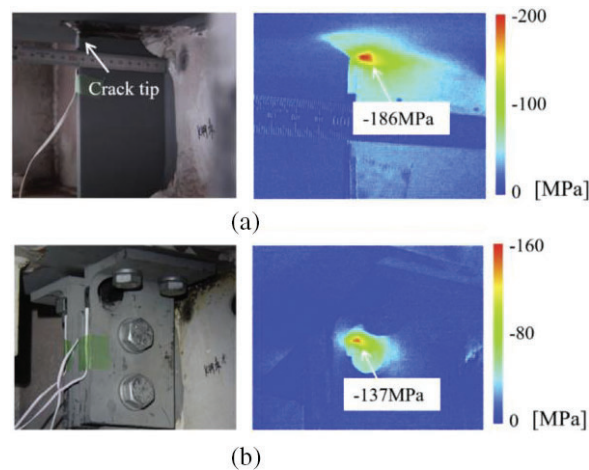
Figure 17: Thermoelastic stress distribution measurement results. (a) Before repair, (b) after repair. Reprinted from Reference [58]

of heat. Therefore, the stress-concentrated region can manifest as “hot spots” when IR readings are taken [55,56]. Sakagami et al. [57,58] performed extensive work on the application of the thermoelastic stress evaluation method to determine the severity of stress distribution reduction in members of steel bridges with fatigue cracks during repair and rehabilitation works (Fig. 17). They claim that it is possible to detect fatigue cracks by measuring stress distribution around the tips of cracks using the thermoelastic stress measurement technique.

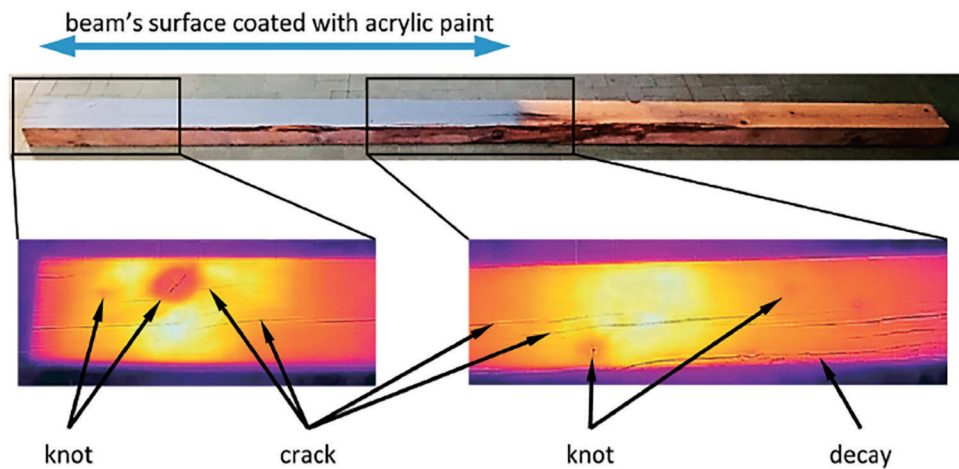
Figure 19: Active IRT for detection of obscured wood defects. Reprinted from Reference [75]

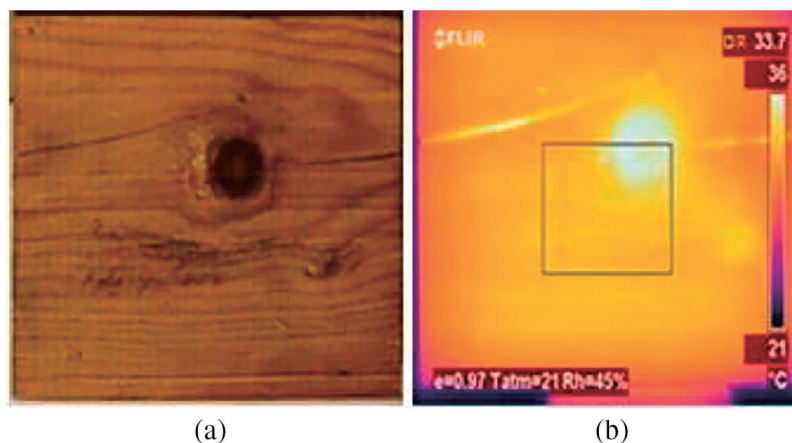
Figure 20: Picture (a) and a thermogram (b) of a pine sample indicating knot and crack. Reprinted from Reference [76]

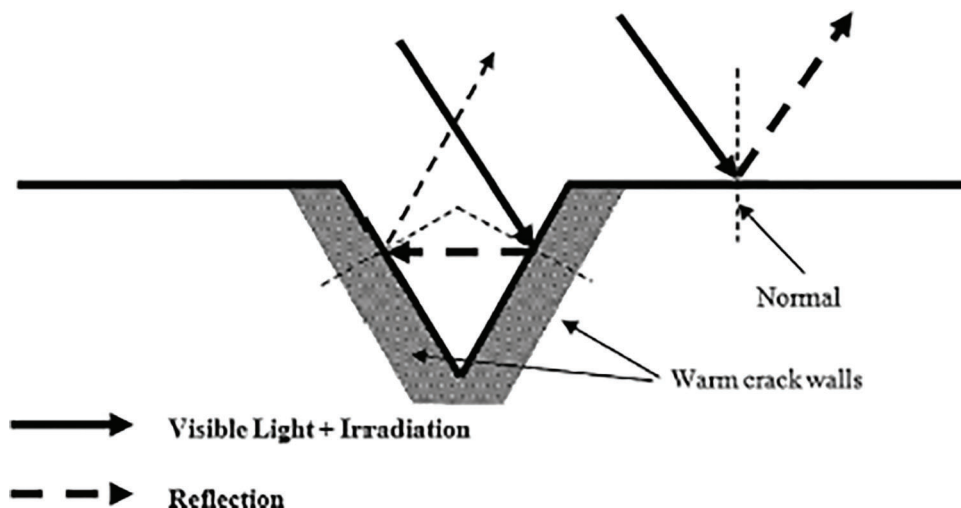
Figure 21: Reflectivity of radiation on cracked surface. Reprinted from Reference [93]

The use of IRT for evaluating concrete conditions was investigated by Sham et al. [93]. The authors used flash thermography to detect cracks on the surface of concrete specimens (Figs. 21 and 22). They reported the method to be very effective in detecting 0.5 to 1 mm width cracks on several concrete specimens. Moreover, they also go on to suggest using the active thermography method to locate cracks that are smaller than 0.5 mm.

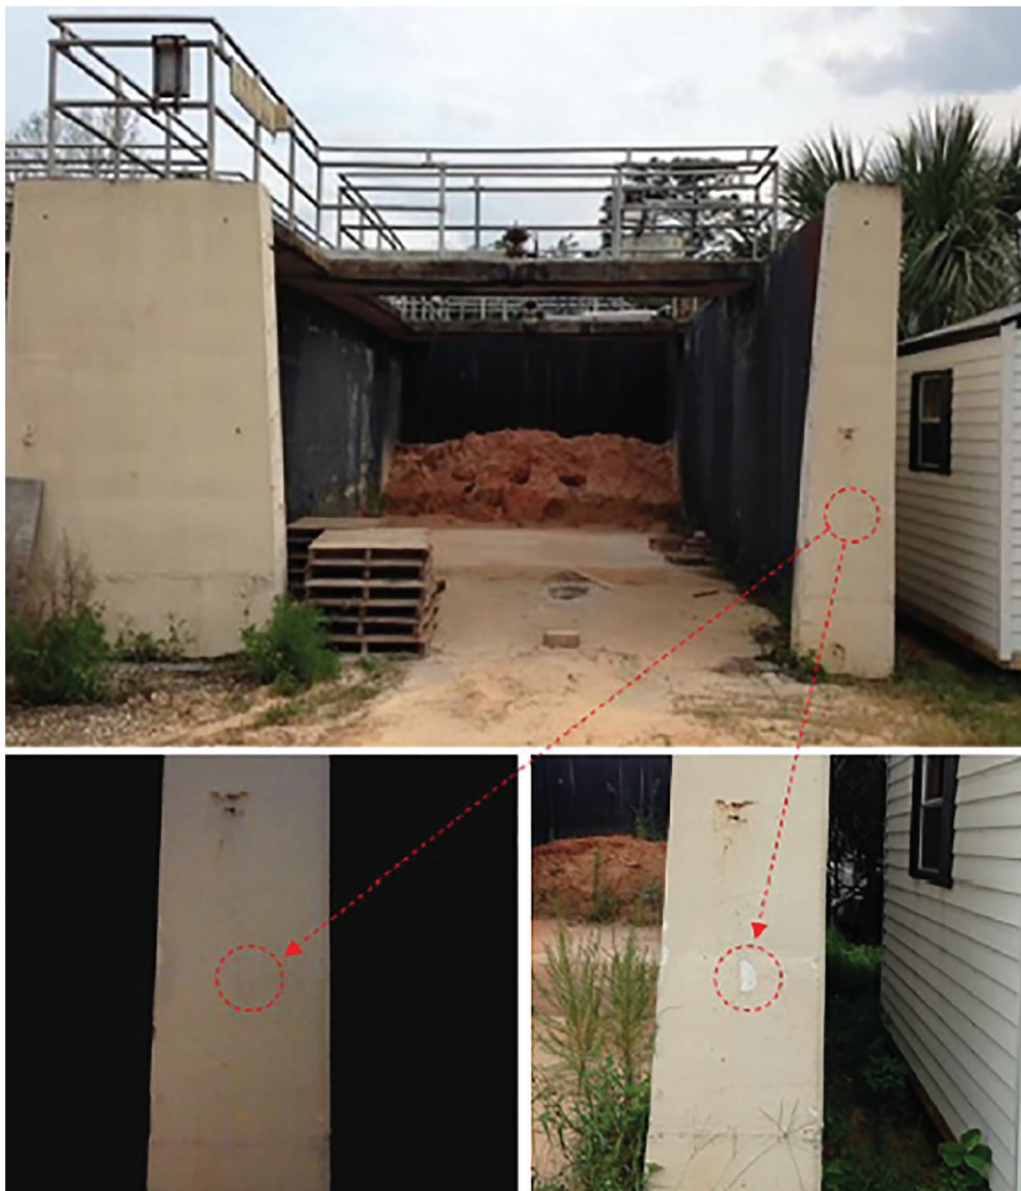
Figure 23: Concrete structure with delaminations. Reprinted from Reference [95]

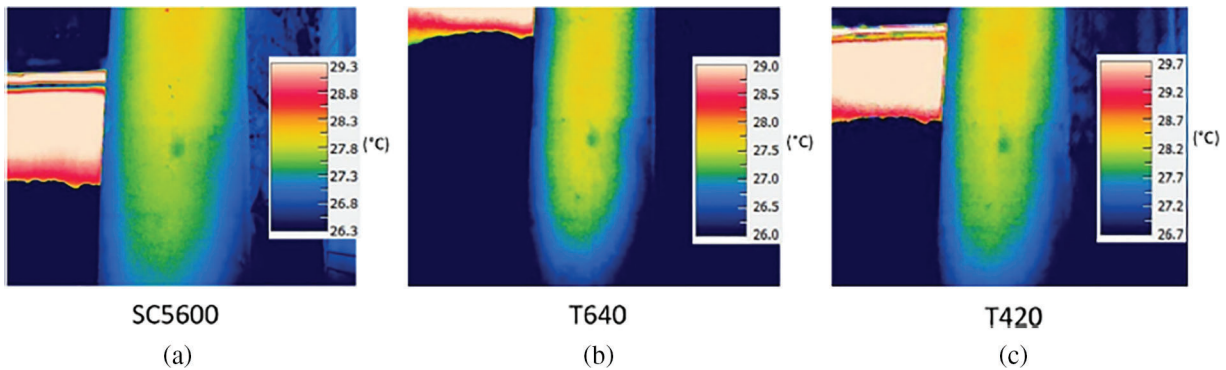
Figure 24: Raw IR images taken by different cameras. (a) SC5600, (b) T640, (c) T420. Reprinted from Reference [95]

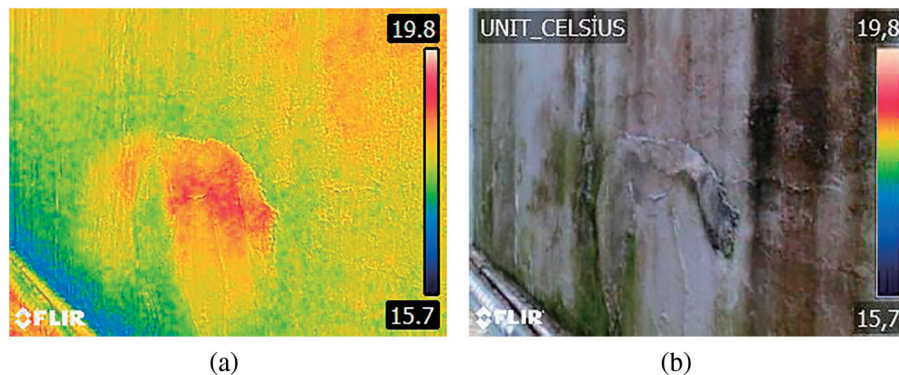
Figure 25: RC Retaining wall thermal image (a) and visible image (b). Reprinted from Reference [14]

Another study on the application of passive IRT on RC structures was done by Gonen et al. [14]. The researchers employed passive IRT on a reinforced concrete wall located in Turkey, which had a significantly delaminated area. Their objective was to locate the subsurface void behind the plaster on the RC wall in a quicker and easier method relative to a conventional tap test (Fig. 25).

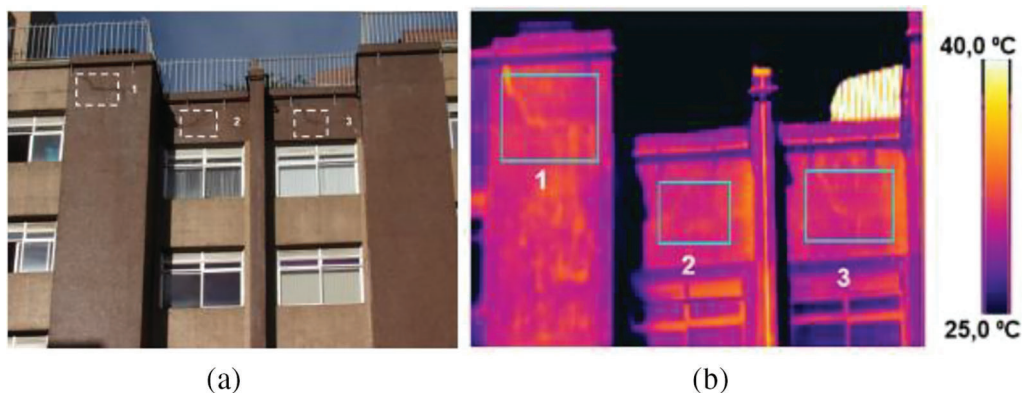
Figure 26: Study sample indicating cracks (a); thermogram showing detection of studied crack (b). Reprinted from Reference [100]

Cracks are common in masonry structures. They normally form in facades of masonry walls and buildings [100] (Fig. 26). They are mostly caused by temperature variations and other climatic conditions. IRT can be used to evaluate such cracks in masonry walls. Proper site conditions and timing allow IRT images to show cracks and defects clearly in masonry facades. The evaluation done using IRT thermograms is much more effective than merely visually inspecting defects from afar [101].

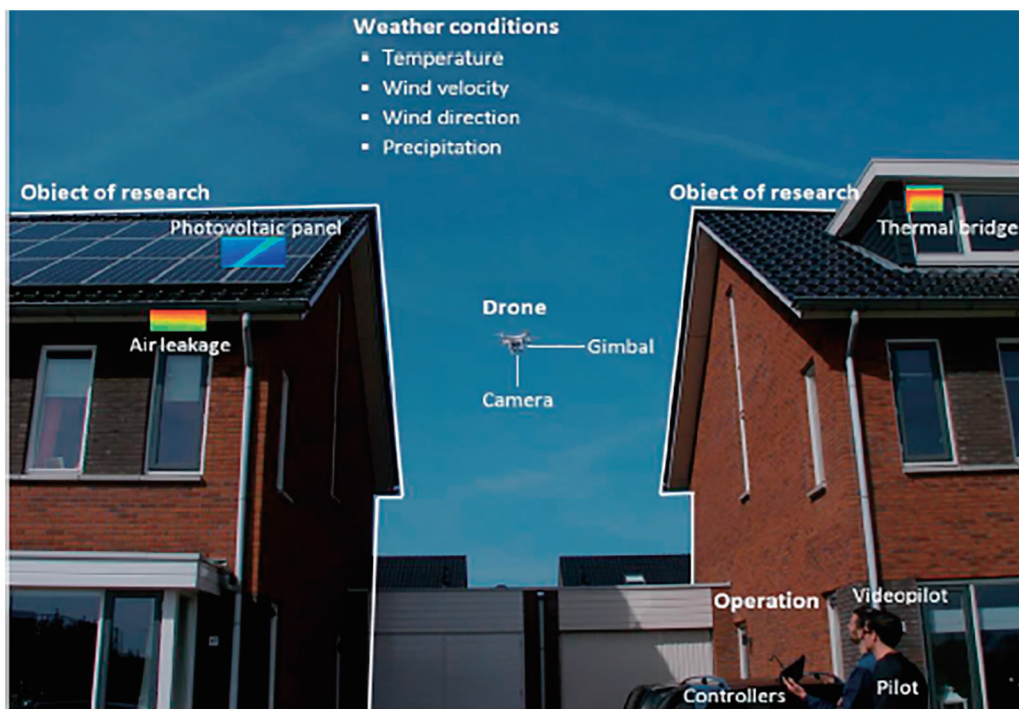
Figure 27: Outdoor building inspection by a drone. Reprinted from Reference [110]

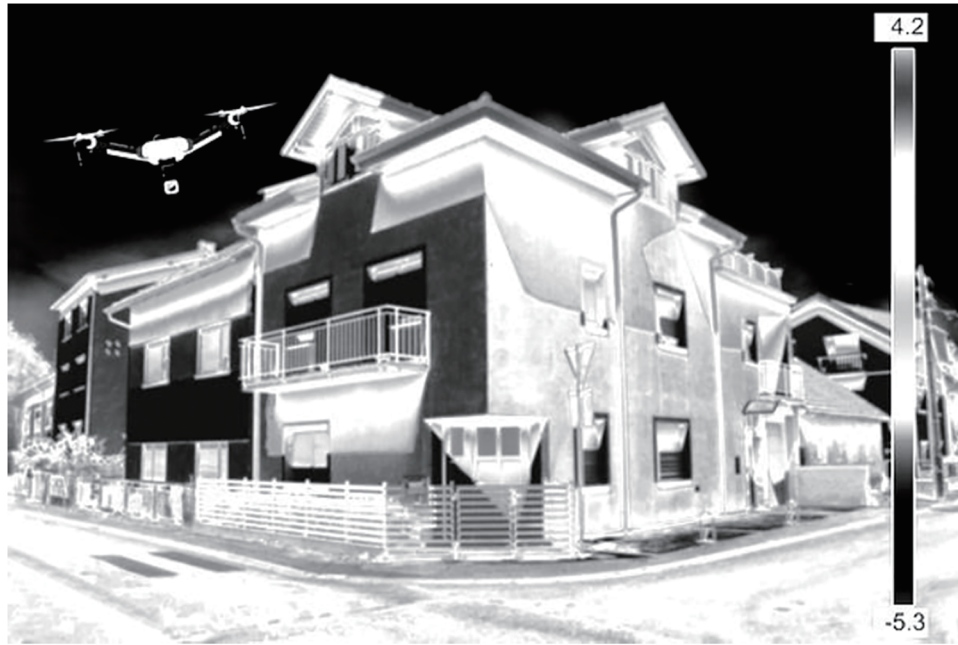
Figure 28: Thermal imaging using a drone. Reprinted from Reference [107]

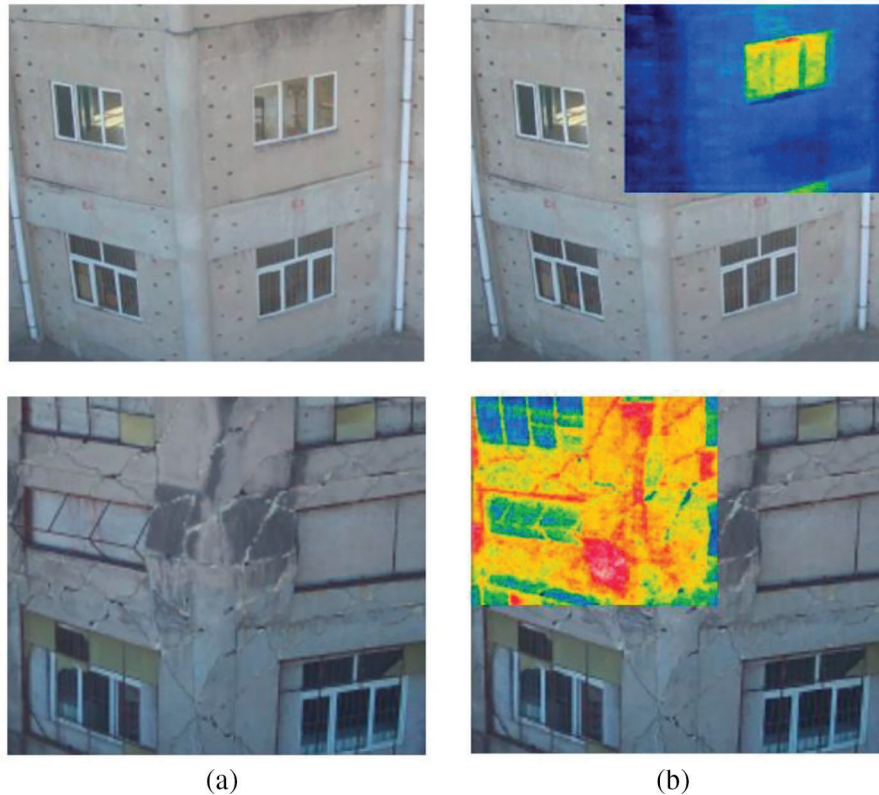
Figure 30: Wall crack damage assessment through thermal imaging. (a) Damaged building exterior, (b) thermal images of the damaged locations. Reprinted from Reference [111]

Fig. 30 shows the results of UAV thermal imaging to assess seismic damage in buildings. The bottom image clearly shows the temperature differential, suggesting cracks around the exterior wall of the building.

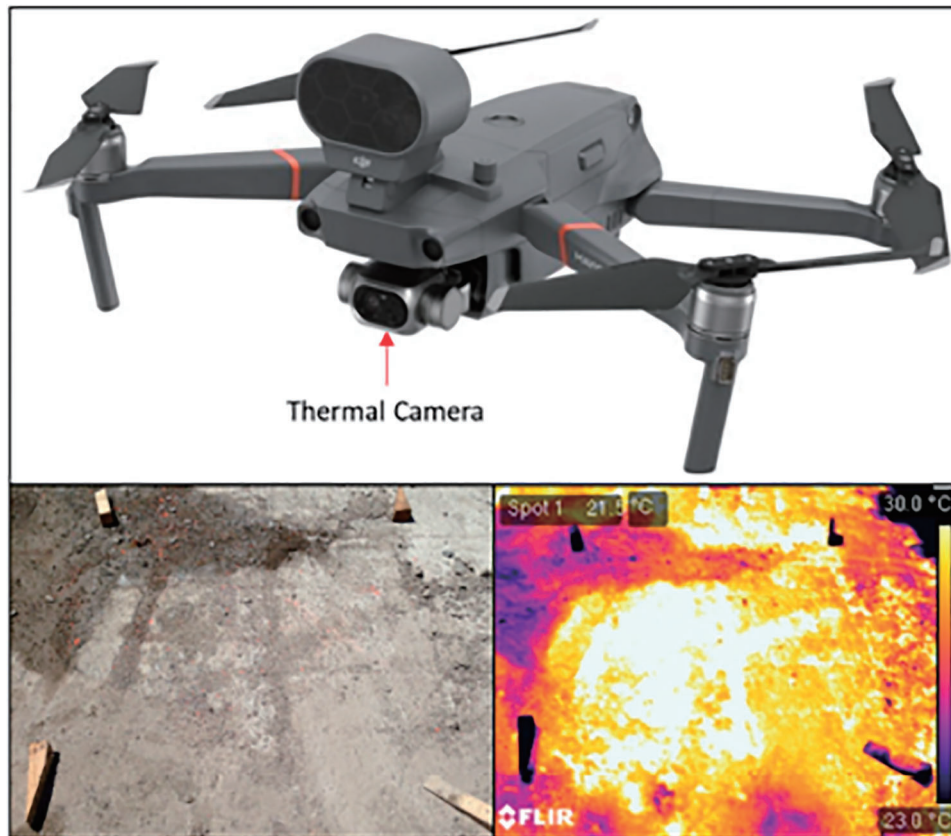
Figure 31: Typical UAV-IRT equipment and sample thermography data. Reprinted from Reference [112]
