Health Monitoring-Based Assessment of Reinforcement with Prestressed Steel Strand for Cable-Stayed Bridge

Muling River Bridge in Mishan City is located at K247+799 of Jixian-Dangbi Highway. The main bridge is a reinforced concrete cable-stayed bridge with a structure of two towers and two cable planes. The height of the tower is 14 m, the length of the bridge is 106.4 m, and the span is 28 m + 50.4 m + 28 m. The bridge is 9 m wide, with a sidewalk of 1 m+ a driveway of 7 m + a sidewalk of 1 m. The bearing adopts PTFE plate rubber bearing, and the bridge deck is paved with 5~10 cm reinforced concrete. The lower structure abutment adopts gravity abutment, and the tower foundation adopts caisson foundation. The original design load grade for the automobile –20, and the check the load grade for the trailer –100. The elevation of the bridge is shown in Figs. 1 and 2, respectively.

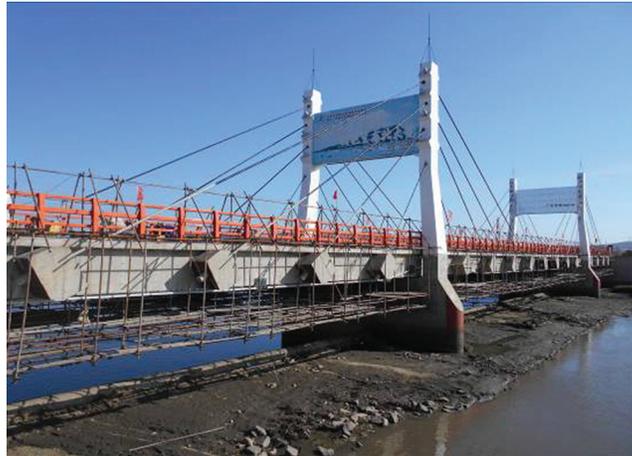
Figure 1: Elevation photo of Muling River Bridge

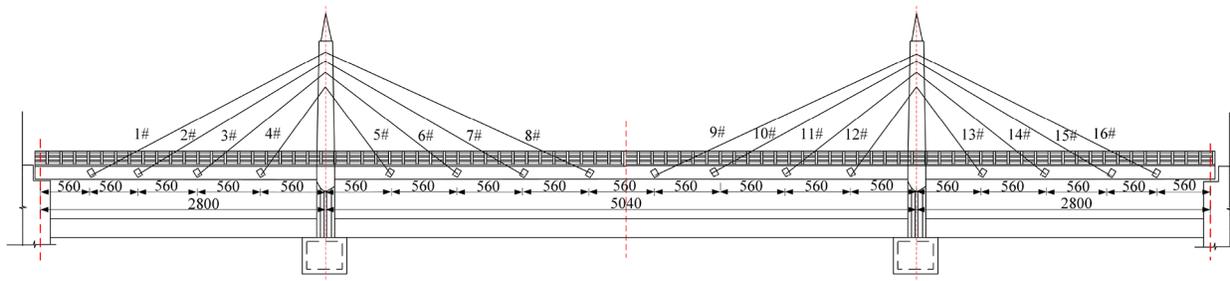
Figure 2: Elevation drawing of Muleng River Bridge (Unit: cm)

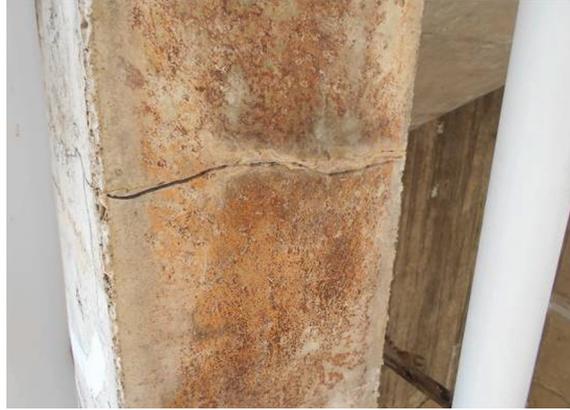
Figure 3: Vertical cracks in main girder structure

During routine inspection, the first span vertical crack mainly exists in the middle of the span. The vertical fracture length is about 100 cm, and the fracture width is about 0.12 mm. The crack of second span is mainly vertical cracks, which mainly exists in the intermediate of the span and cable anchorage zone. The vertical crack length is between 100 cm and 240 cm, and the crack width is between 0.17 mm and 0.30 mm. The third span crack is mainly vertical crack and oblique crack, mainly exists in the middle of the span. The vertical crack length is between 70 cm and 120 cm, and the crack width is between 0.21 mm and 0.40 mm. The oblique crack length is between 70 cm and 100 cm, and the crack width is between 0.16 mm and 0.20 mm. The steel plate at the anchorage end of the cable of the whole bridge is

As shown in the Figs. 3 and 4, the shrinkage crack and temperature crack may exist in the reinforced concrete structure when it is formed, and the corrosion of the environment makes the shrinkage crack of the main girder increase. In addition, the increase of the number of vehicles and the increase of the load of vehicles will cause the bridge to produce excessive stress, the stress exceeds the cracking strength of concrete, so that the concrete in the tensile zone and shear zone will produce stress cracks. As shown in the Fig. 5, due to the influence of rain and snow, the concrete on the surface of bridge pier will accelerate aging and corrosion, which will eventually lead to concrete spalling and steel corrosion. As shown in the Fig. 6, the cable anchorage area may be pulled out due to low steel mesh placement rate and insufficient anchorage depth. The damage of cable anchorage area seriously affects the safety of bridge operation.

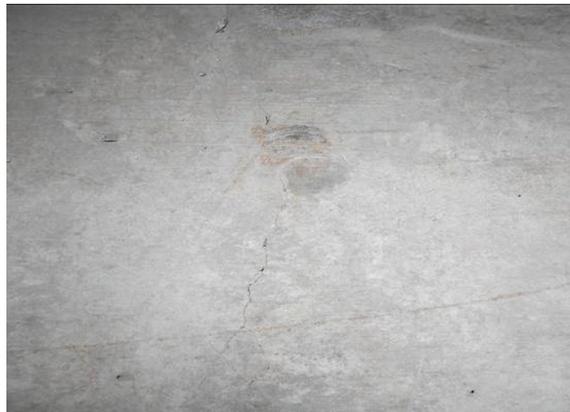
Figure 4: Oblique crack in main girder structure

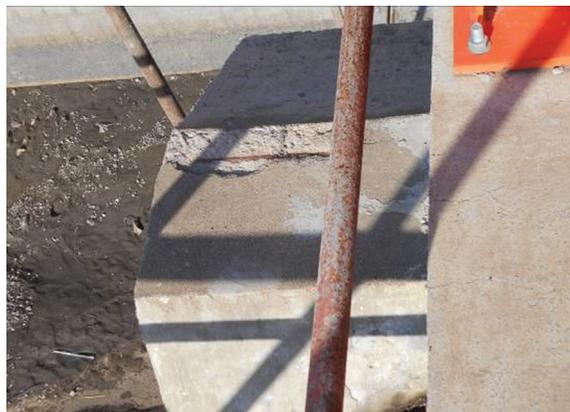
Figure 5: Leakage reinforcement

corroded, with an area of 10.1 m^2 . The concrete reinforcement at the anchor end of the left-1# stay cable is exposed, and the anchor of the left-6# and right-10# stay cable is pulled out. The damage cases are observed as follows:

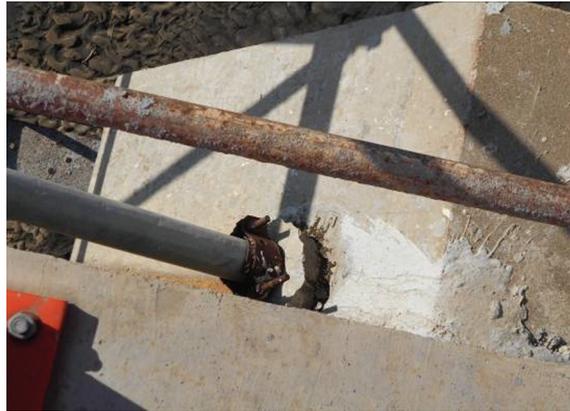
Figure 6: Cable anchor pulled out

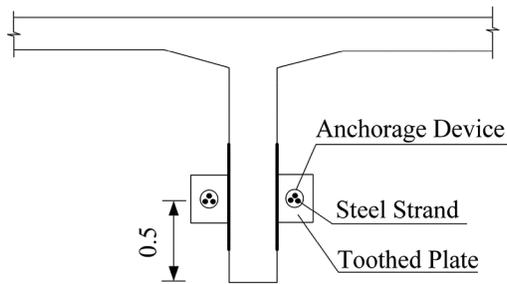
Figure 7: Layout of tensioning ends

A bundle of prestressed steel strands is arranged on both sides of each girder. Each bundle is made of three high strength and low relaxation steel strands of 15.24 mm specification, with a standard strength of 1860 MPa and an elastic modulus of 195000 MPa. The tension control stress of a single strand is 168.05 MPa, and that of prestressed steel bundle is 1209 MPa, which is 65% of the standard strength. Considering the fatigue performance of external prestressing tendons, the tensile range of prestressing tendons is generally 55%~65% of the designed tensile strength. It is bent and anchored at the

corresponding webs at both ends of the T beam respectively. The specific layout of the external bundle is shown in [Figs. 7–10](#).

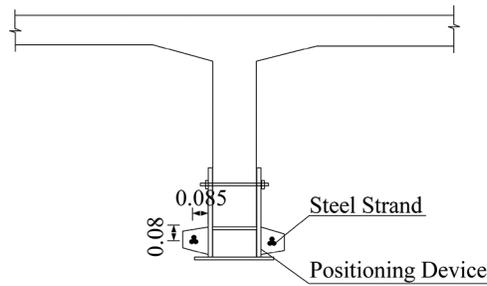
Figure 8: Arrangement of the mid-span section

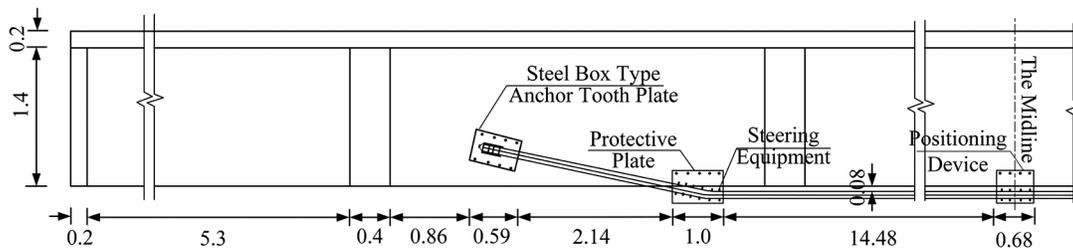
Figure 9: External longitudinal profile

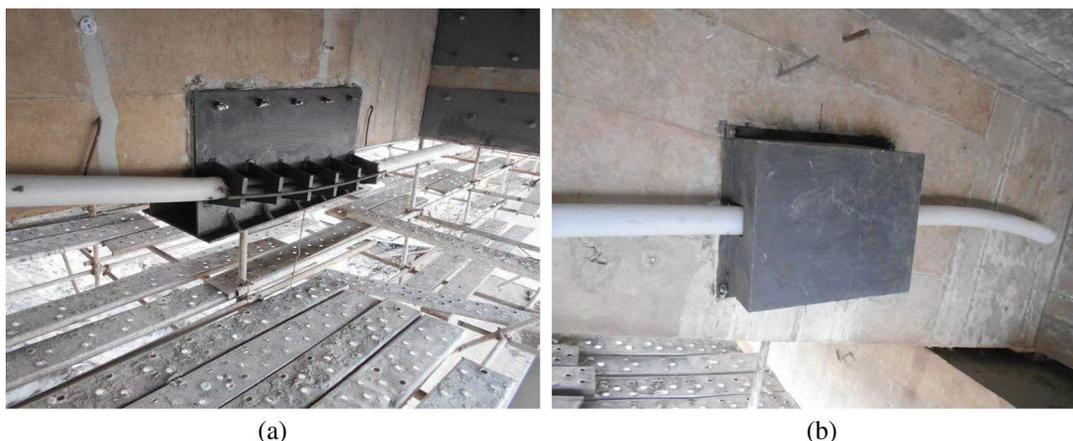
Figure 10: External prestressed reinforcement of main girder

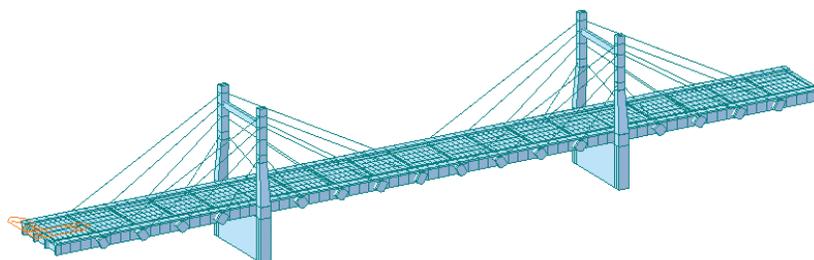
Figure 11: Calculation model of Muleng River Bridge in Mishan City

The internal force calculation model of this project is calculated by Midas/Civil, a special finite element calculation software for bridges. The finite element model of the full bridge is shown in Fig. 11. Beam elements are used to simulate main girders, pylons and piers, while truss elements are used to simulate stay cables. The whole finite element model of the cable-stayed bridge has 800 nodes, 767 elements and 735 beam elements. There are 32 tension-only truss (stay cable) elements. The girder and tower are used as common joints to simulate the consolidation system of the cable-stayed bridge. The elastic connection boundary condition of the main girder is adopted, and the rigid connection boundary condition of the anchor point of the cable to the main girder and the main tower is adopted. The correctness of the model is verified by the load test data of the bridge, and the reinforcement analysis is carried out on the basis of the finite element model.

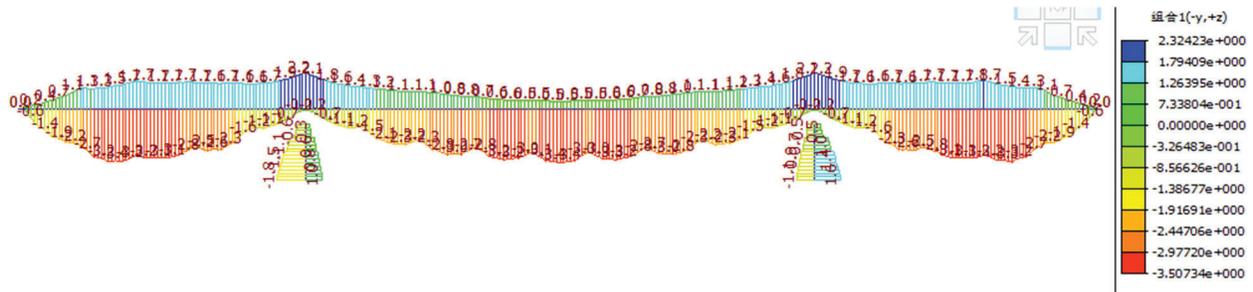
Figure 12: Upper edge stress diagram

The load combination is “1.2 transverse load + 1.4 live load”. Fig. 12 shows the stress diagram of the upper edge of the main girder. The top edge stress is $-3.5 \text{ MPa} \sim 2.3 \text{ MPa}$. All of them did not exceed the permitted standard value. Fig. 13 shows the stress diagram at the lower edge of the main girder. The bottom edge strain is $-3.5 \text{ MPa} \sim 2.3 \text{ MPa}$, which meets the requirement of the code value. After the

reinforcement of external prestressed strand, the stress at the upper and lower edges of the control section of the main girder meets the requirements.

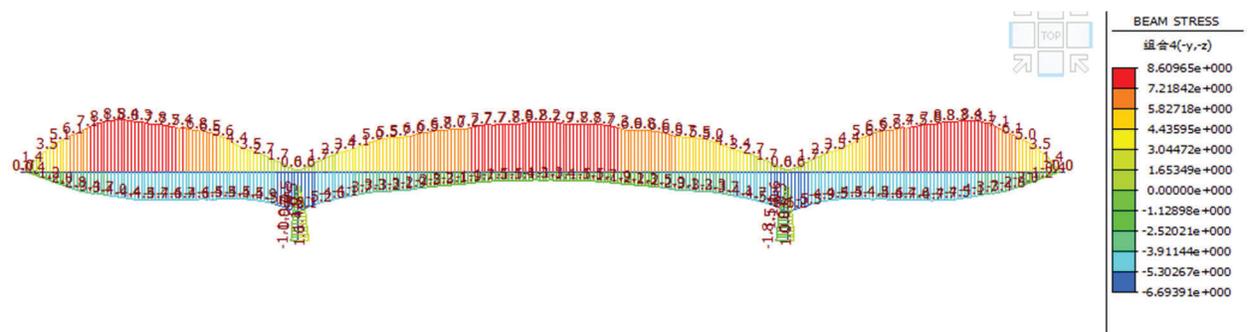
Figure 13: Lower edge stress diagram

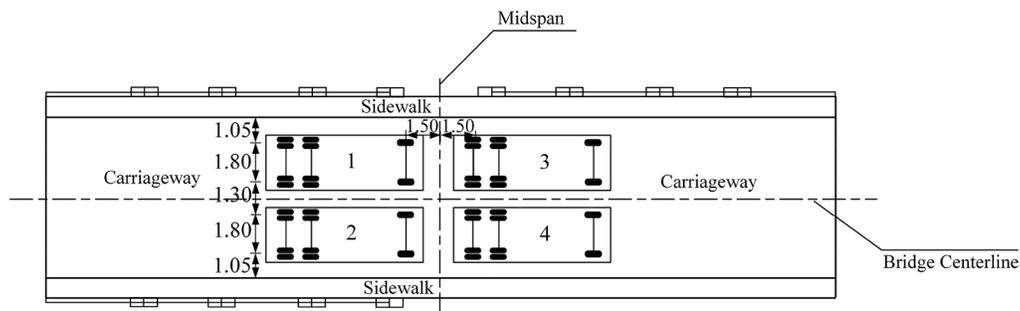
Figure 14: Condition 1 and Condition 3 (Unit: m)

Working condition 1: Symmetric load of maximum bending moment of the mid-span section. (2# span)

Working condition 3: Symmetric load of maximum bending moment of the mid-span section. (3# span)

Loading arrangement in each working condition is shown in Figs. 14–17.

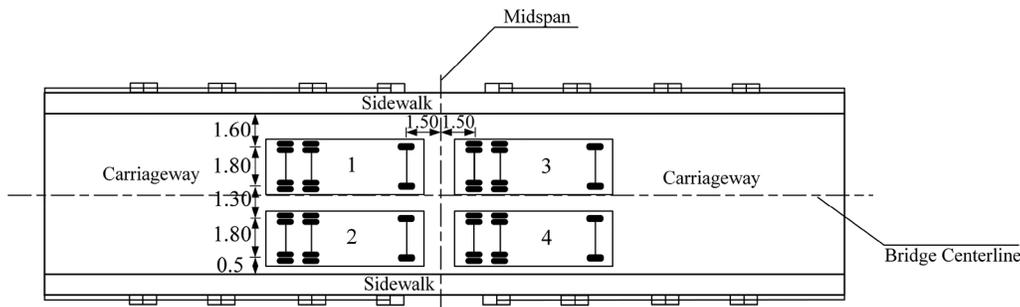
Figure 15: Condition 2 and Condition 4 (Unit: m)

Working condition 2: Eccentric load of maximum bending moment of the mid-span section. (2# span)

Working condition 4: Eccentric load of maximum bending moment of the mid-span section. (3# span)

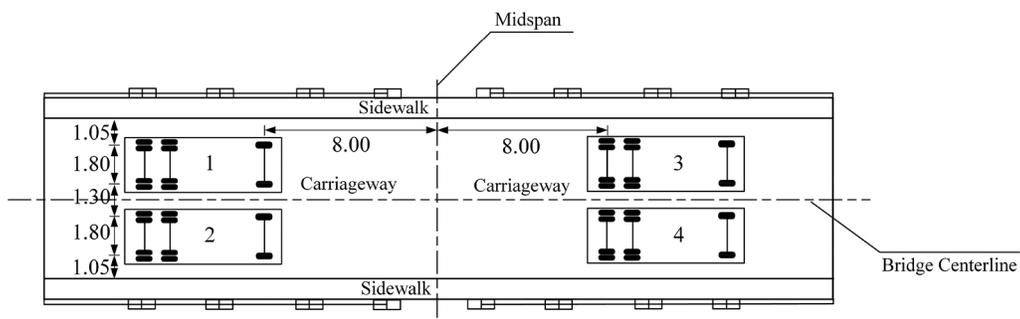
Figure 16: Condition 5 (Unit: m)

Working condition 5: Symmetrical load of maximum negative bending moment of pier top section.

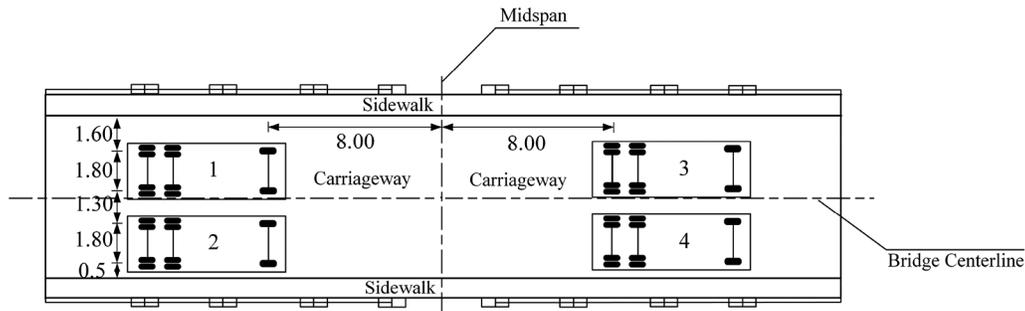
Figure 17: Condition 6 (Unit: m)

Working condition 6: Eccentric load of maximum negative bending moment of pier top section.

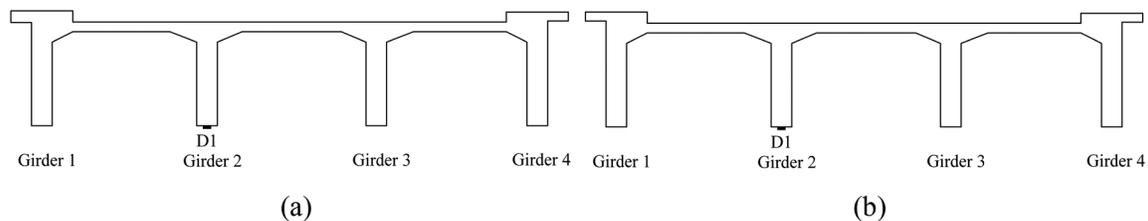
Figure 18: Main girder deflection point arrangement (a) 2# span (b) 3# span

Combined with field testing and finite element analysis, the section that may appear the most dangerous is determined as the test section. As shown in Fig. 18, a static level is installed at the second and third span 1/2 of the bridge as the deflection monitoring point. As shown in Fig. 19, strain sensors are installed on the top edge and bottom edge of the second and third span beams of the bridge to monitor the strain changes of the bridge. Layout of measurement points for tower deviation is shown as Fig. 20.

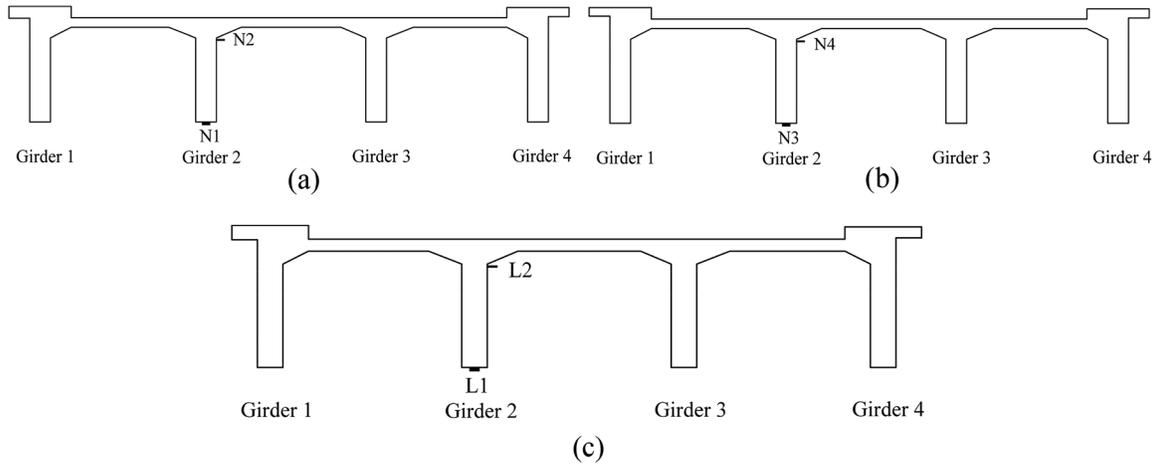
Figure 19: Arrangement of main girder strain measuring points (a) 2# span (b) 3# span (c) Beam section at the pier top

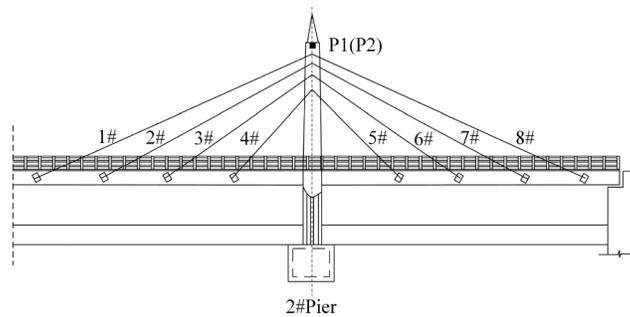
Figure 20: Layout of measurement points for tower deviation

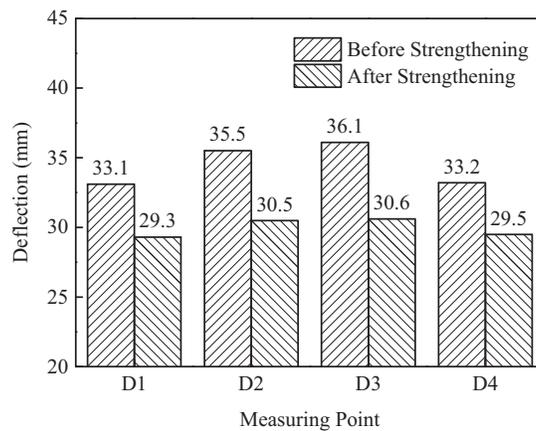
Figure 21: Deflection on Condition 1

In order to understand the stiffness of the bridge before and after reinforcement, the mid-span deflection of the second and third span before and after reinforcement is collected. The results of the second span are shown in Figs. 21 and 22. In condition 1, the deflection of each measuring point decreases obviously after reinforcement. The maximum deflection of point D3 is 36.1 mm before reinforcement, which decreases to 30.6 mm after reinforcement, a decrease of 15.3%. Before reinforcement, the minimum deflection at point D1 is 33.1 mm, but it is reduced to 29.3 mm after reinforcement, a decrease of 11.5%. The maximum deflection at point D4 is 48.1 mm before the reinforcement, which decreases to 38.2 mm after the reinforcement, which decreases by 20.6%. The minimum deflection at point D1 before reinforcement is

33.4 mm, which decreases to 29.8 mm after reinforcement, a decrease of 11.1%. It fully shows that the stiffness has been improved. There are many stress cracks in the original beam, and these cracks will increase with the increase of load, resulting in low stiffness. Due to the application of prestress in the bridge, the cracks of the original beam are closed. Even if the vehicle load is applied, the cracks do not increase, leading to the improvement of the overall stiffness of the bridge.

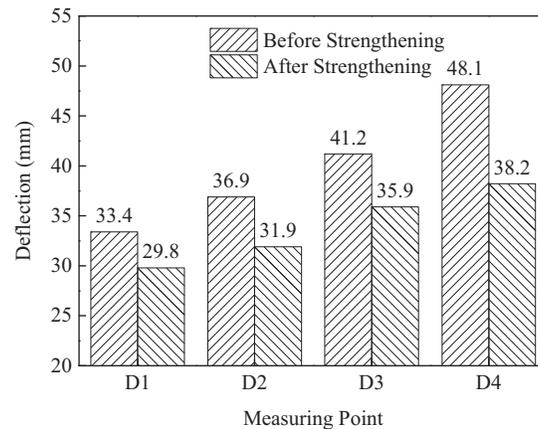
Figure 22: Deflection on Condition 2

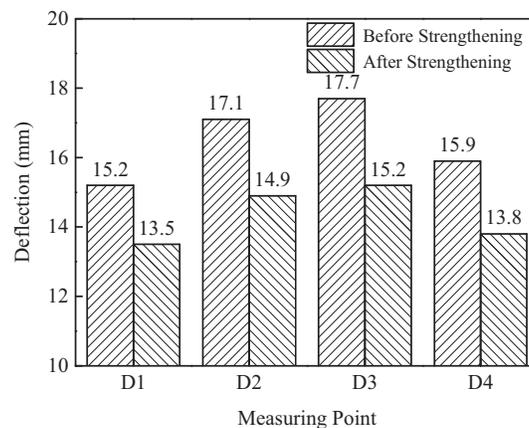
Figure 23: Deflection on Condition 3

The deflection results of the third span are shown in Figs. 23 and 24. In the case of symmetric load loading, the reduction of deflection after reinforcement can be clearly seen in the figure. The maximum deflection at point D3 is 17.7 mm before reinforcement, but decreased to 15.2 mm after reinforcement, which decreased by 14.2%. The minimum deflection at point D1 is 15.2 mm before reinforcement, but decreases to 13.5 mm after reinforcement, a decrease of 11.2%. When the eccentric load is loaded, the deflection also decreases to different degrees. Before the reinforcement, the maximum deflection at point D4 is 18.9 mm, which decreases to 16.3 mm after the reinforcement, reducing by 13.8%. Before the reinforcement, the minimum deflection at point D1 is 11.5 mm, which decreases to 9.8 mm after reinforcement, reducing by 14.8%. It shows that the stiffness of the bridge is improved and meets the requirements.

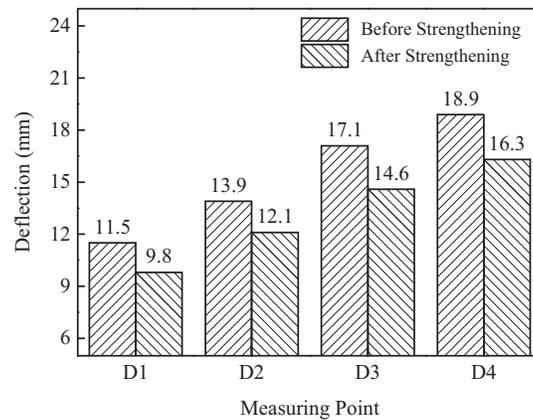
Figure 24: Deflection on Condition 4

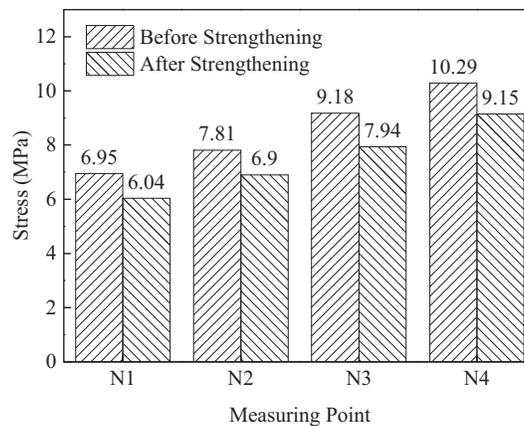
Figure 25: Stress on Condition 1

In order to understand the strength of the bridge, the stress of the bridge before and after reinforcement is tested. Figs. 25 and 26 show the bottom stress before and after reinforcement under eccentric loads respectively. As shown in Fig. 25, the maximum stress at point N4 before reinforcement is 10.29 MPa, which decreases to 9.15 MPa after reinforcement, a decrease of 11.1%. Before reinforcement, the minimum stress at point N1 is 6.95 MPa, which decreases to 6.04 MPa after reinforcement, a decrease of 13.1%. As shown in Fig. 26, the maximum stress at point N4 is 9.93 MPa before reinforcement, which

decreases to 8.63 MPa after reinforcement, a decrease of 13.1%. Before reinforcement, the minimum stress at point N1 is 6.79 MPa, but after reinforcement, it is reduced to 6.04 MPa, which is reduced by 11.0%. Other measurement points also have a certain extent of reduction, indicating that the strength of the structure has been improved. The steel strands make the concrete prestress to overcome the tensile stress caused by the vehicle load, and the tensile stress at the bottom edge of the beam is obviously reduced after reinforcement. Thus, the strength of the beam can be enhanced.

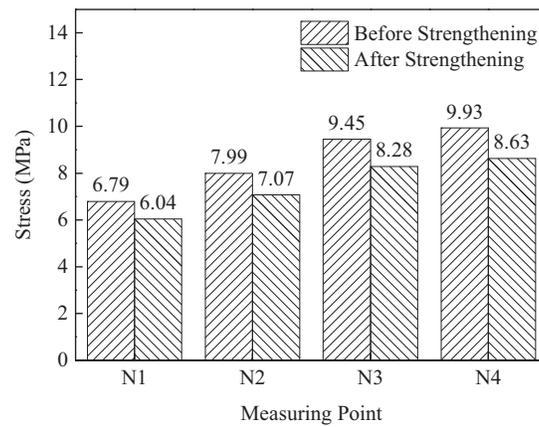
Figure 26: Stress on Condition 2

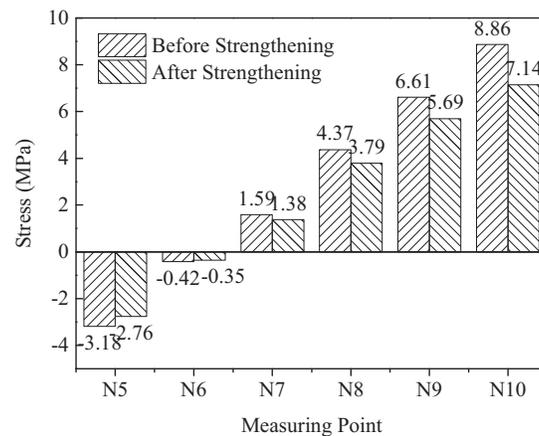
Figure 27: 2-3# beam stress (Condition 1)

Fig. 27 shows the stress comparison diagram before and after reinforcement of the measuring point along the beam height of the second span 3# beam under eccentric load. It can be seen from the figure that the upper edge of the main beam is under compression and the lower edge is under tension. The tensile stress of point N6 is 0.42 MPa before reinforcement, which is reduced to 0.35 MPa after reinforcement, which is reduced by 16.7%. The compressive stress of point N7 before and after reinforcement is 1.59 MPa and 1.38 MPa, which decreases by 13.2%. The N10 measuring point at the lowest edge of the main girder has the maximum compressive stress, which is 8.86 MPa and 7.14 MPa before and after strengthening respectively, reducing by 19.4%.

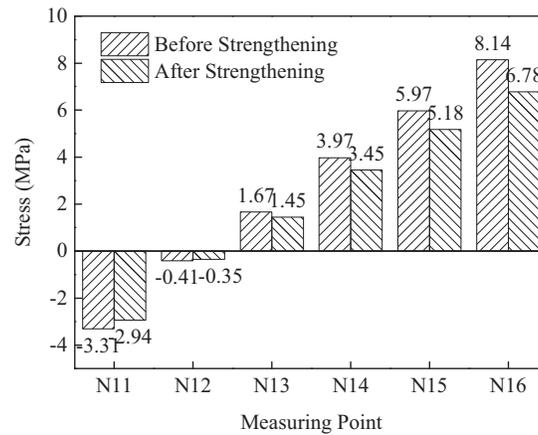
Figure 28: 2-4# beam stress (Condition 2)

Fig. 28 shows the stress before and after reinforcement of the second span 4# beam at the measuring point. It can be seen from the figure that the upper edge of the main beam is under compression and the lower edge is under tension. The tensile stress of N12 before reinforcement is 0.41 MPa, and after reinforcement it is reduced to 0.35 MPa, which is reduced by 14.7%. The compressive stress at point N13 is 1.67 MPa and 1.45 MPa respectively before and after reinforcement, which decreases by 13.2%. The compressive stress at the measuring point N16 at the lowest edge of the main girder is the largest, 8.14 MPa and 6.78 MPa, respectively, which decreases by 16.7%. The other measurement points are also greatly reduced, indicating that the strength of the structure meets the requirements and is improved.

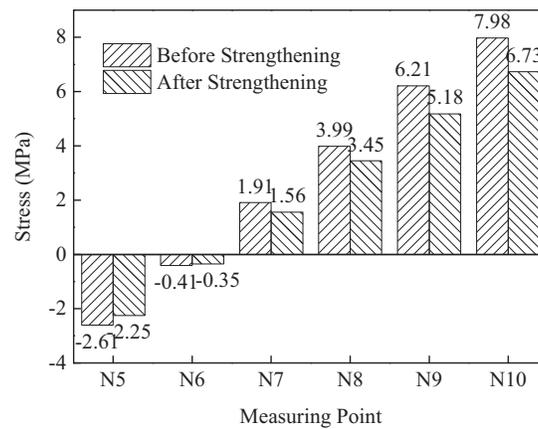
Figure 29: 3-3# beam stress (Condition 3)

Fig. 29 shows the stress of the third span # 3 beam along the beam height under eccentric load. It can be seen that the upper edge of the main beam is compressed while the lower edge is tensile. The tensile stress at the measuring point N6 is still tensile. The tensile stress before reinforcement is 0.41 MPa, and after reinforcement it is reduced to 0.35 MPa, which is reduced by 14.7%. The compressive stress before and after reinforcement is 1.91 MPa and 1.56 MPa, respectively, which decreases by 18.3% from the measuring point N7 to compression. The compressive stress at the measuring point N10 at the lowest edge of the main girder is the largest, which is 7.98 MPa and 6.73 MPa, respectively, reducing by 15.7%.

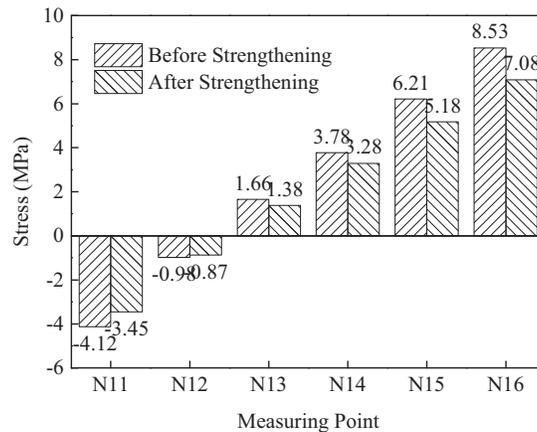
Figure 30: 3-4# beam stress (Condition 4)

Fig. 30 shows the stress comparison diagram of the third span 4# beam of along the beam height under the eccentric load. It can be seen from the figure that the upper edge of the main beam is under compression and the lower edge is under tension. The tensile stress of point N12 before reinforcement is 0.98 MPa, and it is reduced to 0.87 MPa after reinforcement, which is reduced by 11.3%. The compressive stress at point N13 is 1.66 MPa and 1.38 MPa respectively before and after reinforcement, which decreases by 16.9%. The N16 measuring point at the bottom edge of the main girder has the maximum compressive stress, which is 8.53 MPa and 7.08 MPa respectively before and after reinforcement, decreasing by 17.0%. The other measurement points are also greatly reduced, indicating that the strength of the structure has been improved.

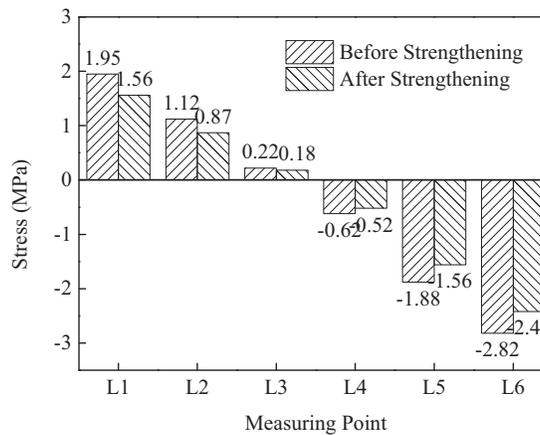
Figure 31: Stress (Condition 5)

Fig. 31 shows the stress comparison diagram before and after the reinforcement. The stress distribution at pier top is opposite to the mid-span stress, and the upper edge is the tension and the lower edge is the pressure. The tensile stress at L1 measuring point on the upper edge of the top section of the front pier is the largest, which is 1.95 MPa, and it is reduced to 1.56 MPa after reinforcement, which is reduced by 20.0%. Before reinforcement, the tensile stress at L3 measuring point is the smallest, which is 0.22 MPa, and decreases to 0.18 MPa before reinforcement, which is reduced by 18.2%. The compressive stress at the measuring point L4 is the smallest. The compressive stress before and after the reinforcement is 0.62 MPa and 0.52 MPa, respectively, which is 12.9% lower than that before the reinforcement. The

compressive stress at measuring point L6 is the largest, and the compressive stress before and after reinforcement is 2.82 MPa and 2.42 MPa, respectively, which is reduced by 14.2% compared with that before reinforcement. The reduction range of other measurement points is also between 10%–20%, indicating that the strength of the structure has been improved.

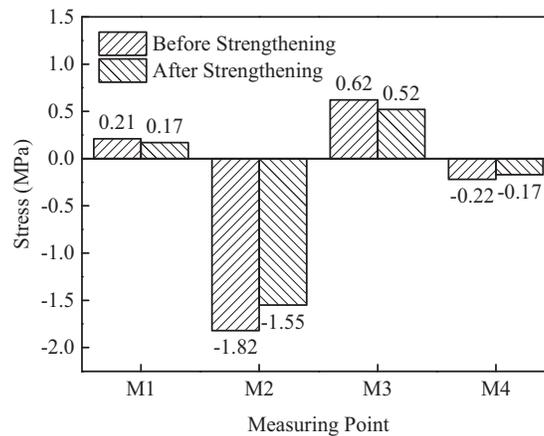
Figure 32: Tower stress (Condition 1)

Fig. 32 shows the tower stress under eccentric load (Condition 1) before and after reinforcement. The tensile stress at the measuring point M1 is 0.2 MPa and 0.17 MPa before and after reinforcement, which decreases by 19.1% compared with before reinforcement. The compressive stress at M2 measurement point is 1.82 MPa and 1.55 MPa before and after reinforcement, which decreases by 14.9% compared with that before reinforcement. The tensile stress of point M3 measured point is 0.62 MPa and 0.52 MPa respectively before and after reinforcement, which decreases by 16.2% compared with that before reinforcement. The compressive stress of M4 measured point is 0.22 MPa and 0.17 MPa respectively before and after reinforcement, which decreases by 22.7% compared with that before reinforcement.

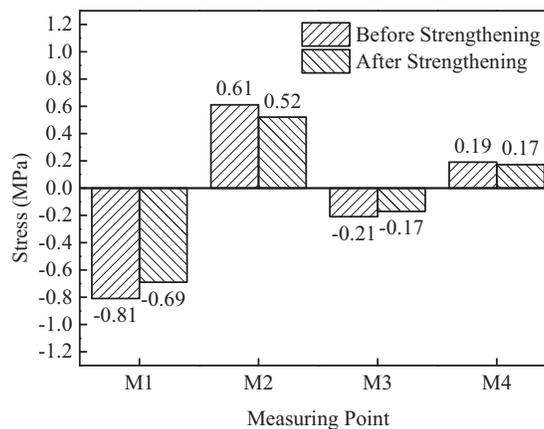
Figure 33: Tower stress (Condition 3)

Fig. 33 shows the tower stress value under eccentric load (Condition 3) before and after reinforcement. Due to the change of loading position, the stress at each measuring point under this working condition is just opposite to that of the previous loading. The tensile stress at M2 measurement point is 0.61 MPa and

0.52 MPa respectively before and after reinforcement, which decreases by 14.8% compared with that before reinforcement. The compressive stress at M3 measurement point is 0.21 MPa and 0.17 MPa respectively before and after reinforcement, which decreases by 19.1% compared with that before reinforcement. The tensile stress at the measuring point M4 is 0.19 MPa and 0.17 MPa respectively before and after reinforcement, which decreases by 10.6% compared with that before reinforcement. Under the same load, the stress of each measuring point decreases in different degrees after reinforcement, which indicates that the strength of the structure meets the requirements and the strength is improved.

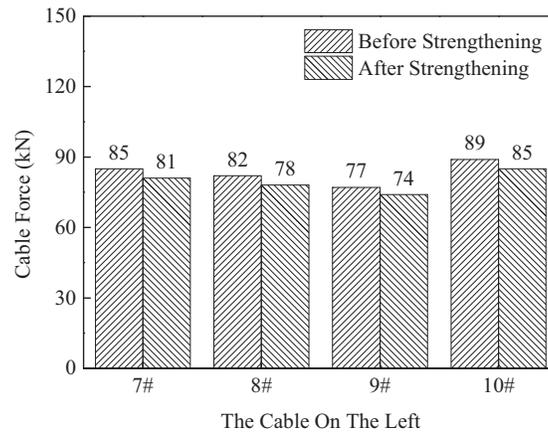
Figure 34: Upstream cable force comparison

Under the symmetrical loads (the second span) on the left side of the cable force contrast is shown in Fig. 34. Under the symmetrical loads (the second span) the right side of the cable force contrast is shown in Fig. 35. After the reinforcement, the measured values of the left 9# and right 8# cables are 4.9% smaller than those before the reinforcement, and the measured values of the left 9# and right 8# cables are 3.9% smaller than those before the reinforcement. The decrease range of the cable force of the other cables is 3.9%~4.9%.

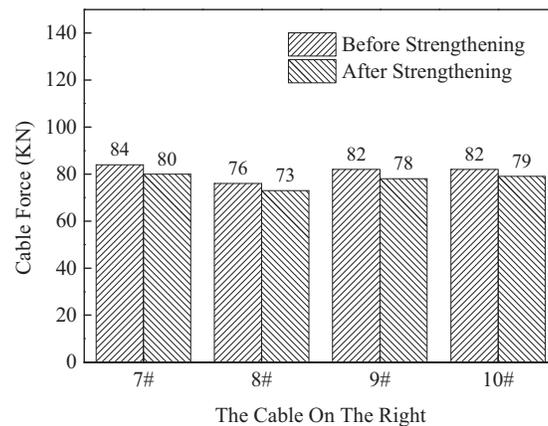
Figure 35: Downstream cable force comparison

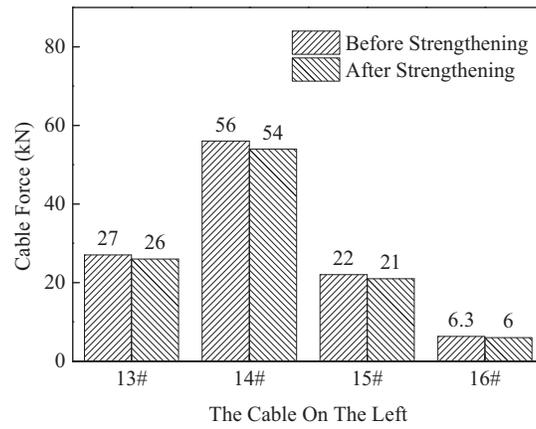
Figure 36: Upstream cable force comparison

Fig. 36 shows the comparison diagram of cable forces on the left side under eccentric load (the middle of the third span), and Fig. 37 shows the comparison diagram of cable forces on the right side under eccentric load (the middle of the third span). As shown in the figure, under the action of eccentric load, the cable force of the bridge increases, and the cable force measured on the right is obviously higher than that on the left, and the measured cable force after reinforcement is all smaller than that before reinforcement. Among them, the cable force value after the reinforcement of the left 14# cable is 3.6% lower than that before the reinforcement, the measured value of the left 16# cable is 4.8% lower than the theoretical value, and the cable force decreases within the range of 3.6%~4.8% after the reinforcement of the other cables.

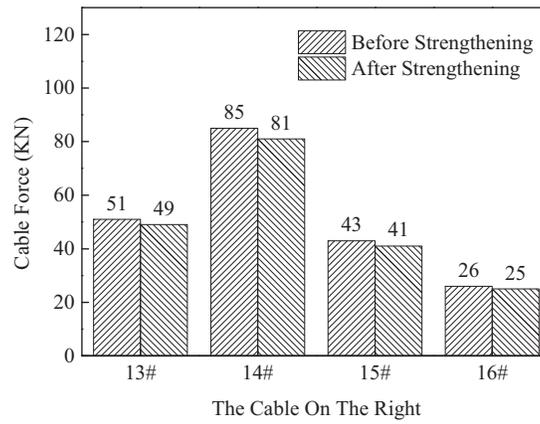
Figure 37: Downstream cable force comparison

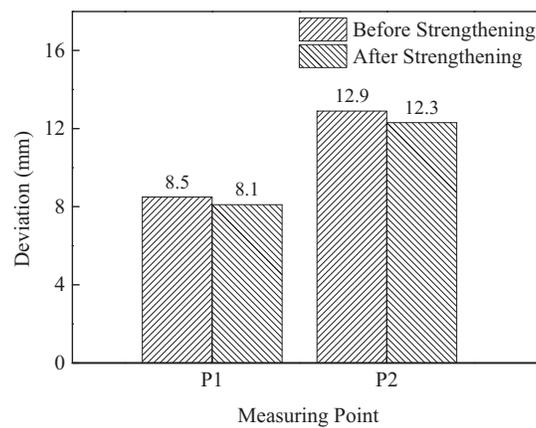
Figure 38: Tower migration contrast in working Condition 1

Under the symmetrical loads (the second straddle in the middle) in the second span, the bridge tower deviation contrast value is shown in Fig. 38. Under the symmetrical loads (the third straddle straddle) in the third span, the bridge tower deviation contrast diagram is shown in Fig. 39. On both sides of the cable tower deformation uniformity is good, the cable tower offset values are less than the offset value of reinforcement former, reduce the range of 4.5%~5.6%, enough stiffness cable tower structure are proved.

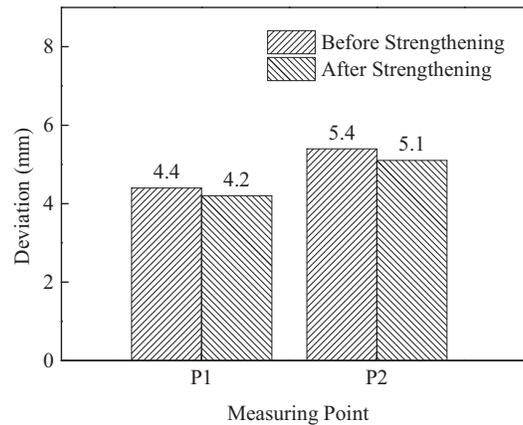
Figure 39: Tower migration contrast in working Condition 2

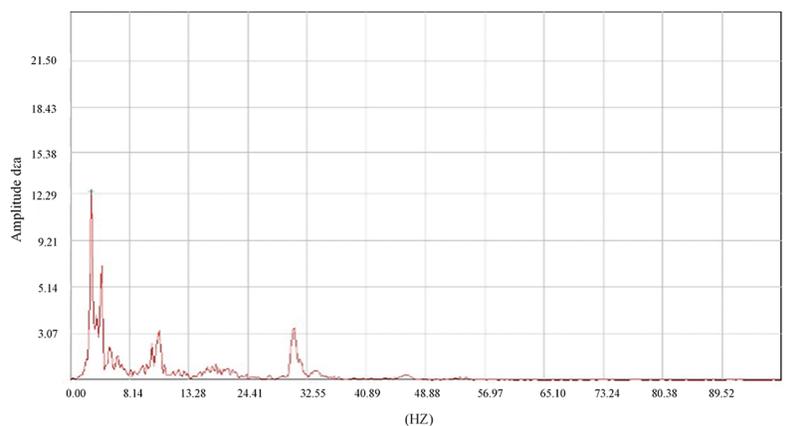
Figure 40: Natural spectrum diagram of pulsation test bridges ($f = 2.71$ Hz)

The measured natural vibration frequencies of the third span are shown in [Figs. 40–43](#).

The measured natural vibration frequency of the bridge at the vehicle speed of 10 km/h, 20 km/h and 30 km/h. The frequency of the third span is 2.71 Hz~2.82 Hz. The measured data are larger than the theoretical data, which indicates that the bridge structure has greater actual stiffness.

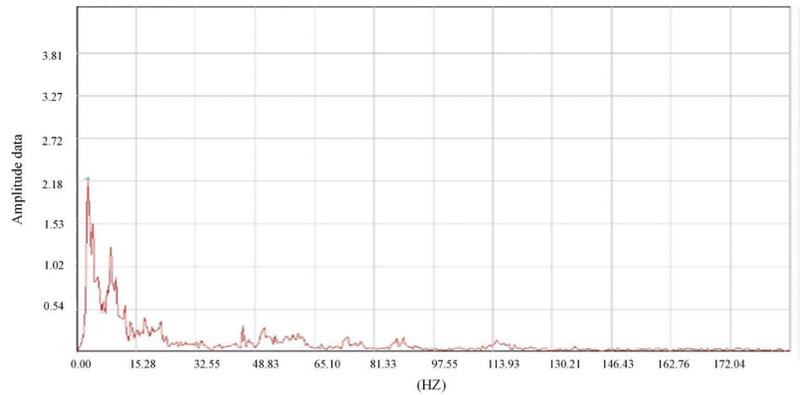
Figure 41: Natural spectrum diagram of bridge at 10 km/h ($f = 2.75$ Hz)

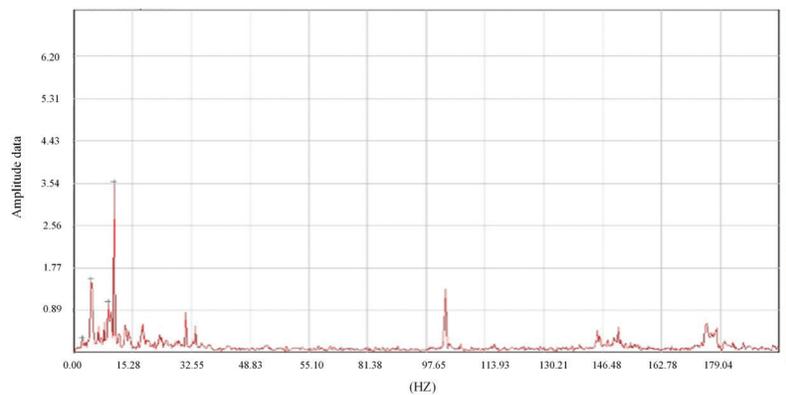
Figure 42: Natural spectrum diagram of bridge at 20 km/h ($f = 2.77$ Hz)

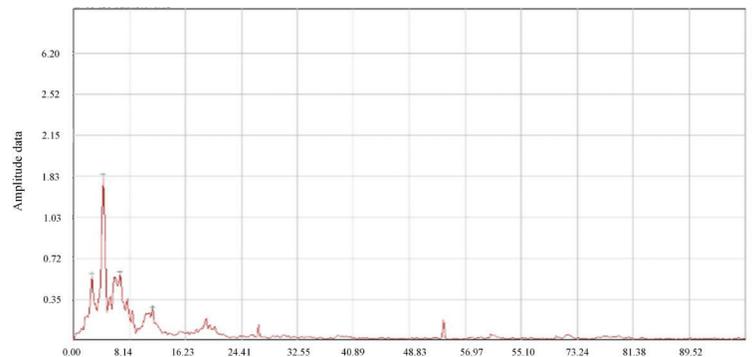
Figure 43: Natural spectrum diagram of bridge at 30 km/h ($f = 2.82$ Hz)

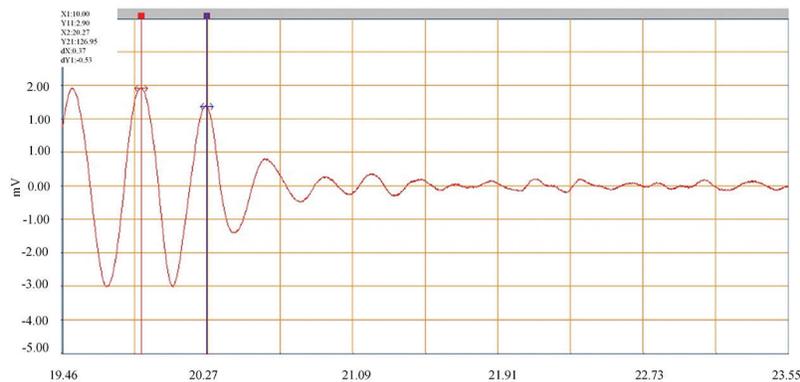
Figure 44: Jumping attenuation curve 1 (damping ratio 0.027)

The measured damping ratio reflects the ability of the bridge structure to dissipate the external energy input. A large damping ratio indicates that the bridge structure has a strong ability to dissipate the external energy input and the vibration attenuation is fast. Small damping ratio indicates that the bridge structure has poor ability to dissipate the external energy input and the vibration attenuation is slow. However, excessive damping ratio indicates that there may be cracks in the bridge structure or abnormal working condition of the support. The data curves of jump test and brake test are collated and analyzed, and their attenuation rule is taken as the reference of the measured damping ratio of the bridge. The damping ratio of the third span can be calculated according to Figs. 44–47.

The damping ratio of the bridge structure is between 0.01 and 0.08. Through the analysis of the test data, it is known that the damping ratio of the third span is between 0.027 and 0.042, and the measured values are all within a reasonable range.

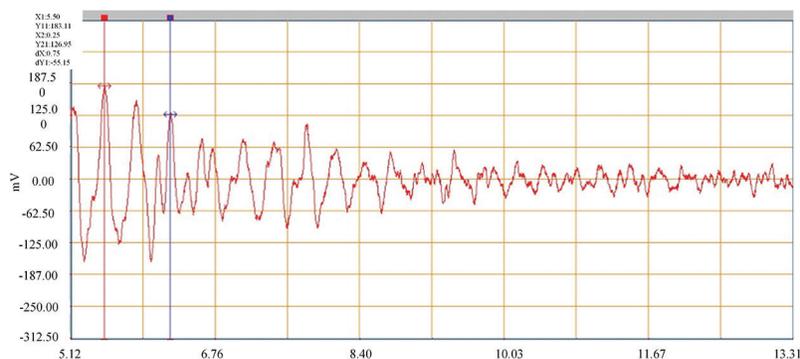
Figure 45: Jumping attenuation curve 2 (damping ratio 0.030)

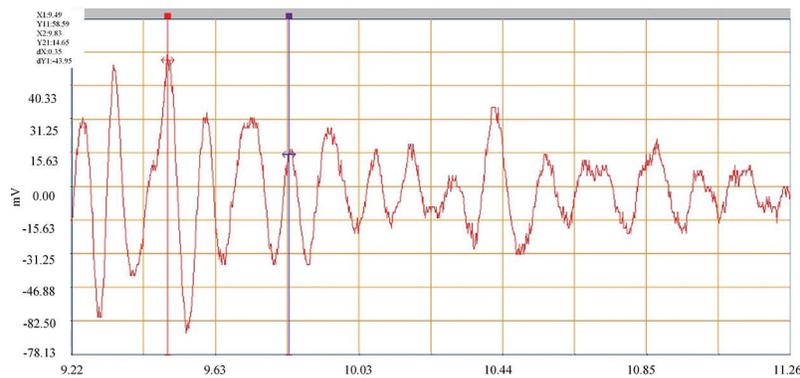
Figure 46: Brake attenuation curve 1 (damping ratio of 0.037)

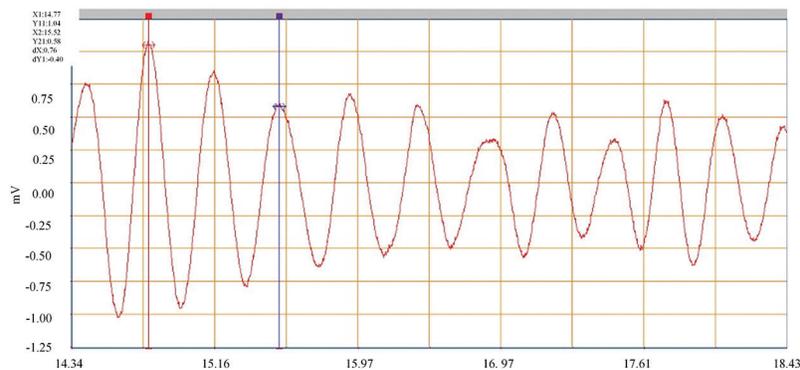
Figure 47: Brake attenuation curve 2 (damping ratio of 0.042)

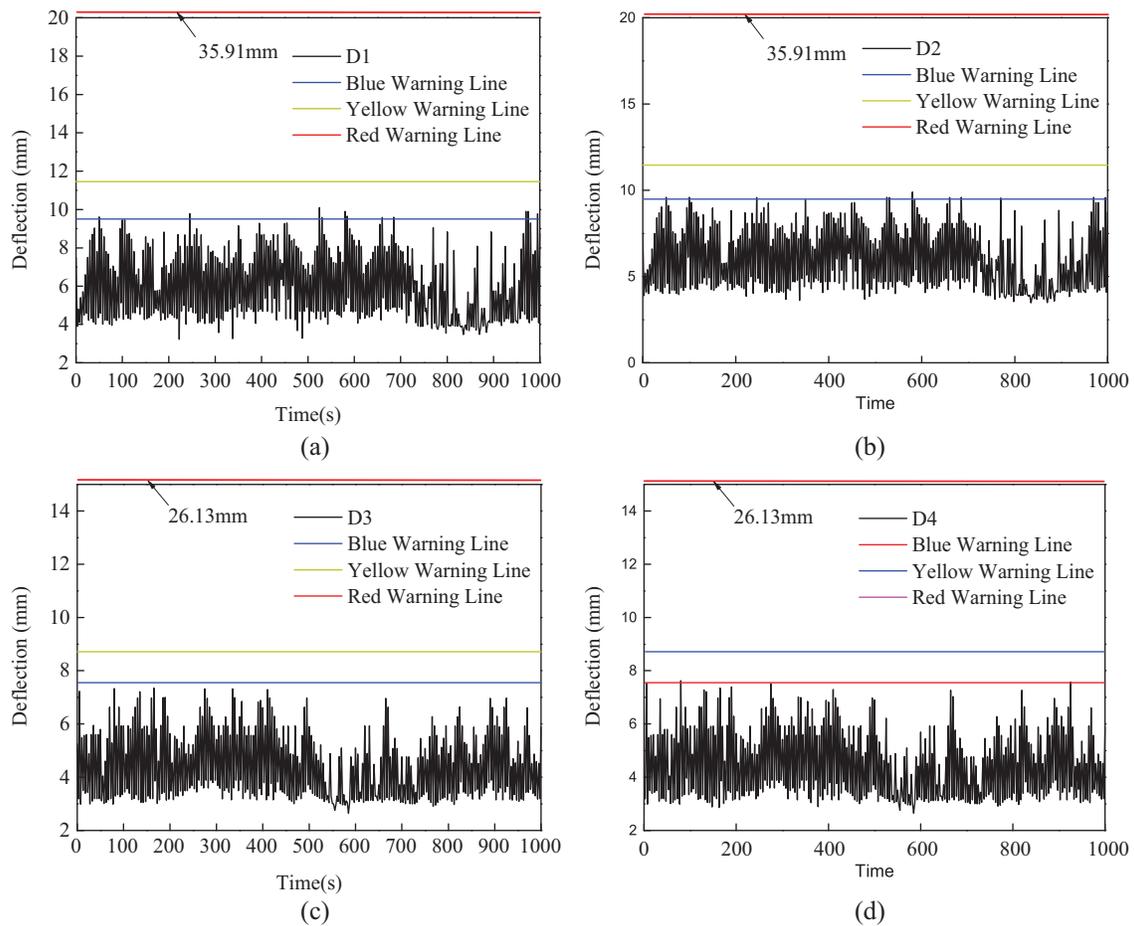
Figure 48: Time history diagram of main beam deflection measurement points (a) Point D1 (b) Point D2 (c) Point D3 (d) Point D4

Deflection curves of the second and third spans in 1000 s have been collected for this health monitoring. According to the established early warning system of Muling River Bridge, the safety monitoring of the normal performance of main girder can be realized. The deflection time history curves of the second and third spans are shown in Fig. 48. It can be seen from the figure that only a small number of data exceed the blue warning limit and innumerable data exceed the yellow warning limit, indicating that the structure is in a safe state.

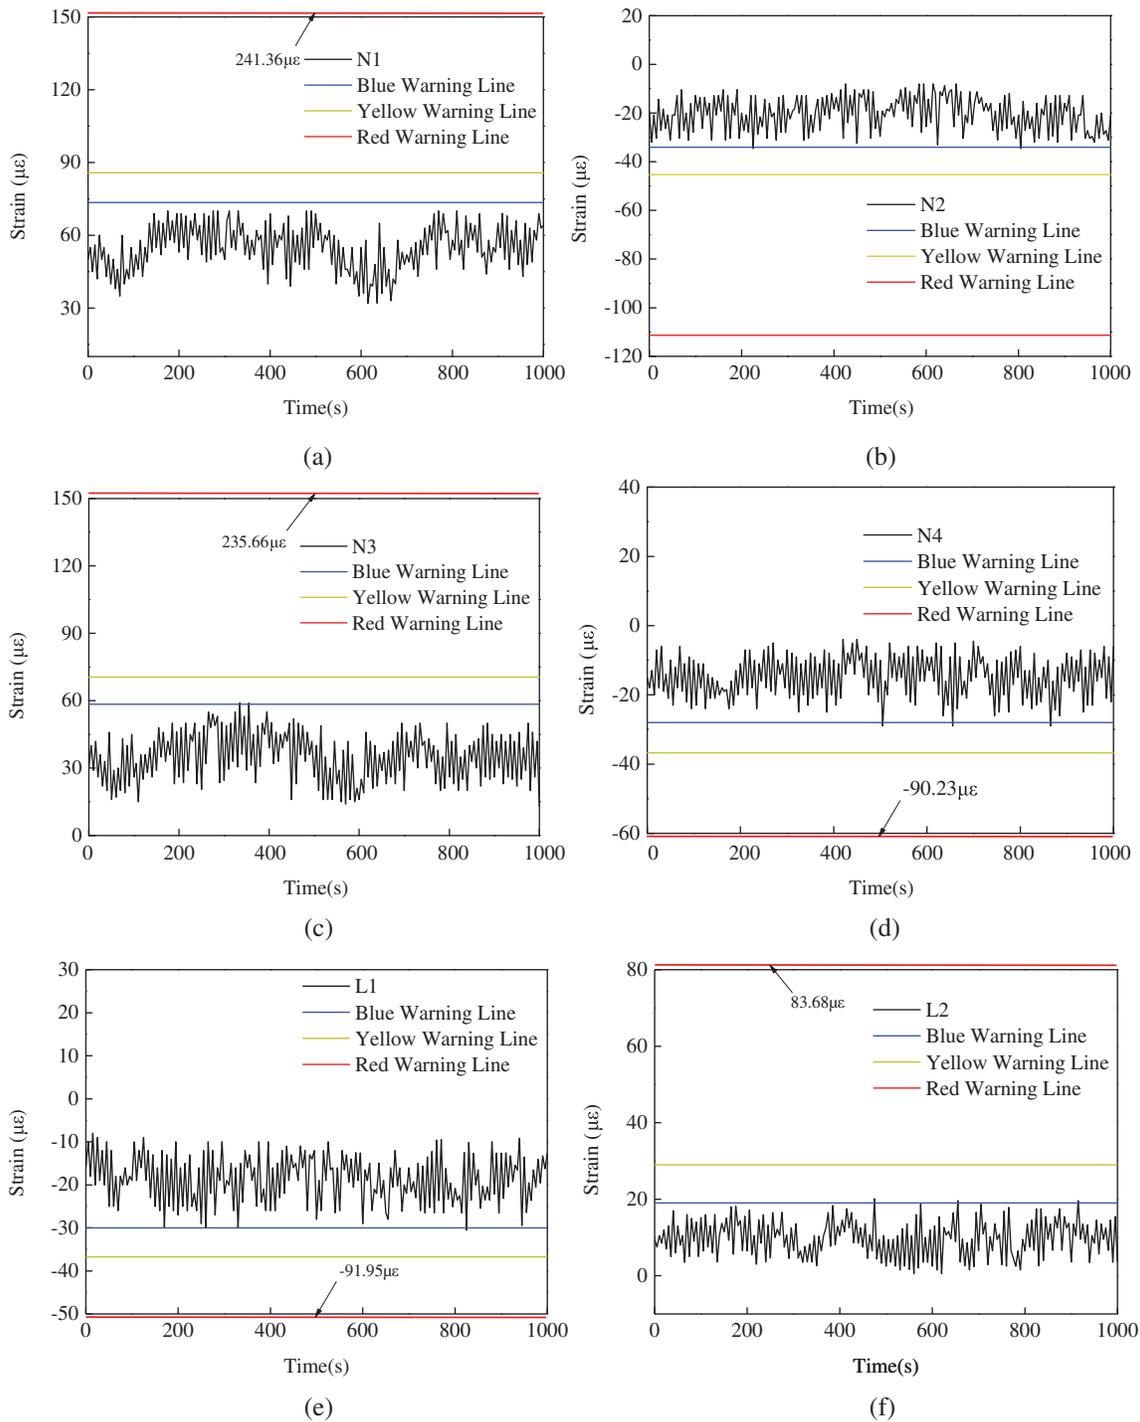
Figure 49: Time history diagram of main girder strain measuring points (a) Point N1 (b) Point N2 (c) Point N3 (d) Point N4 (e) Point L1 (f) Point L2

According to the established early warning system of Muling River Bridge, the safety early warning of main girder strain monitoring data can be realized. The strain curves of the first and fourth spans have been collected for 1000 s. The time history curves of the strain measuring points of the first span, the second span and the top of the 2# pier are shown in Fig. 49. As can be seen from the figure, a very small amount of data is close to the blue warning limit, and countless data exceed the yellow and red warning limit, indicating that the structure is in a safe state.
