Study on Properties of Blue-Brick Masonry Materials for Historical Buildings

Shaochun Ma^{1,2,*}, Lin Wang¹ and Peng Bao^{1,*}

¹Kaifeng Research Center for Engineering Repair and Material Recycle, School of Civil Engineering and Architecture, Henan University, Kaifeng, 475004, China

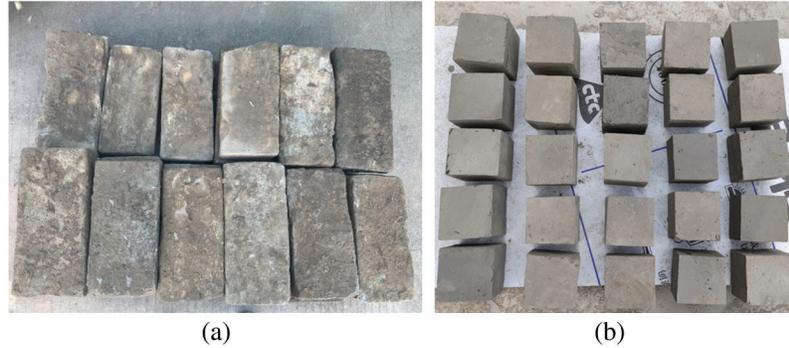
coefficient, and frosting, in addition to comparative X-ray diffraction (XRD) and scanning electron microscopy (SEM) analyses on the ordinary and frosted samples. Fig. 2 shows the sample preparation.

Figure 2: Sample fabrication (a) Blue brick samples, (b) Sample finished products

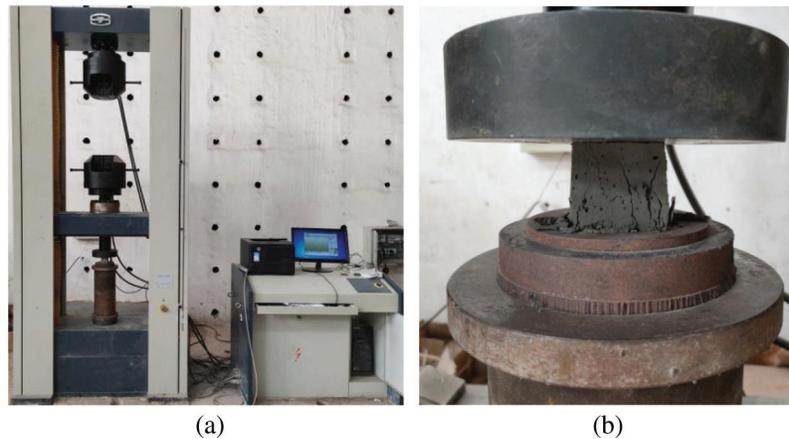
Blue brick served as a load-bearing building material. To utilize the characteristics of the material, people evaluate its bearing capacity and determine its strength grade. Therefore, it was necessary to assess the current mechanical properties of blue bricks to provide further reinforcement and maintenance of masonry structures. According to the relevant regulations in “Test Methods for Wall Bricks” GBT 2542-2012 [12], “Fired Common Bricks” GBT 5101-2017 [17] and “Basic Materials for Cultural Relic Building Maintenance” Blue Bricks WW/T 0049-2014 [11], a microcomputer-controlled electron universal testing machine WDW-600E was adopted. Its measurement accuracy was $\pm 1\%$, and the maximum axial force was 600 kN. Fig. 3 gives further details.

Figure 3: Compressive strength test (a) Compression test device, (b) Destruction diagram of test piece

Cleaned up surface dust on the test piece and numbered them separately. Next, aligned and axially loaded, ensuring no eccentricity in loading. The loading rate was 1 mm/min. During the loading process, the microcomputer image and the specimen’s crack development trend until the specimen was destroyed and recorded the corresponding test phenomena and results.

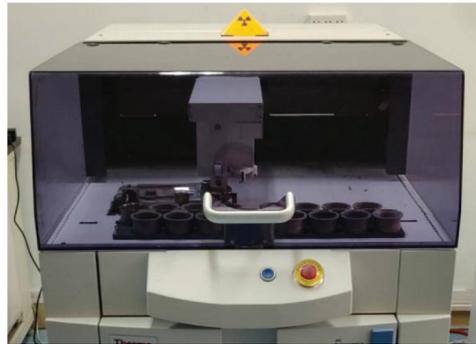
In studying the characteristics of blue brick materials, it was necessary to determine their chemical composition. Therefore, the chemical composition of ordinary samples and samples after frosting of blue brick was obtained by XRF analysis, which was used to analyze the variation of the main elements before and after the frosting of blue brick materials. Fig. 4 illustrates the ARL Perform’ X4200 spectrometer that analyzed the X-ray fluorescence spectrum, and the element analysis range was O-U. In the X-ray fluorescence spectrum analysis test, the blue brick specimens were ground into powder according to the requirements for specimen preparation and dried in a 105°C blast drying oven. The white frosting powder formed on the specimen’s surface was subsequently scraped off.

Figure 4: Experimental apparatus for X-ray fluorescence spectrometry

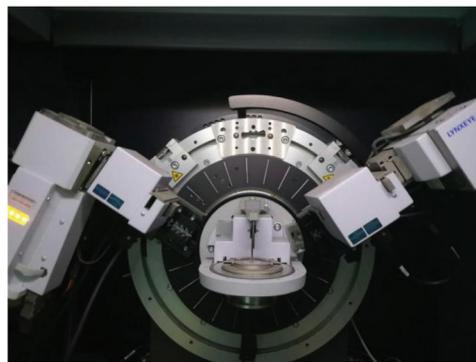
The compositions of the material shed helpful information to the characterization study of blue brick materials. The International Center for Diffraction Data published the diffraction data of various substances in PDF2-2004. The main material composition and the types of soluble salts in the materials were obtained through XRD analysis of the ordinary samples and the samples after frosting to analyze the variation of the material composition of blue brick before and after frosting. X-ray diffraction analysis used a D8-ADVANCE diffractometer (Fig. 5) with an angular accuracy of 0.0001° , and the scan range was $5^\circ\sim 90^\circ$. Blue brick specimens were ground into powder for the X-ray diffraction test as required and dried in the 105°C blast drying oven. Information as obtained from the typical samples of blue brick samples before and after frosting. A laser diffractometer provided the relevant XRD spectrum.

Figure 5: X-ray diffraction test device

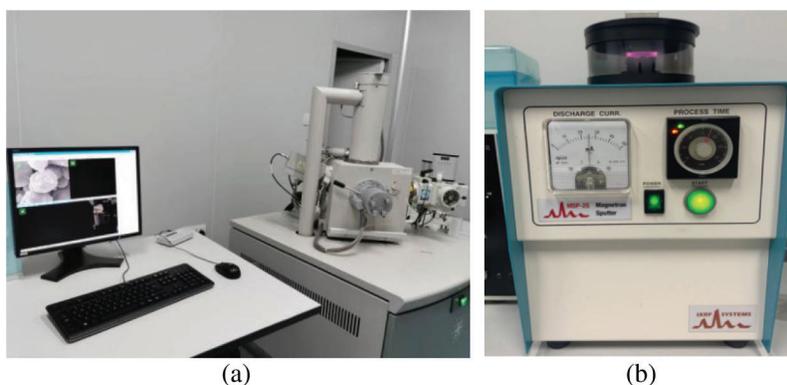
According to the relevant regulations in “Analysis Methods of Rock Sample by Scanning Electron Microscope” SY/T 5162-2014 [20]. Scanning electron microscopy was used to observe the internal structure of blue brick materials. By studying the micro structural changes of specimens before and after frosting. The cross-sectional microstructure and pore characteristics of blue brick materials were observed. The microstructure analysis supported learning the attributes of blue brick materials and the compactness of the sample particles [21]. The SEM specimens of blue brick specimens were analyzed in a FEI Quanta 250 environmental scanning electron microscope. Its accelerating voltage was 50 kV, the beam current was 80100 Ma, and the resolution was 1.0 nm/15 kV, as shown in Fig. 6. In the SEM test, the size of the blue brick sample required was $5\text{ mm} \times 2\text{ mm} \times 2\text{ mm}$. The specimens were dried in a 105°C blasts drying oven to constant mass, and the ordinary specimens and frosted specimens were thus

obtained, respectively. After vacuum gold plating, the blue brick samples were electronic scanned and images appropriately magnified, creating conditions for the study of microscopic morphology.

Figure 6: Scanning electron (a) Scanning electron microscope test device; (b) Vacuum gold plating

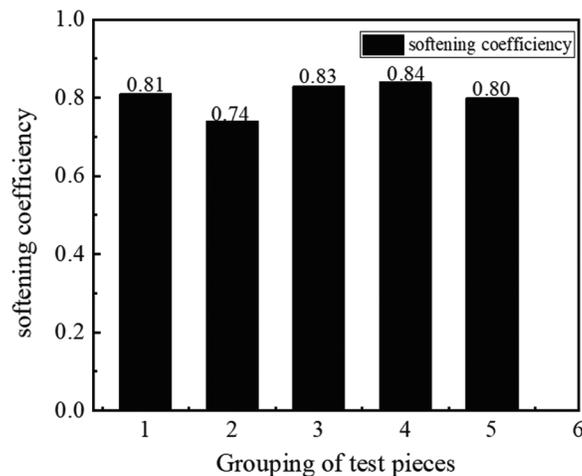
Figure 7: Softening coefficient of blue brick

The softening coefficient showed the water resistance of blue brick materials and was adopted as an essential basis for material selection [24,25]. Generally, materials with softening coefficient greater than 0.85 were water-resistant materials. The softening coefficient must be greater than 0.85 for important constructions in moist environments or under long-term water. The softening coefficient must not be less than 0.70 for building materials with lighter or secondary structures subjected to moisture.

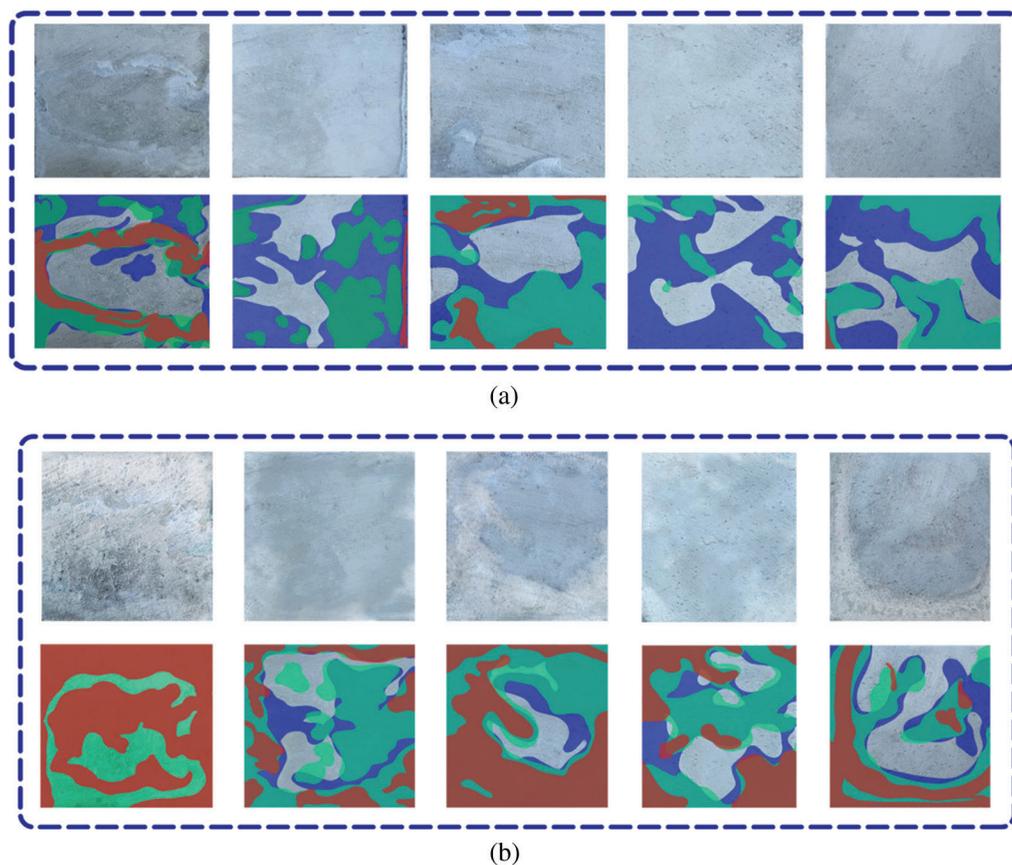
The frosting test repeated a process five times. After the first cycle, slight frosting occurred. The phenomenon was not evident after the second to fourth cycles but remained similar to the first cycle results. At the end of the fifth cycle, the specimen became pulverized. As shown in the chart, the severity of the frost phenomenon, from severe to slight, was designated red, green, and blue. The results of one cycle are shown in Fig. 8a. A thin layer of white salt crystals with powder and membrane was precipitated on the surface of the blue brick. However, the surface of the brick was still clearly visible, and there were no erosion and pulverization phenomena. The results from five cycles are shown in Fig. 8b. With the cyclical alternation in the frost test, increasing white salt crystals were formed on the surface of the specimen. Crystal growth trend spreads from the edges to the middle and the upper surface of the lower. The color of the specimen also changed with increasing dry-wet cycles. The surface of the specimen was no longer smooth and flat, and erosion and pulverization also occurred. A slight surficial drop occurred at the corners of the specimen, and the original color of the brick also changed.

Figure 8: Comparison plot of the pan-frost test results (a) The Result of one cycle (b) The Result of five cycles

In general, the frosting was a quantifiable process. The alternating dry and wet simulate the natural environment of the historic building. The results of the frosting test not only proved the existence of soluble salts in the blue bricks but also provided clues to the source of blue brick and the impact of changes in environmental humidity on the durability of brick. The soluble salt in the pores of the blue brick will absorb water to form a crystalline salt with some crystal water. After the salt crystallized, the volume increased, causing an expansive force in the pores of the blue brick. With repeated changes of the environmental humidity, the soluble salt circulated back and forth within the interior and surface of the brick, and the expansion force formed in the pores of the blue brick was also increasing, which led to the phenomena of pulverization and erosion on the surface of the blue brick reducing the brick

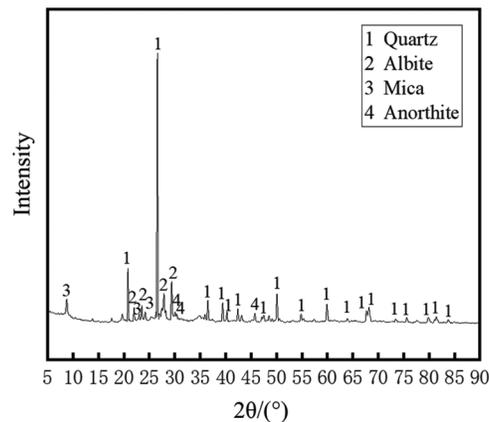
XRD analysis was carried out on the ordinary blue brick samples obtained and the frosted samples. By importing the obtained XRD spectrum to the data analysis software, the mineral composition was obtained. Fig. 9 shows the main mineral composition of the blue brick specimen. The coordinate axis was the diffractometer angle, and the curve in the figure reflected the abundance of mineral composition under different test angles. The No. 1 diffraction peak was that of the quartz (SiO_2), with the peak at 26.8° . The No. 2 peak was albite ($\text{Na}(\text{AlSi}_3\text{O}_8)$), at 29.6° . The No. 3 diffraction peak was mica, appearing at 8.9° . The No. 4 diffraction peak was anorthite ($\text{Ca}(\text{AlSi}_3\text{O}_8)$), occurring at 29.8° . In general, the better the crystallinity of the crystal was, the sharper and more precise the corresponding diffraction peak was, and the peak value also represented the abundance of the substance. The results showed that the quartz content was the highest, followed by an albite, anorthite, and mica, and mica content was the lowest. Therefore, the composition of blue brick was mainly composed of quartz and feldspar.

**Figure 9:** XRD pattern of ordinary blue brick

Based on the above analysis, we concluded that the frosting process was similar to the water washing process, which soaked the specimen with demonized water. However, after frosting, the peak value of feldspar materials became relatively weak; especially the peak value of calcium feldspar was no longer sharp as calcium carbonate was produced from the reaction of calcium feldspar and water, and calcium carbonate was not soluble in water. Therefore, after washing, the peak value of calcite was more prominent.

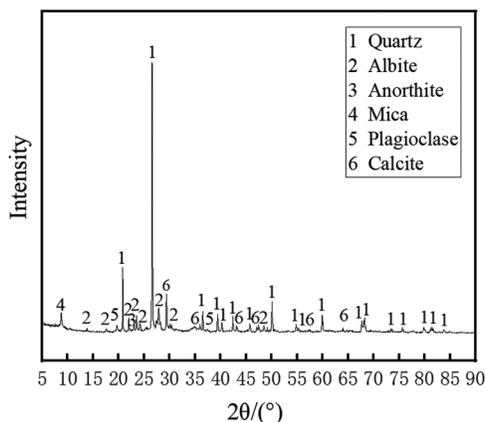
The main mineralogical composition of the frosted brick specimen is shown in Fig. 10. The No. 1 diffraction peak was that of quartz (SiO_2), with a peak at 26.5° . The No. 2 diffraction peak belongs to albite ($\text{Na}(\text{AlSi}_3\text{O}_8)$), at 27.8° . The No. 3 diffraction peak at 22.8° was that from anorthite ($\text{Ca}(\text{AlSi}_3\text{O}_8)$). The diffraction peak No. 4 at 8.6° was that of mica. The No. 5 diffraction peaks at 19.6° and 37.3° were of plagioclase. The No. 6 diffraction peak was that of calcite (Calcium Carbonate) with a peak at 29.3° . Compared with the ordinary sample (without frosting), quartz and feldspar were still the main minerals when the test angle was between 20° and 35° . The difference was that calcite occurred. Calcite belongs to the carbonate mineral group, and its occurrence further confirmed the existence of salt substances in the internal voids of bricks, which caused the reaction of some new minerals interaction water. In this study, blue brick ordinary and frosted samples and Shanxi Ming and Qing ancient brick composition were similar and dominated with quartz and feldspar material [3], but with the frosted samples, calcite appeared. In the design of European brick, quartz was the main component, and feldspar was less [30].

Figure 10: XRD pattern of blue brick after frost

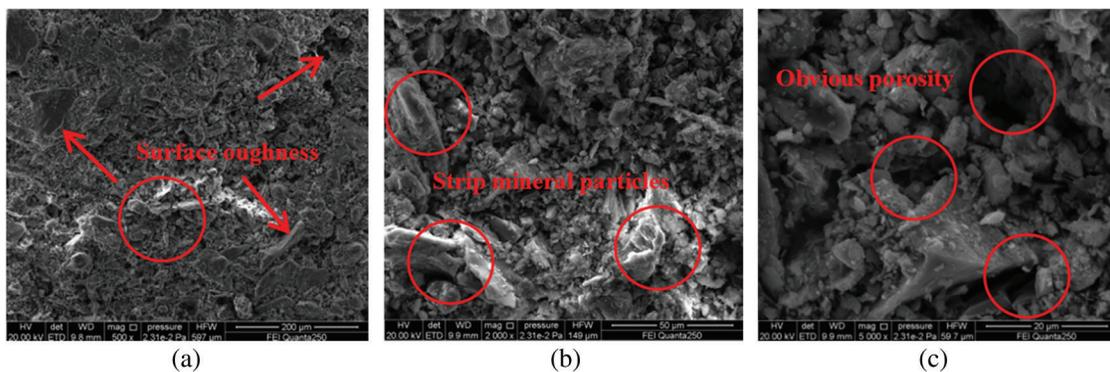
Fig. 11 displays the internal situation of ordinary blue brick specimens. The images showed that the texture of the blue brick was uniform. About 500 times magnifications, the microstructure of the sample was mainly a closely arranged tiny particle skeleton. The surface was relatively rough, and the overall structure was loose. At 2000 times magnification, many micron-sized mineral particles with different forms such as flake, strip, and block were evident. Smaller mineral particles surrounded by the larger particles, and the pores in the brick appeared abundant. At 5000 times magnification, the sample's broken internal structure and the angularity of the crystals were apparent. Some grains appeared broken, the gap between mineral particles was large, the pore structure between skeletons was prominent, and the structural coupling power was relatively weak.

Figure 11: Scanning electron microscope (SEM) images of blue bricks (a) 500-fold magnification, (b) 2000-fold magnification, (c) 5000-fold magnification

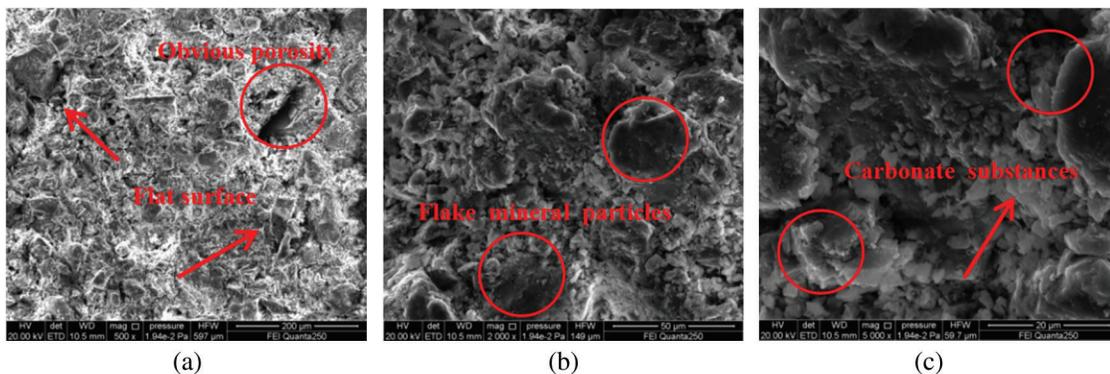
Fig. 12 displays the internal status of the frosted specimens. The images showed that there were some soluble substances in the blue brick. Due to the effect of a moist environment and groundwater, these substances gradually precipitated and weakened the fusion between mineral particles in brick. The precipitated material remained within the pores or on the surfaces of the brick, and the interaction of the minerals with water formed more new minerals. These minerals within the brick's pores eventually led to the brick's collapse under the long-term repetitive crystallization pressure [31]. At 500 times magnification, fractures occurred within the frosted specimen, and noticeable pores appeared. Compared

with ordinary samples, the arrangement of mineral particles was significantly different. A tiny particle skeleton no longer dominated the view, but the mineral particles were relatively closely arranged, incorporating carbonates between particles. At 2000 times magnification, the sample was relatively flat inside. No sharp strip-shaped mineral particles were visible, but many granular, flake and block-shaped mineral particles were visible. It was a consequence of the washing in the frosting process. At 5000 times magnifications, the sample was relatively flat and contained many dispersed particles. The space between mineral particles was small, and the coupling power was reasonably good. Compared with ordinary samples, the broken grains and pore structure between skeletons were not significant.

Figure 12: Scanning electron microscope (SEM) of blue brick frost samples (a) 500-fold magnification, (b) 2000-fold magnification, (c) 5000-fold magnification

In summary, compared with the ordinary samples (without frosting), the frosting caused carbonates to form within the blue brick. These products filled the bricks' internal pores in the short term, making the brick skeleton tighter and improving the mineral particles' binding forces. However, frost also broke the fusion between the original mineral particles within the brick body to expand these tiny particles. In addition, the emergence of new substances produced grain growth pressure, resulting in a gradual increase of crystallization pressure between minerals within the brick. The continuous changes in the surrounding environment and climate humidity in practical engineering induced the frost phenomenon. The presence of crystalline salt substances in the atmosphere led to new mineral particles within the brick, filling the internal pores in the brick. The crystalline material repeatedly circulated between the brick's surface and interior, cracking and disintegrating the brick material and affecting the durability and safety of brick
