Study on the Durability of Recycled Powder Concrete against Sulfate Attack under Partial Immersion Condition

Hualei Bai^{1,2}, Ying Li^{1,2,*} and Dahu Dai^{1,2}

¹School of Civil Engineering, Qinghai University, Xining, 810016, China

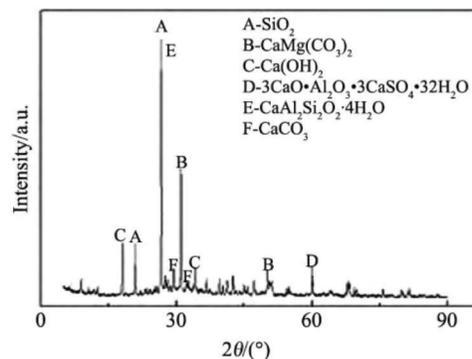
Figure 1: XRD diffraction pattern of RFP

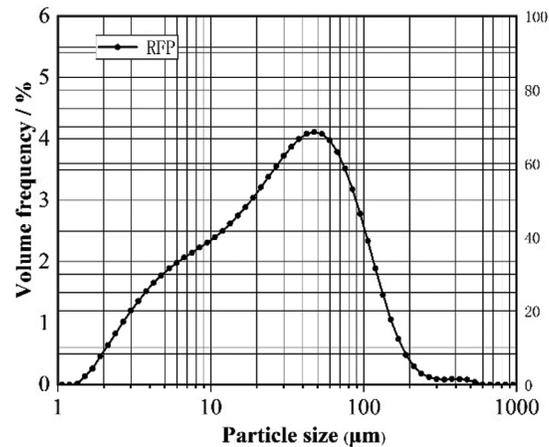
Figure 2: Particle size distribution of RFP

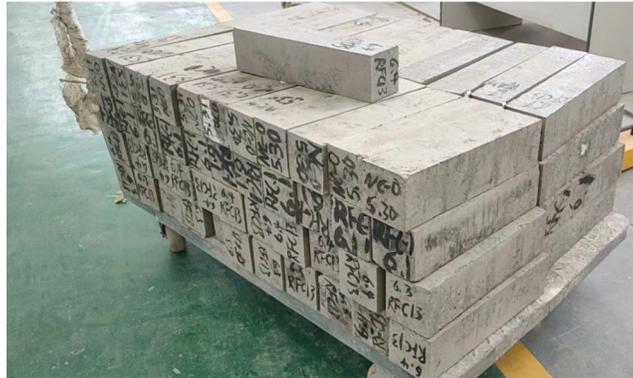
Figure 3: 100 mm × 100 mm × 400 mm sample diagram

According to the mixing ratio in Table 2, 0%, 10%, 20%, 30%, and 40% RFP were used to replace the cement and make three prismatic test blocks of 100 mm × 100 mm × 400 mm. A group of 3 pieces was used for comparison, and a total of 105 pieces of prismatic concrete were produced. Some samples are shown in Fig. 3. The casted test blocks were kept at room temperature for 24 h before removing the molds. The test blocks were placed in a standard curing room for 28 d. Afterward, the test blocks were removed from the curing room and dried naturally for 2 d. The blocks were weighed, and the weights were recorded as the original masses. Then, the test blocks were placed into 5% Na₂SO₄ and MgSO₄ solution, exactly half immersed. Since most concrete components are often semi-buried or semi-immersed in an underground sulfate environment, in order to simulate this actual engineering environment, a half immersion method was adopted to study the durability of RPC. The partial immersion at room temperature was maintained for 30, 60, 90, 120, 150, and 180 d. Afterward, the test blocks were taken out and dried naturally for 2 d before weighing them again. For each immersion period, 45 pieces of the test blocks were cut into equal cubes of 100 mm × 100 mm × 100 mm, as shown in Fig. 4. The compressive strength of the concrete cubes was measured according to the Chinese Standard for Test Methods of Concrete Physical and Mechanical Properties (GB/T 50081-2019) [35].

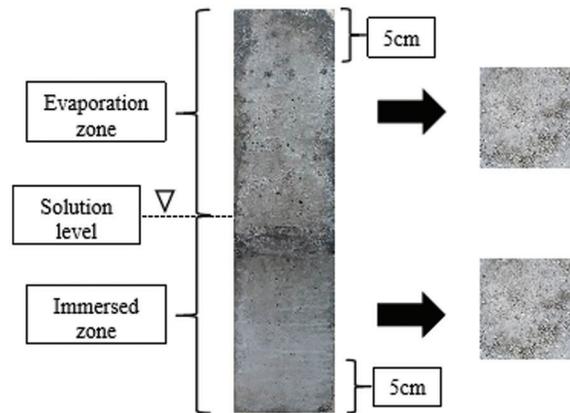
Figure 4: Sampling schematic

After the destruction, two cube concrete test blocks were taken from the same position, and a total of six of each group were taken and put into the analysis of pure alcohol to stop hydration. Changes in the microstructural composition of the samples were tested using SEM-EDS and XRD. The sample soaked in the analysis of pure alcohol was taken out and dried in an oven at 80°C for 6 h. Three of the damaged samples in each group were tested by SEM-EDS (JSM-5610LV) to observe the characteristics of the hydration products and erosion products. EDS energy spectrum was used to analyze the element types and contents of the samples, and SEM images were used to qualitatively analyze the erosion products. The other 3 damaged samples in each group were ground using a grinder, and the crystal phase of the concrete was analyzed using an X-ray instrument (Rigaku D/MAX 2500PC) to observe the hydration products and the microstructure composition of the upper and lower parts of the RPC during immersion.

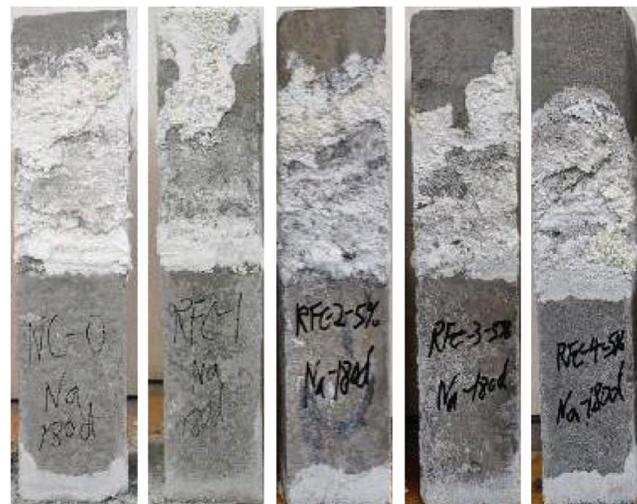
Figure 5: Corrosion morphology of RPC in Na_2SO_4 solution
 Note: The replacement rate is 0%, 10%, 20%, 30%, and 40% from left to right.

The changes in RPC morphology after partial immersion in sulfate solution for 180 d are shown in Figs. 5 and 6. Under partial immersion in Na_2SO_4 solution, many white crystals appear on the upper part of the concrete. The peeling of NC-0 is not apparent, and the cement paste on the surface of RPC-4 peels off partially. With the increase of RFP content, the flaking of the middle part increases gradually and the sulfate crystallization appears on the bottom surface. The surface crystalline morphology of RPC changes with the increase of immersion time, and the crystallization process is generally divided into three stages. In the early stage, long crystals formed at the middle part of the concrete. The concrete sample was intact, and the crystal area was about 5 mm from the solution. In the middle stage, the middle part of the concrete crystallized from fiber length to powder. Due to the evaporation and absorption of water [36,37], a high concentration zone formed on the liquid surface, and Na_2SO_4 gradually crystallized on the concrete surface. In the late stage, the crystalline state was in the cross-distribution of powder and flocculation, and the surface of the RPC was partially peeled off at the crystalline position above the liquid level.

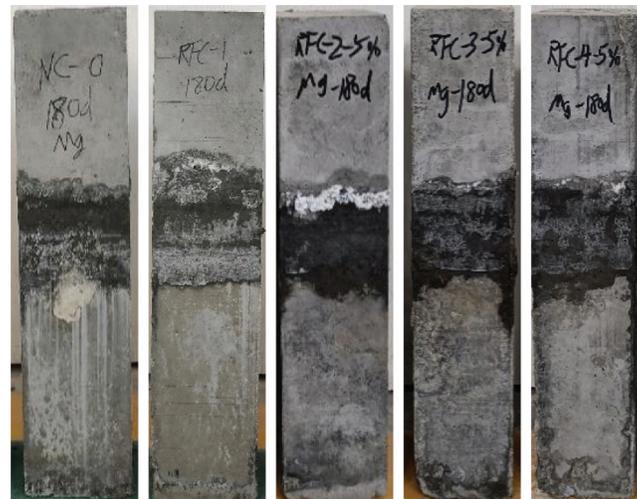
Figure 6: Corrosion morphology of RPC in MgSO_4 solution
 Note: The replacement rate is 0%, 10%, 20%, 30%, and 40% from left to right.

Fig. 6 shows the concrete morphology after being eroded by MgSO_4 for 180 d. A large number of paste-like viscous salt crystals appeared near the liquid level of the concrete. After removing the viscous material, the surface of the samples showed spalling spots, and the number of spots increased gradually with the increase of the RFP content. In the process of MgSO_4 solution eroding, viscous crystals formed gradually. At the liquid level, a high concentration zone of MgSO_4 was formed. After the concentration gradient, the ions diffused and migrated to the upper part of the concrete. In summary, it can be seen that the main difference in the morphology of the concrete after erosion by Na_2SO_4 and MgSO_4 solutions is the crystal shape and the spalling position. The surface morphology of concrete in Na_2SO_4 solution is dominated by white powdery crystals, while transparent paste-like crystals dominate the surface morphology of concrete in MgSO_4 solution. After removing the crystalline salt on the concrete surface, it can be found that the surface spalling of the middle and upper part of concrete after Na_2SO_4 erosion was more severe, while the lower part of concrete after MgSO_4 erosion showed sporadic spalling and the middle and upper part was intact.

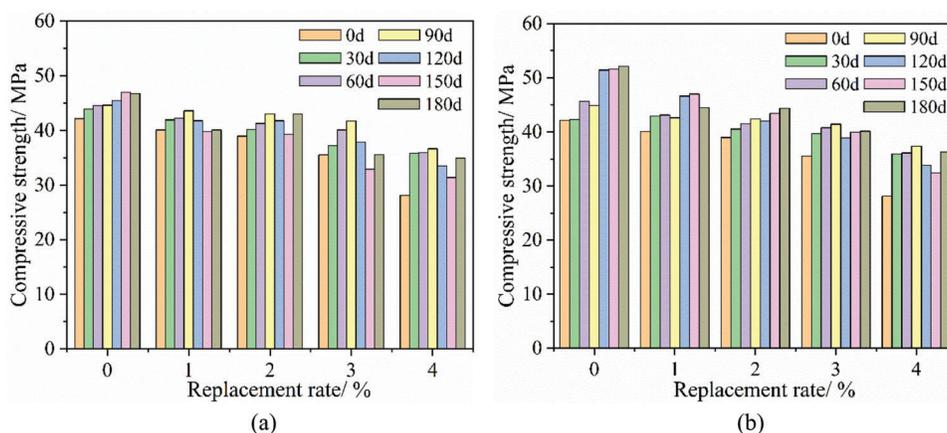
Figure 7: Compressive strength variation of the concrete in Na_2SO_4 solution

The concrete test blocks of the upper and lower parts were subjected to a cubic compressive strength test. Fig. 7a shows the compressive strength variation pattern of the upper part with immersion time in the Na_2SO_4 solution. The general compressive strength of the control group (NC-0) increased with immersion time. The high concentration zone of Na_2SO_4 is in the middle part of ordinary concrete immersed in the Na_2SO_4 solution. After the concentration gradient effect, it gradually extended to the upper concrete and formed a small number of erosion products (gypsum and ettringite) to fill the concrete, which resulted in the strength enhancement of the upper part [38]. The compressive strength of concrete in the upper part at 180 d was 46.69 MPa, indicating that ordinary concrete had good durability against sulfate. With the increase of time, the compressive strength of RPC increased gradually. RPC has obvious peaks at 90 d, with the peaks of RPC-1, RPC-2, RPC-3, and RPC-4 being 43.6, 42.98, 41.74, 36.64 MPa, respectively. After 180 d of immersion, RPC-2 had the highest compressive strength of 43.03 MPa, which was 3.67 MPa lower than NC-0. The results showed that RPC could produce secondary hydration, pozzolanic effect, and filling effect of sulfate attack products, which could enhance the early strength of RPC. In the late immersion stage, the RFP refines the pore size and the filling effect of the Na_2SO_4 erosion product (ettringite), further enhancing the late strength of RPC-2 with 20% RFP. Morphology analysis indicated that with the increase of RFP replacement rate, increasingly larger surface layers fall off the concrete, while the compressive strength remained unchanged. Therefore, the inner concrete core was not significantly affected, and the later strength was stronger than the initial strength.

Fig. 7b shows the histogram of compressive strength in the lower part of the concrete with time under partial Na_2SO_4 immersion. The compressive strength of NC-0 gradually increased with immersion time, reaching 52.14 MPa at 180 d. Moreover, the compressive strength in the lower part of ordinary concrete at 180 d was 5.45 MPa higher than that of the upper part, and more corrosion products formed in ordinary concrete because the lower part was fully immersed. With immersion time below 90 d, the compressive strength in the lower part of RPC gradually increased with time. The compressive strengths of RPC-3 and RPC-4 were 41.44 and 37.34 MPa at 90 d. The peak compressive strength in the lower part of the concrete appeared slightly different in time. The peak compressive strength in the concrete with 10% and 30% RFP appeared at 120 d. However, the peak compressive strength in the concrete with 20% and 40% RFP appeared at 90 and 150 d, respectively. After 180 d of immersion, the compressive strength of the concrete with 10% RFP decreased to 44.48 MPa, and that of the concrete with 20% RFP increased further to 44.37 MPa. The compressive strength could reach about 85% of the blank group, and the RPC was not yet damaged by erosion. At the same time, the strength of the lower part of RPC-2 was 3.11% higher than the upper part concrete at 180 d. When RPC was corroded by the Na_2SO_4 solution, the peak compressive strength in the lower part of the concrete with different RFP replacement rates was higher than that of the upper part, indicating that the upper part of RPC was more seriously affected by the partial immersion in Na_2SO_4 . These results are consistent with those of other scholars [39]. Na_2SO_4 had a positive effect on the increase of concrete strength under short-term partial immersion, and RPC had the properties of ordinary concrete, especially those with the RFP replacement rate of 20% (RPC-2), which showed excellent resistance to Na_2SO_4 erosion. The results showed that the infiltration of erosion products (ettringite and gypsum) produced by Na_2SO_4 could fill the pores of the concrete [40,41] and reduce their size, and the recycled micro-powder could refine the pore size, thus improving the compressive strength of the concrete.

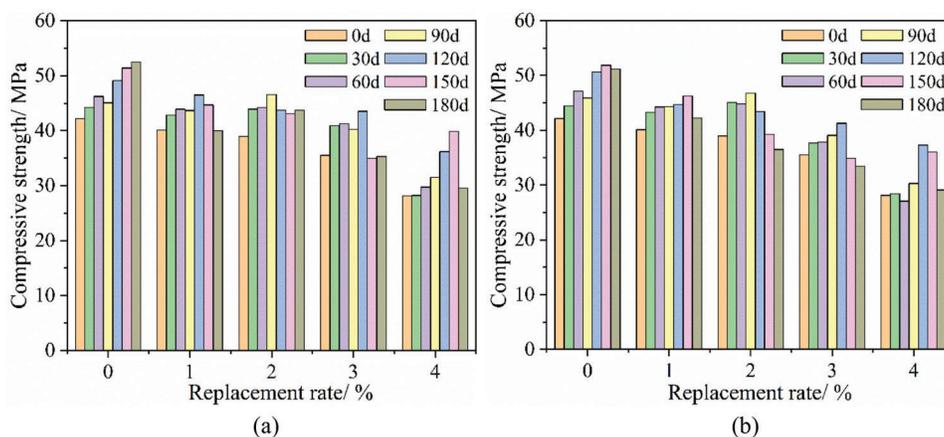
Figure 8: Compressive strength variation of concrete in MgSO_4 solution

Fig. 8a shows the variation of compressive strength with time in the upper part of the concrete immersed in MgSO_4 . The compressive strength of NC-0 increased to 52.46 MPa at 180 d. With different RFP replacement rates, the compressive strength of RPC showed different changing patterns. At 180 d, the compressive strength of RPC-1, RPC-2, RPC-3, and RPC-4 decreased to 39.95, 43.7, 35.29, and 29.56 MPa, respectively. However, the compressive strength of RPC-2 reached 83.3% of that of NC-0. The compressive strength in the upper part of the concrete immersed in the MgSO_4 solution was higher than that immersed in the Na_2SO_4 solution, indicating that the upper part of the concrete was corroded more seriously in the Na_2SO_4 environment. These results are consistent with the findings by [42]. In the early immersion stage, Mg^{2+} could increase the compressive strength under the action of RFP.

Fig. 8b shows the variation of compressive strength in the lower part of the concrete immersed in $MgSO_4$ solution. Under $MgSO_4$ erosion, ordinary concrete (NC-0) showed the peak compressive strength of 51.87 MPa at 150 d. At 180 d, the compressive strength of NC-0 is 51.16 MPa, which was 1.3 MPa lower than the strength of the upper part of the concrete. When immersed in $MgSO_4$ solution, the compressive strength of RPC-1, RPC-2, RPC-3, and RPC-4 peaked at 46.26, 46.75, 41.27, and 37.27 MPa at 150, 90, 120, and 120 d, respectively. The main reason is that as the number of RFP increases, the pores of the concrete are filled, the erosion products (ettringite) increase simultaneously, and the superimposed effect increases the strength of the concrete. At 180 d, the compressive strength in the lower part of RPC with 10%, 20%, 30%, and 40% RFP decreased to 42.2, 36.5, 33.42, and 29.1 MPa, respectively, and the strength of the upper part of RPC-2 was 7.2 MPa higher than the lower part after 180 d of 5% $MgSO_4$ erosion. The compressive strength of RPC-4 decreased to about 56.7% of that of NC-0, while that of RPC-2 was 71% of that of NC-0. Therefore, the RPC with 20% RFP had good durability. The intrinsic factor may be the hydration reaction of part of the RFP, which reduces the internal C_3A content and thus achieves the sulfate resistance. Under $MgSO_4$ erosion, the compressive strength in the upper part of RPC with RFP replacement rates over 10% was higher than that in the lower part. The reason for the lower compressive strength in the lower part of the concrete immersed in Na_2SO_4 might be due to the chemical erosion by $MgSO_4$ that produced ettringite and gypsum and the reaction between Mg^{2+} and C-S-H that produced gypsum and ettringite. At the same time, pH was reduced, which was beneficial to the formation of gypsum [43].

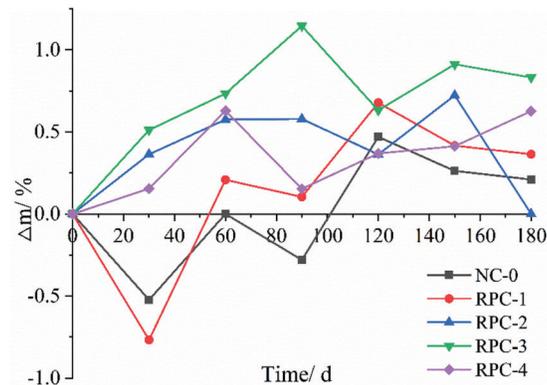
Figure 9: Mass loss rate variation of concrete in Na_2SO_4 solution

Fig. 9 shows the variation pattern of mass loss rate with time in RPC immersed in Na_2SO_4 solution. The mass-loss of RPC is affected by the increase of corrosion products and the surface peeling of concrete. The mass loss rate variation of NC-0 is similar to that of RPC with 10% RFP. The mass-loss rates of NC-0 and RPC-1 at 180 d are 0.209% and 0.364%, while that of concrete with 20%, 30%, and 40% RFP are 0%, 0.83%, and 0.627%. The mass-rate of RPC-2 showed a similar pattern to RPC-3. The mass of RPC-4 with 40% RFP kept decreasing from 90 d, indicating that the corrosion by Na_2SO_4 intensified as the RFP content exceeded a certain amount. Due to the high solubility of Na_2SO_4 on the concrete surface, the high concentration of Na_2SO_4 diffuses and gradually invades the interior, producing erosion products (gypsum and ettringite) in the surface layer. As the porosity of the surface layer decreased, the infiltration of Na_2SO_4 was reduced, and the excessive Na_2SO_4 physically crystallized on the surface. With the accumulation of ettringite and gypsum on the concrete surface, the pressure inside the pores increased. Over time, the corrosion products inside the concrete increase, filling the pores and communicating apertures. The mass of RPC-2 remained relatively stable during the immersion, and the increase at 90 d may be due to the large number of erosion products produced inside the concrete, filling the internal pores.

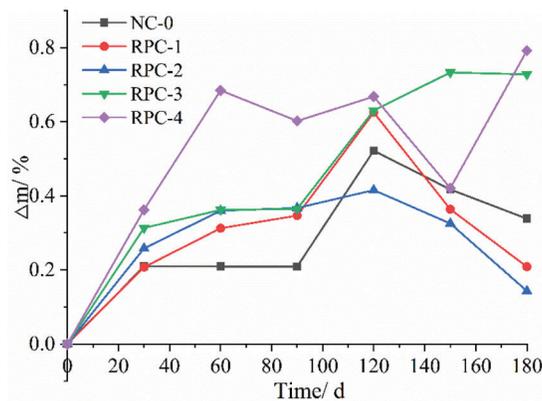
Figure 10: Mass loss rate variation of concrete in MgSO_4 solution

Fig. 10 shows the mass-loss rate variation of concrete immersed in $MgSO_4$ solution. The mass-loss rates of NC-0 and RPC-1, RPC-2, RPC-3, and RPC-4 at 180 d were 0.34%, 0.2%, 0.143%, 0.73%, and 0.792%, respectively. The mass of NC-0 and RPC all reduced. The mass-loss rate increased with the increase of RFP content, which may be attributed to the lower rate of erosion product accumulation and the higher rate of surface peeling. With the increase of RFP content, the pores inside the concrete were refined, which

decreased the solution absorption. Secondly, a viscous protective film formed on the concrete surface under the erosion of MgSO_4 , which slowed down the solution immersion. As Ca^{2+} precipitated from C-S-H [44], the pH of the concrete decreased, which was more favorable to cause internal damage and mass loss to the concrete. When the RFP content exceeded 30%, the mass loss became more severe.

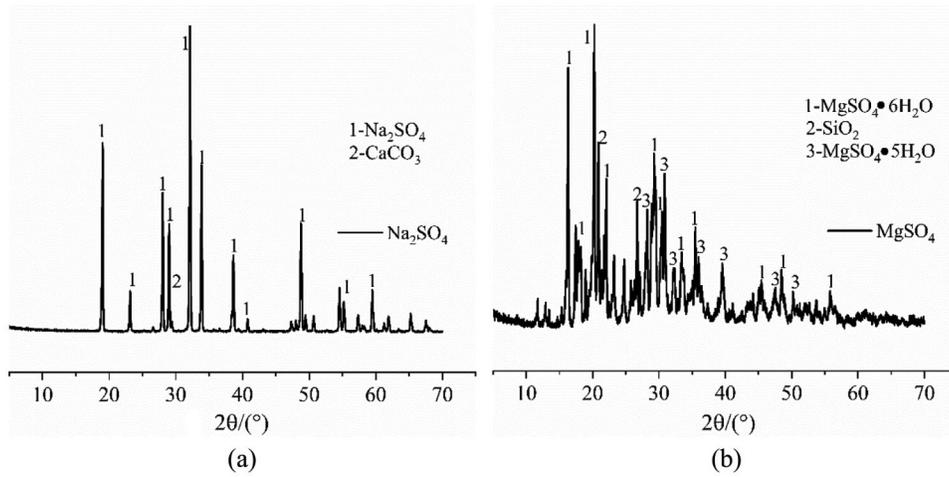
Figure 11: XRD spectrum of concrete surface precipitates

After the 180 d immersion in Na_2SO_4 , the powder crystalline products on the middle surface of the concrete sample were collected and analyzed using XRD. After 180 d of immersion in MgSO_4 solution, the viscous matter on the middle surface of the concrete was collected with a knife and analyzed using XRD. As shown in Fig. 11, Na_2SO_4 crystals are the main salt precipitates in the middle of the samples soaked in the Na_2SO_4 solution, while $\text{MgSO}_4 \cdot 6\text{H}_2\text{O}$ is the main salt precipitates in the middle of the samples soaked in the MgSO_4 solution.

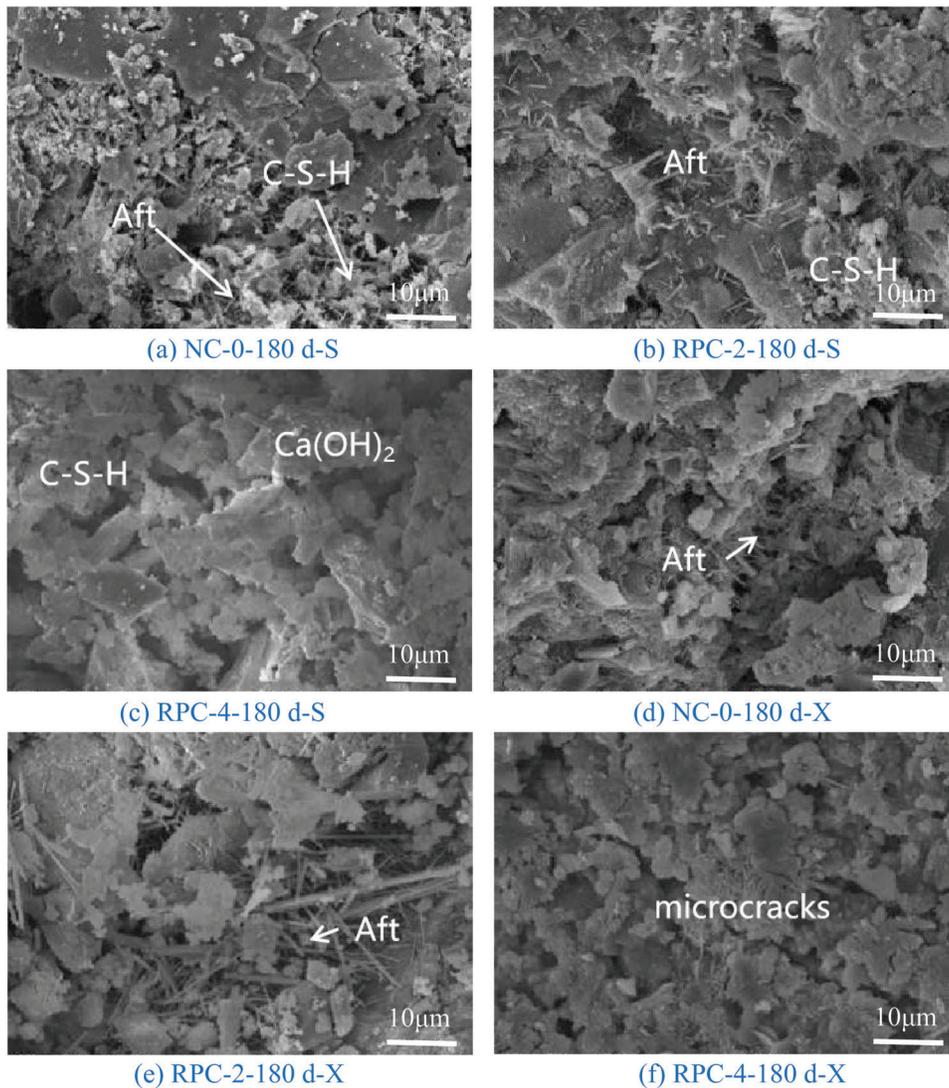
Figure 12: SEM diagram of concrete with different RFP replacement rates $\times 2000$ times

In Fig. 12, hydration products can be observed in the NC-0 concrete microstructure, including massive gypsum, needle-rod-like ettringite, gel products, and some scattered particles in the upper part, which may be the crystallization of Na_2SO_4 . Compared with NC-0, the concrete with 20% RFP has many needle-stick and blocky crystals. In particular, the lower part of RPC-2 is rich in needle-rod-like ettringite. Therefore, the compressive strength in the lower part of RPC-2 is higher than that of the upper part because of the higher amount of corrosion and hydration products. The microstructure diagrams of the upper and lower parts of RPC-4 show that the upper part of the concrete has a large amount of CH, gypsum, and flocculent C-S-H. Obvious cracks are observed in the lower part of RPC-2, and CH, AFt, and scattered granular materials are observed around the cracks. The scattered granular material may be thenardite, indicating the predominant chemical erosion inside the concrete. In contrast, the concrete with 40% RFP shows mainly flocculent and lumpy crystals. These results show that with the increase of the RFP content, the needle and rod crystals inside the concrete decrease, but the lumpy crystals increase.

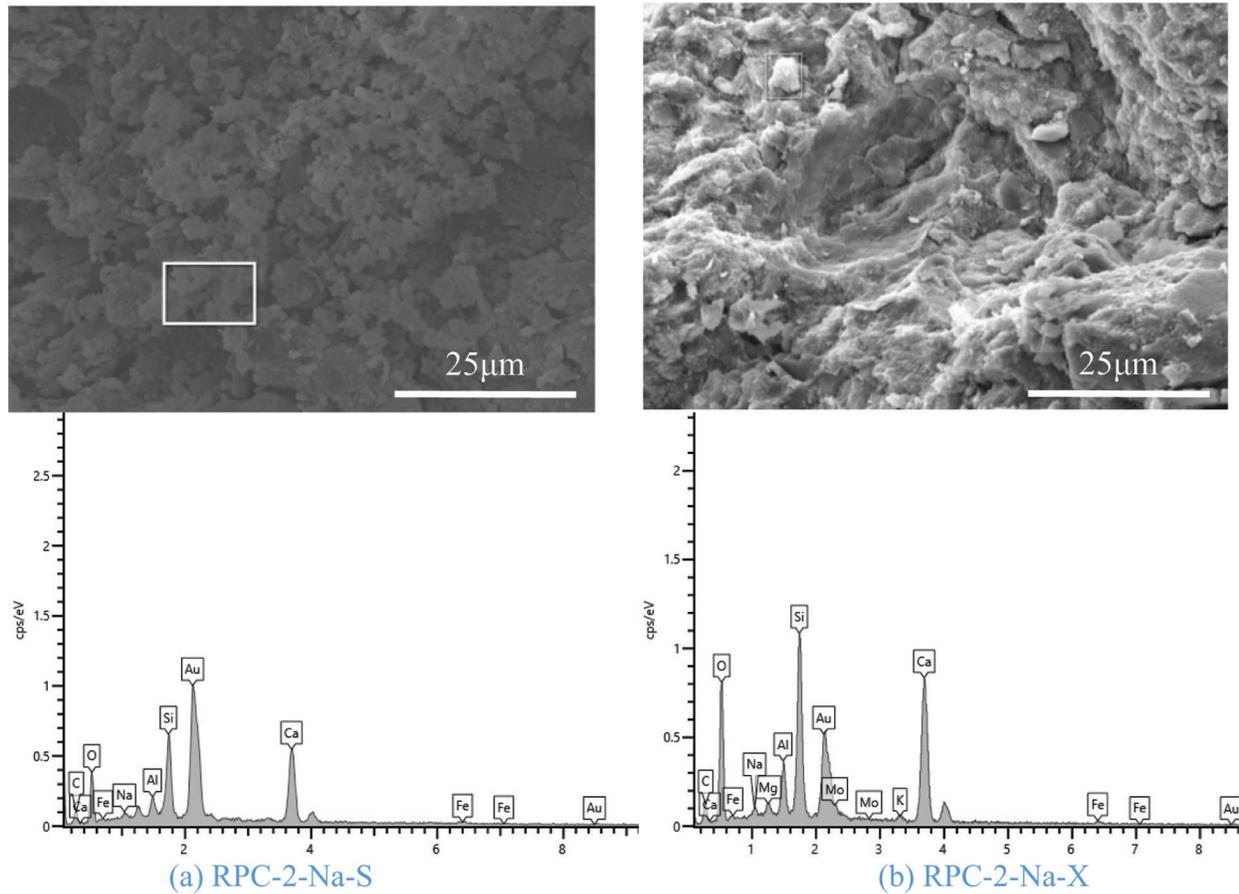
Figure 13: EDS diagrams of the concrete

Note: S represents the upper part of the concrete, X represents the lower part, and 180 d represents the immersion time.

Fig. 13 shows the EDS of concrete. In the energy spectrum of RPC-2 after the 180 d immersion in Na_2SO_4 , the main elements in the upper part are Si, Ca, O, and Al, which may be C-S-H, C-A-H, and AFm. In the lower part of the diagram, more marked Ca and O elements are observed, and the marked O elements are significantly increased. In addition to the small amount of Mg elements, the calibrated substances may have produced AFm [22]. Therefore, Na_2SO_4 was consumed initially to produce monosulfide sulfoaluminate. The average temperature in Xining, Qinghai Province is between -1°C and 15°C throughout the year, which is favorable for the production of the AFm phase.

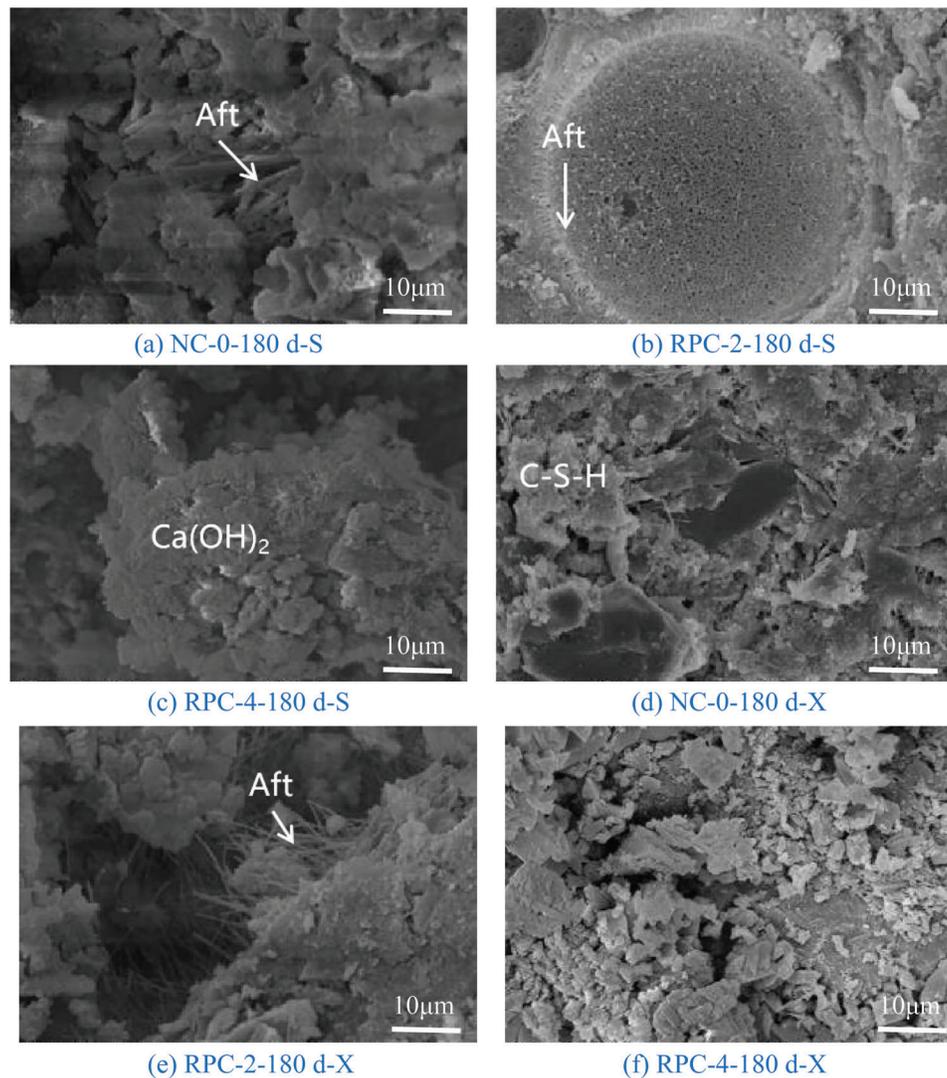
Figure 14: SEM diagram of concrete with different RFP replacement rates $\times 2000$ times

Fig. 14 shows the SEM image of concrete after 180 d of partial immersion in MgSO_4 . The main chemical erosion reaction in the MgSO_4 solution is as follows:

Compared with Na_2SO_4 , the formation of ettringite [45] and gypsum is promoted by the interaction of Mg^{2+} and sulfate after MgSO_4 enters the concrete. The erosion product of concrete in MgSO_4 solution is $\text{Mg}(\text{OH})_2$, which changes the pH inside the concrete and transforms the C-S-H to an unbonded C-M-H gel [46,47]. In the upper part of NC-0, needle-rod-like ettringite and massive gypsum can be observed, while in the lower part, small pores filled with ettringite and part of prismatic gypsum can be observed. Compared with the Na_2SO_4 solution, after immersion in the MgSO_4 solution for 180 d, less ettringite and more plate-like crystals were observed in NC-0.

A large amount of ettringite can be observed in the microstructure of RPC-2. In the upper part, the interfacial transition zones between aggregate and mortar had a large amount of reticulated ettringite and sporadic gel, while massive gypsum, ettringite, and part of CH were observed in the lower part. In addition, a large amount of ettringite grew inside the pores of the lower part of the concrete. Besides plate-like CH and prismatic gypsum, ettringite is barely visible in the microstructure of RPC-4. In contrast to the Na_2SO_4 solution, a larger amount of particulate matter was observed in the lower part of RPC-4 immersed in the MgSO_4 solution. The higher the RFP replacement rate, the larger the amount of gypsum produced in the concrete. As a result, the concrete microstructure became looser, and the compressive strength of RPC-4 decreased. Therefore, with higher RFP replacement rates, the RPC is more prone to gypsum-type damage under the combined action of SO_4^{2-} and Mg^{2+} .

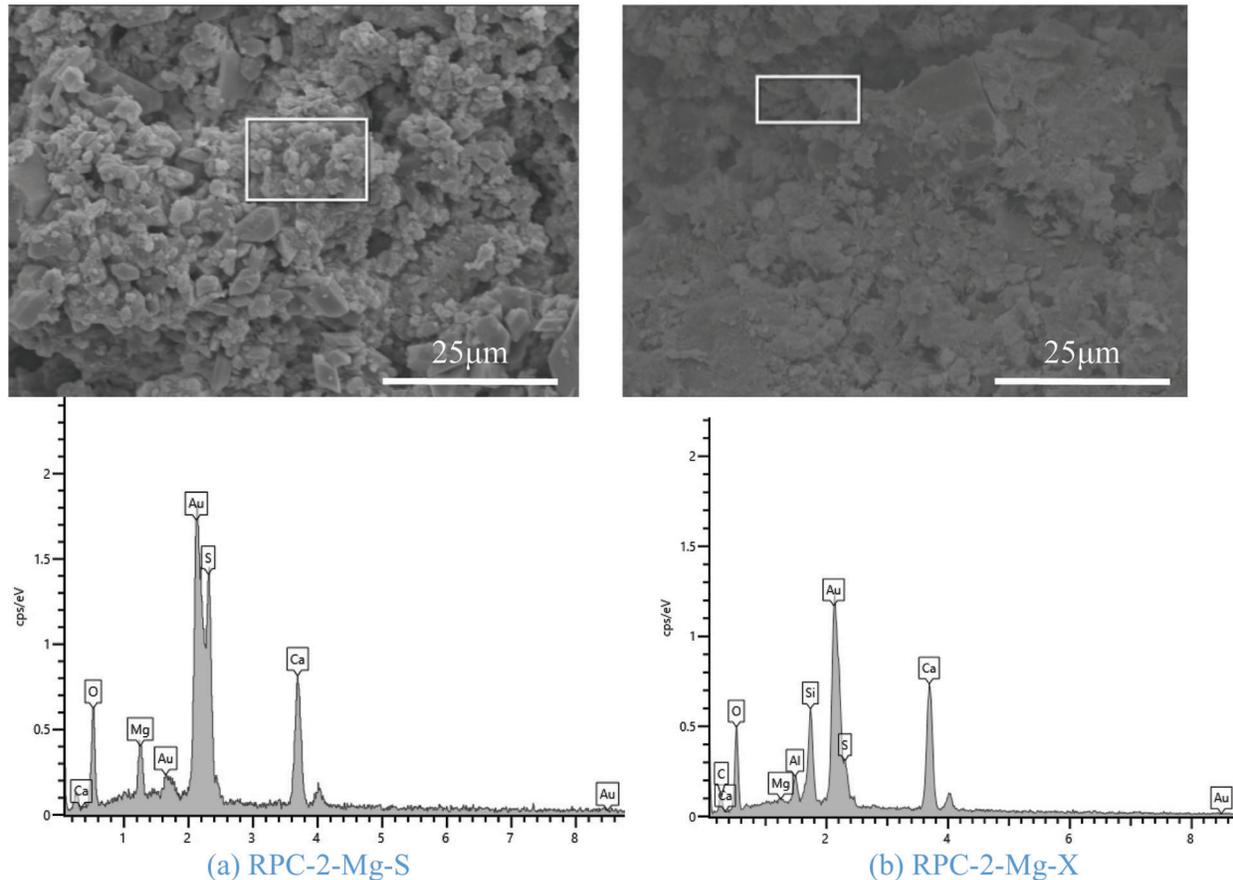
Figure 15: EDS diagram of concrete

The elemental composition of the microstructure of RPC-2 after the 180 d immersion measured by EDS is shown in Fig. 15. The predominant elements in the upper part of RPC-2 are S, Ca, O, Mg, and S, indicating that the calibrated substances are probably CaSO_4 , gypsum, M-S-H, and thenardite. The large prismatic crystals in the electron micrograph are gypsum, and the small number of granular crystals are thenardite. Therefore, the reaction between MgSO_4 and $\text{Ca}(\text{OH})_2$, chemical erosion, and physical crystallization erosion of MgSO_4 occurred in the upper part of the concrete. The elements in the lower part of RPC-2 are Ca, Si, O, Mg, S, Al, Mg, and C. The peak value of S in the lower part was significantly reduced, and M-S-H, gypsum, and some $\text{Mg}(\text{OH})_2$ may have been produced in the lower part. Eroded by MgSO_4 , the microstructure of RPC-2 changed, and a large amount of gypsum filled its interior. Thus, strong gypsum erosion occurred in the lower part of the concrete.

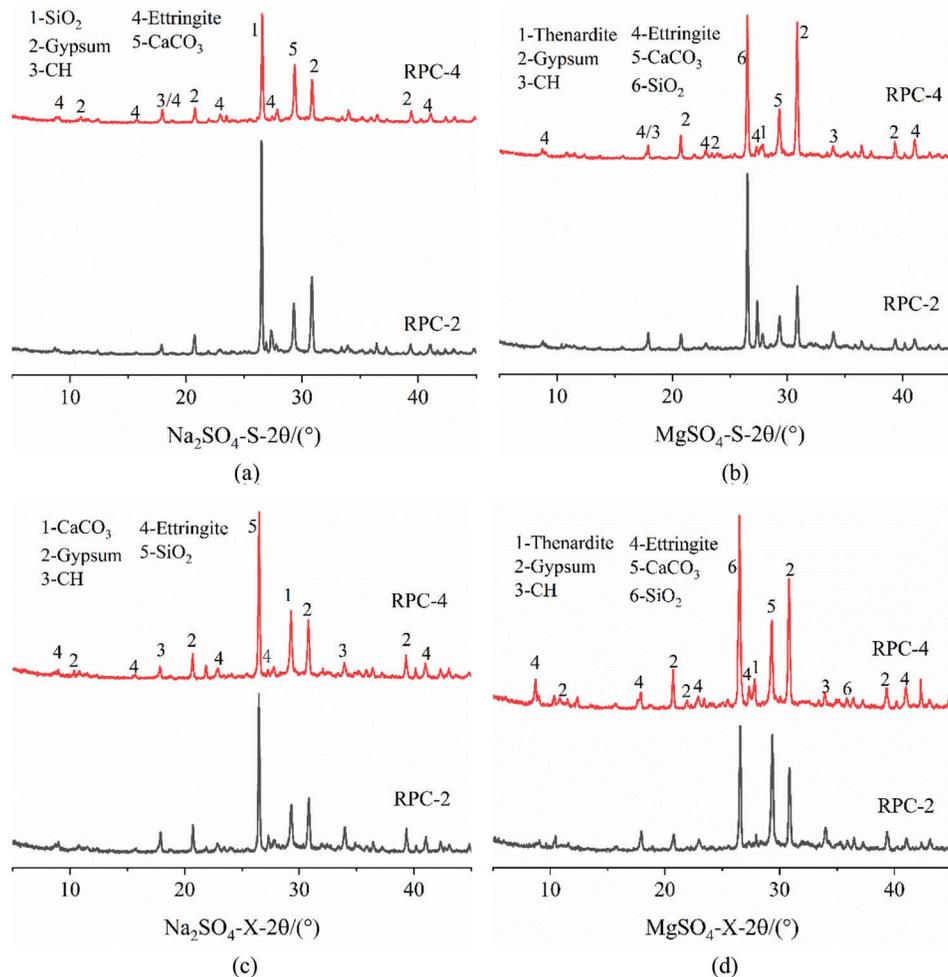
Figure 16: XRD pattern of the concrete

To further understand the corrosion products, we performed XRD tests on concrete samples after 180 d of Na_2SO_4 or MgSO_4 immersion. Fig. 16 shows the comparison between the XRD results of RPC-2 and RPC-4. The analysis results show that CaCO_3 , SiO_2 , gypsum, CH, and ettringite are present in the samples after Na_2SO_4 erosion. The contents of gypsum and ettringite (Aft) in RPC-2 were higher than those in RPC-4. The difference between gypsum peaks in RPC-2 and the lower part of RPC-4 is not significant, and the peak Aft of RPC-4 is approximately twice that of RPC-2. After 180 d of Na_2SO_4 erosion, chemical reactions occurred in the upper and lower parts of the concrete to produce gypsum and ettringite, predominantly gypsum. Gypsum erosion was not enhanced with the increase of the RFP replacement rate. Considering the morphology of the concrete, it is safe to conclude that under partial immersion, the upper part of the concrete undergoes internal chemical erosion and physical crystallization on the surface, while the lower part only undergoes chemical erosion. The reason may be that the upper

part has a higher rate of water evaporation due to its contact with air. Thus, the Na_2SO_4 concentration is higher on the surface, and its physical crystallization ensues. In contrast, the lower part is in contact with water, which is not evaporated. Thus, the physical crystallization of Na_2SO_4 on the concrete surface is not possible without a high concentration zone.

After 180 d of partial immersion in MgSO_4 solution, the material composition of the upper and lower parts of the concrete samples is mainly SiO_2 , gypsum, CaCO_3 , CH, and AFt. SiO_2 is mainly derived from the sample containing a certain amount of sand. CaCO_3 is produced by the carbonation of concrete. Gypsum and AFt are the erosion products of concrete attacked by MgSO_4 . The gypsum and calcium alumina diffraction peaks of RPC-2 compared to the upper part of RPC-4. Above the liquid level, the gypsum peak of RPC-4 is higher, but the difference between the peaks of ettringite is not significant, and the pattern is opposite to the results of Na_2SO_4 soaked concrete. At the RFP replacement rate of 40%, MgSO_4 causes more serious chemical erosion in concrete, indicating that a higher RFP replacement rate is more favorable for the reaction between MgSO_4 and RPC. In the lower parts, gypsum and ettringite peaks of RPC-4 were higher than that of RPC-2, and the peak of gypsum in RPC-4 is about 1.5 times that of RPC-2. Therefore, gypsum-based chemical erosion occurred in the upper and lower parts of the RPC immersed in MgSO_4 solution for 180 d. At the concentration of 5%, the chemical reaction between the RPC and MgSO_4 was more intense than that between the RPC and Na_2SO_4 . The reason may be that Mg^{2+} enters the concrete and reacts with it to form $\text{Mg}(\text{OH})_2$, which reduces the pH of RPC. Thus, the decalcification process is

accelerated, resulting in the transition from C-S-H to non-coagulable M-S-H [46,47] and an increase in gypsum production. The results showed that the effects of RFP replacement rate superimposed with the MgSO_4 erosion effects. The higher the RFP replacement rate, the higher the gypsum production.

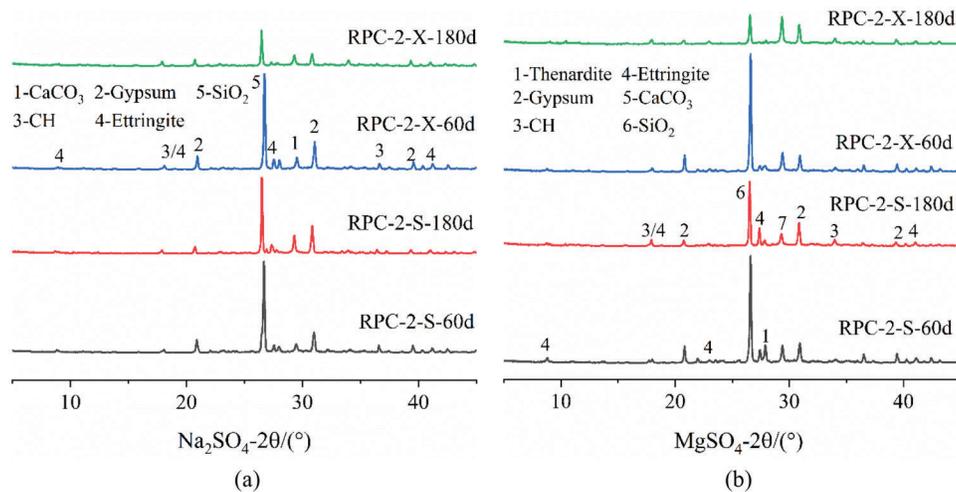
Figure 17: XRD pattern of the concrete

The XRD results of RPC with 20% RFP immersed in sulfate solutions for 60 and 180 d are shown in Fig. 17. The Na_2SO_4 immersed concrete samples have high SiO_2 diffraction peaks due to the presence of sand. In the upper part, the peak value of gypsum showed limited changes. In the lower part, the peak value of gypsum after 60 d immersion was higher than that after 180 d immersion, and the peak value of ettringite decreased with time. Therefore, the upper part of the concrete immersed in Na_2SO_4 solution undergoes increasingly severe gypsum erosion with the immersion time. However, the amount of ettringite in the lower part of RPC-2 decreased, possibly because the gypsum and ettringite produced in the pre-full immersion period filled the pores on the concrete surface, which led to the reduction of gypsum and ettringite peaks after 180 d.

With 20% RFP, the ettringite peak in the upper part of RPC-2 after 180 d of MgSO_4 immersion was slightly higher than that after 60 d of MgSO_4 immersion, but the changes in gypsum were not significant. In the lower parts, the gypsum peak after 60 d immersion was higher than that after 180 d immersion. Therefore, with the increase of immersion time, more ettringite formed in the upper part, i.e., the chemical erosion inside the concrete immersed in MgSO_4 solution produced ettringite. In the lower part, the chemical reaction inside the concrete gradually stabilized in the late stage, and the changes of gypsum and ettringite became limited.
