Structural Integrity and Durability of High Voltage Composite (Non-Ceramic) Insulators

M. Kumosa¹

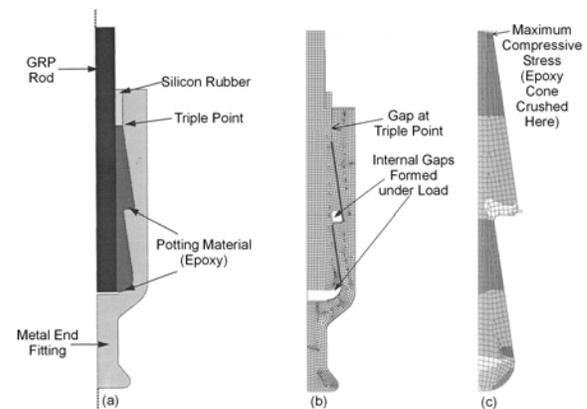
Figure 11: Finite element model of suspension insulator with the epoxy cone end fittings; (a) end fitting design (schematic) (b) deformed finite element mesh and (c) mechanical stress distributions in the cones.
