## Experimental and Finite Element Analysis of Corroded High-Pressure Pipeline Repaired by Laminated Composite

### ABSTRACT

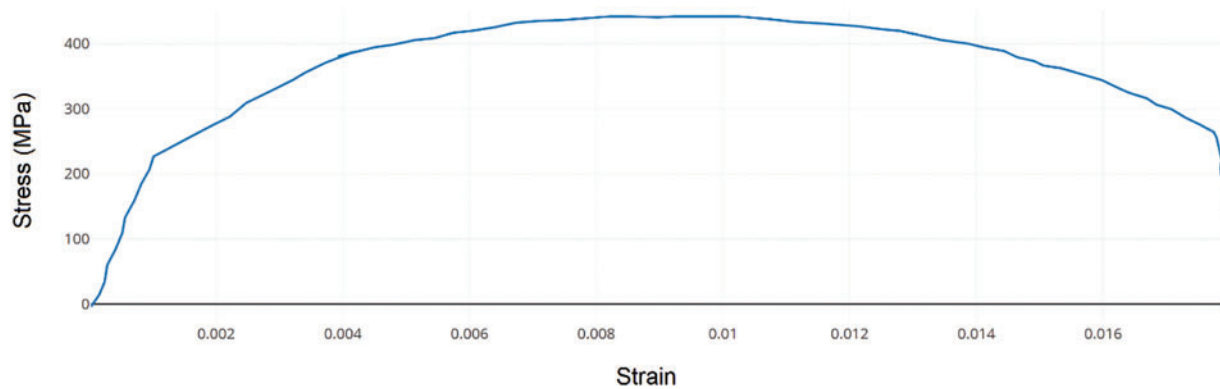
**Figure 2:** Stress-strain diagram of tensile test

The mechanical properties of the pipe including yield strength, ultimate strength and module of elasticity were obtained by preliminary tests performed according to the ASTM E8/E8M standards. The stress-strain diagram of a sample of pipe material with the specifications mentioned in Fig. 1 is shown in Fig. 2. To mitigate the statistical dispersion, the tensile tests were performed 4 times and the mechanical properties were calculated as average of the preliminary test results. An image of the test can be observed in Fig. 3.

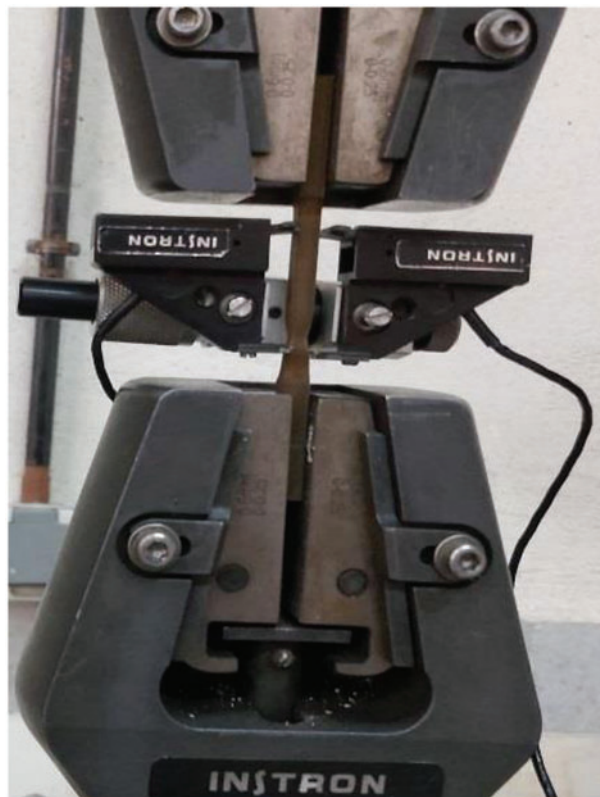
**Figure 3:** Tensile test on the sample

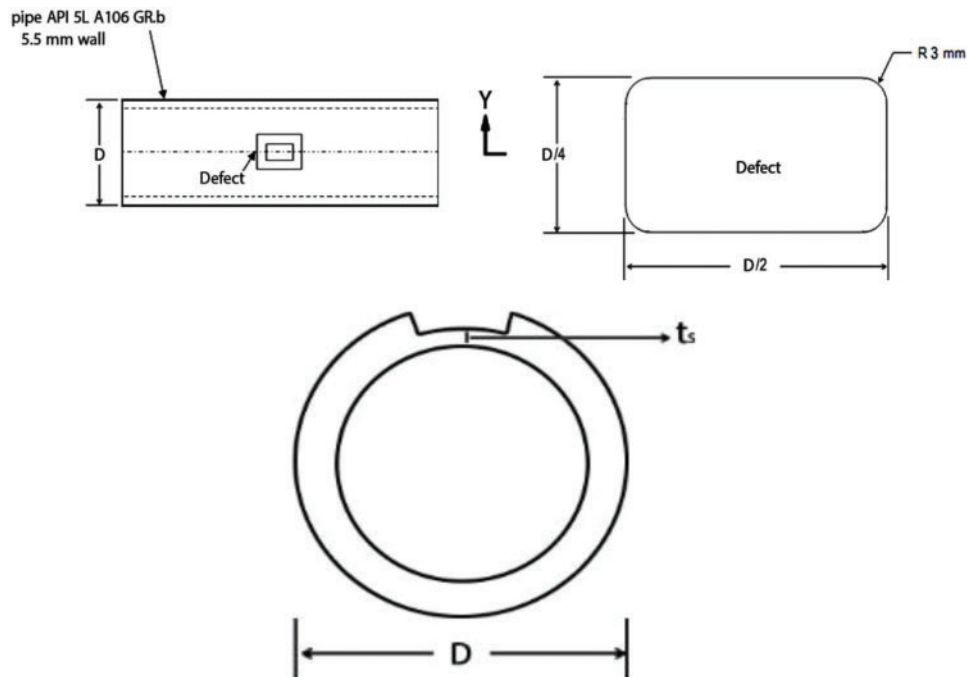
**Figure 4:** Defective pipe design

During the first phase of the experiment, the intact vessel was connected to the hydraulic device and the internal pressure was increased. In the second phase, a defect was created on the outer surface of the pipe. The defect was designed according to the ASME PCC-2 [27] standard with a depth of 70% of the thickness. In Fig. 4a, sketch of the cavity geometry is shown. Also, an image of the defect can be seen in Fig. 5.

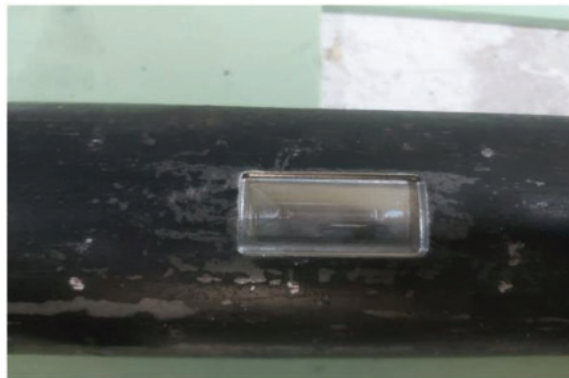
**Figure 5:** Defect created on the tank

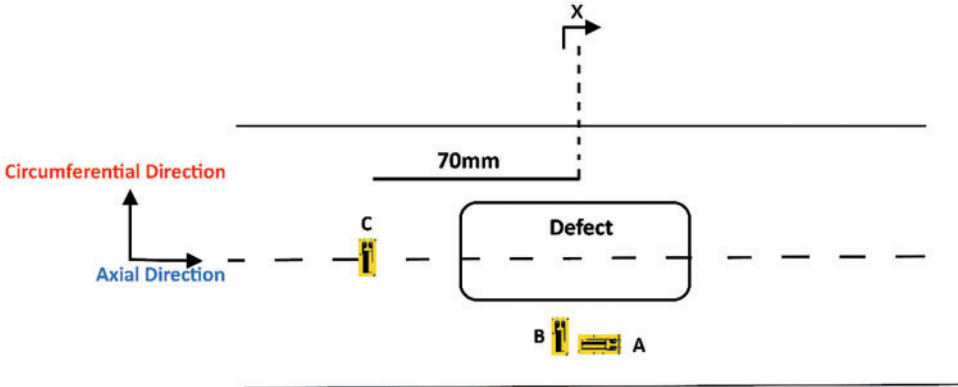
In order to measure the strain and the stress accordingly, the tank was equipped with strain gauges, as shown in Fig. 6. These were positioned on the outer skin of the pressurized tank and connected to a graphical user interface system. In this way, it was possible to monitor and register the stress level in the tank thickness in real-time during the experiments. According to the coordinates system of Fig. 6, the axial strain gauge A and the circumferential one B are positioned in the critical region near the

defect, and the peripheral strain C is located at a distance of 70 mm from the defect, along the axial direction.

Figure 6: Strain gauge coordinates on the defective tank

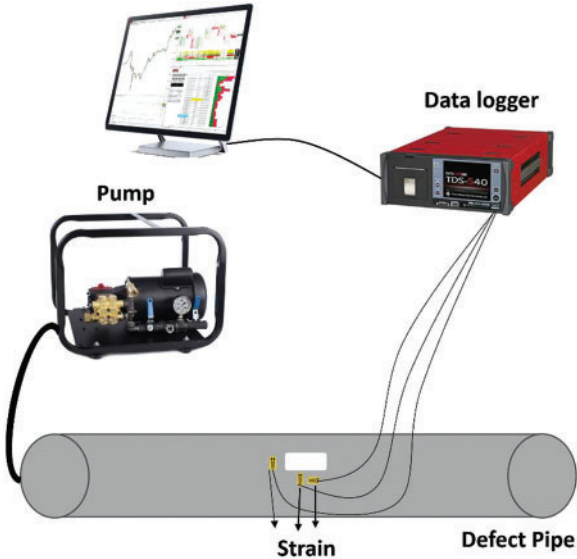
Fig. 7 is a schematic representation of the experimental test rig. The tank is equipped with strain gauges which, in turn, are connected to the Data Logger through soldered wires. The tank is joined with the high-pressure hose of the hydraulic pump and filled with hydraulic oil. With this apparatus, it is possible to monitor the internal pressure of the oil as well as the stress and strain level of the tank on display. Fig. 8 shows the defective tank under test, fully equipped with the strain and pressure gauges.

Figure 7: Schematic diagram of a defective pipe test

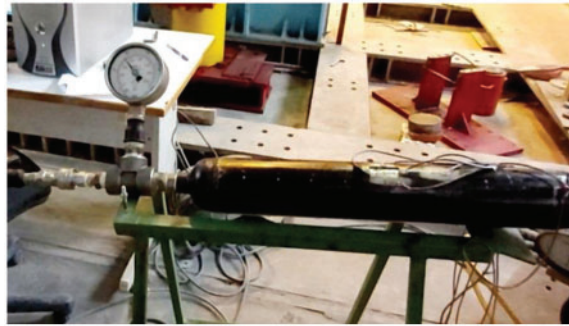
**Figure 8:** Defective pipe test

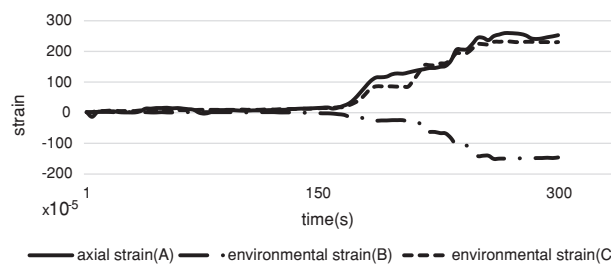
Fig. 9 shows the strain evolution during the test measured by the three strain gauges in the defective pipe. In areas close to the defect, due to geometric changes and non-uniformity of the area, the axial strain (gauge A) is higher than the peripheral strain (gauge B). In fact, the axial gauge detects tensile deformation whereas the circumferential one reveals a compressive deformation. The peripheral strain gauge positioned in C is stretched due to its distance from the defect.

**Figure 9:** Axial and environmental strain measured during the experiment

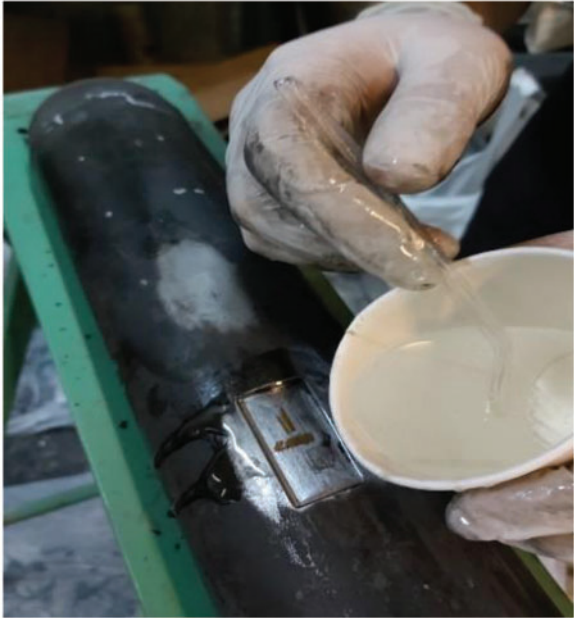
**Figure 10:** Filling the artificial defect with hardener resin

As shown in Figs. 10–12, to repair the defective tank and reduce the strain and concentration of stress in the cavity area, first, the inside of the defect is filled with filler material and then the metal tank is repaired by screwing the composite fabric reinforced with glass fibers. Generally, the filler material is flexible and has a high compressive strength which enables the transmission of the internal stress from the pipe to the composite. In this study, for the first time, it was used as filler material, a mixture of resin and hardener. Next, the surface of the pipe and the composite layers are impregnated with the hardened resin mixture. Thereafter, the layered composite fabric is wrapped onto the defective pipe to reach the minimum thickness of the repair layer as designed by ISO-standards [15] and following the prescriptions of several ASME-standards [18,27–32].

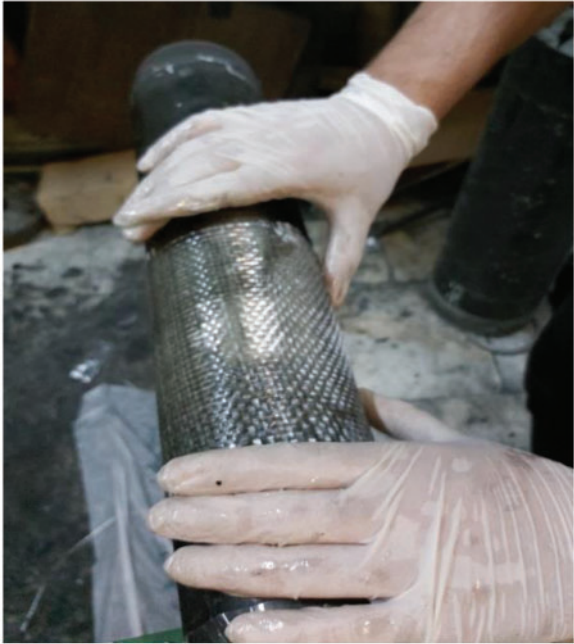
**Figure 11:** Impregnation of composite layers with resin

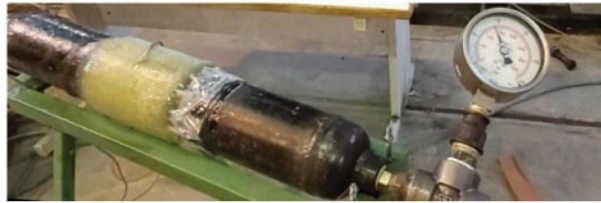
**Figure 12:** Pipe repaired with Glass Fiber Reinforced Polymer (GFRP) under internal pressure

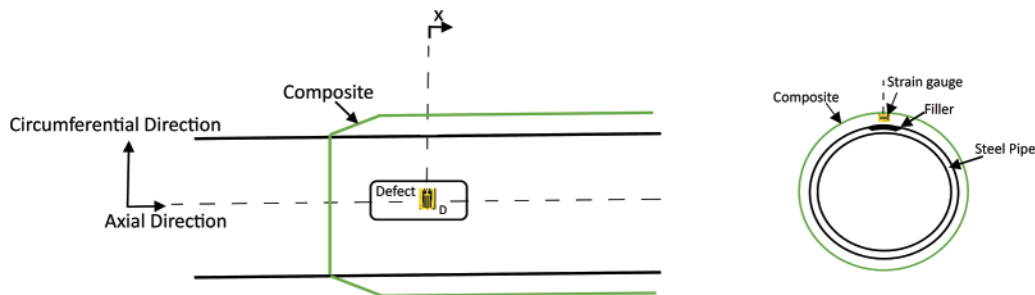
Once the installation of the composite screw was finished, a perimeter strain gauge was attached to the composite fabric as shown in Fig. 13. This was needed to monitor the strain in the repaired area during the final test under the action of the internal pressure.

**Figure 13:** Strain gauge coordinates on the repaired tank

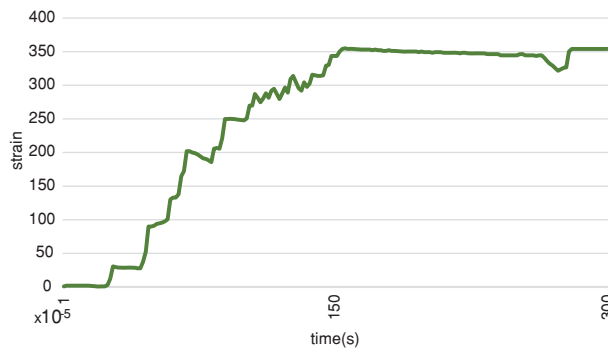
Fig. 14 is a diagram of the circumferential strain evolution of the repaired pipe. The hoop strain was tensile throughout the duration of the experiment, and it presented an increasing trend with the internal pressure. As the defect is repaired, the discontinuities are removed and the cylindrical relations between longitudinal and hoop strain are re-established with the hoop strain being greater than the axial one.

**Figure 14:** Peripheral strain diagram of the repaired tank

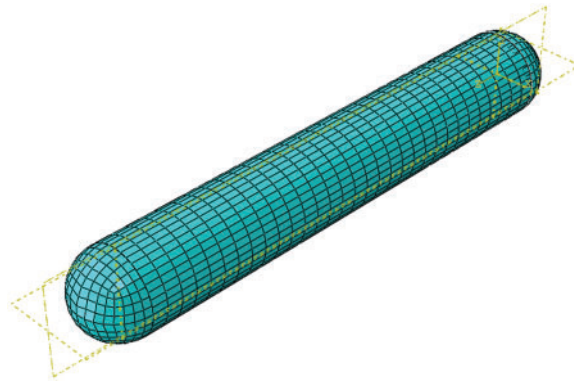
The pipe sample used for the tests was modelled by means of the finite element software ABAQUS as shown in Fig. 15. First, the cylinder geometry and the two hemispherical caps were created and then merged together with a tie constraint. The mechanical properties were defined according to Table 3 and an internal pressure of 10 MPa was applied on the internal surface of the pipe.

**Figure 15:** Pipe modeling in the mesh module

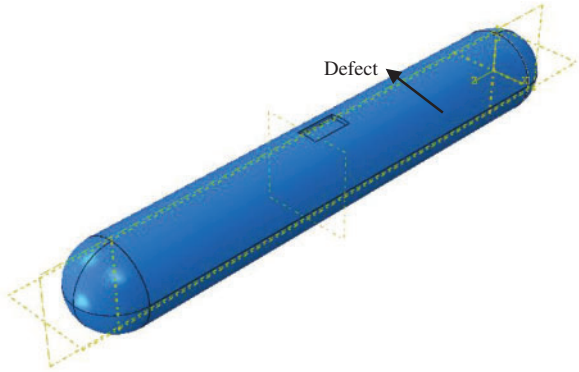
To simulate the defect in the tank, 70% of the pipe wall thickness, located at the middle pipe length as shown in Fig. 16, was removed in accordance with ISO 24817 standard. In accordance with the experimental test conditions, the internal pressure was set to 90 bar.

Figure 16: Tank corrosion in modeling

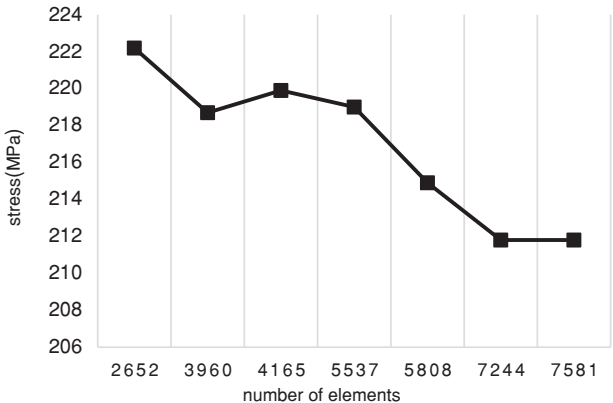
The geometry of the specimen was meshed using second-order hexahedral elements (C3D20). The final mesh was obtained after a convergence analysis, made on the number of elements required in the area surrounding the defect. The converged mesh was made up of 7581 20-node brick elements of type C3D20, as shown in Fig. 17.

Figure 17: Convergence of the element at the location of the pipe defect

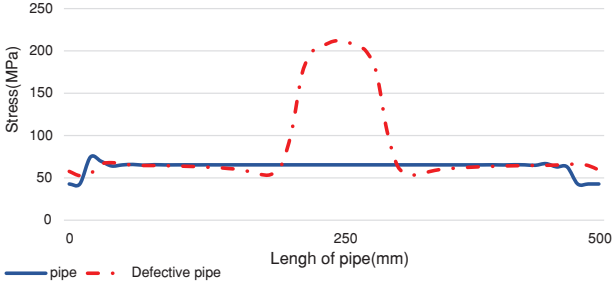
In Fig. 18a, comparison of the von Mises stress distribution along the pipe length is presented for both intact and defective pipe. The portion of pipe under analysis is the area surrounding the defect along the axial direction. It can be seen that within the area of thickness reduction, the stress remarkably increases (by a factor of 4) with respect to the intact vessel. The area directly close to the outer edge of the defect faces a rapid reduction of the stress due to the sharp geometry change. Thus, the presence of the defect has only a local effect as the stress level reaches the non-defective stress level.

Figure 18: Comparison of stress diagrams in healthy and defective pipes

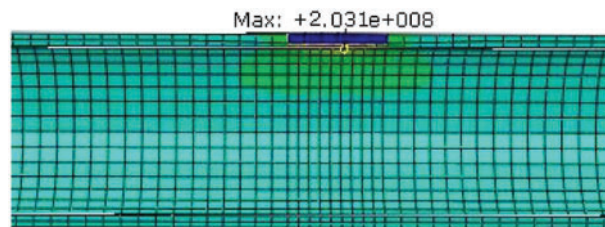
The repair was modelled by means of the finite element software as well as shown in Figs. 19 and 20. The filler resin was inserted in the defect and assembled through a tie-type constraint to the defective pipe geometry. On top of this, a layer of GFRP composite fabric, having a thickness calculated according to Eqs. (17) and (18), was modelled and tied to the global model. The mechanical properties of both the resin and the composite layer were defined according to Tables 3 and 5. The diagram of Fig. 21 shows the von Mises stress trend along the pipe's axial direction for all the configuration under analysis: intact pipe, defective pipe, pipe reinforced with filler resin and pipe repaired with GFRP composite fabric. The diagram shows that the stress concentration decreases by 4% as consequence of the filler resin reinforcement; the reduction increases to 22% after the GFRP composite fabric insertion. A further enhancement of the repaired vessel is shown in Fig. 22. Here, it is visible the circumferential strain reduction by 62% with respect to the pipe configuration before the repair.

**Figure 19:** Placing the filler in the defect of the pipe

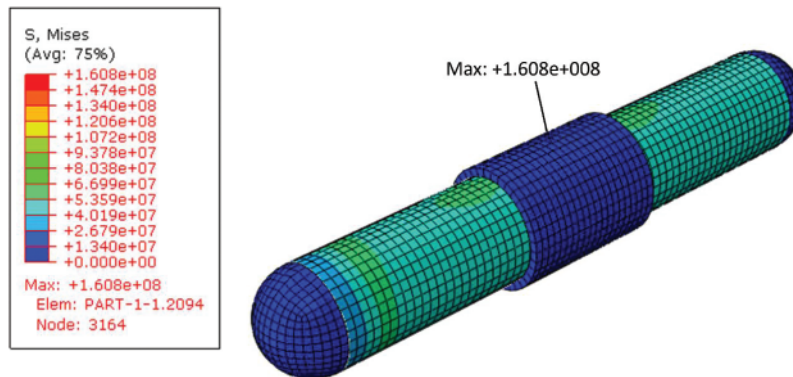
**Figure 20:** Final view of repairing a defective pipe with the help of composite in mesh module

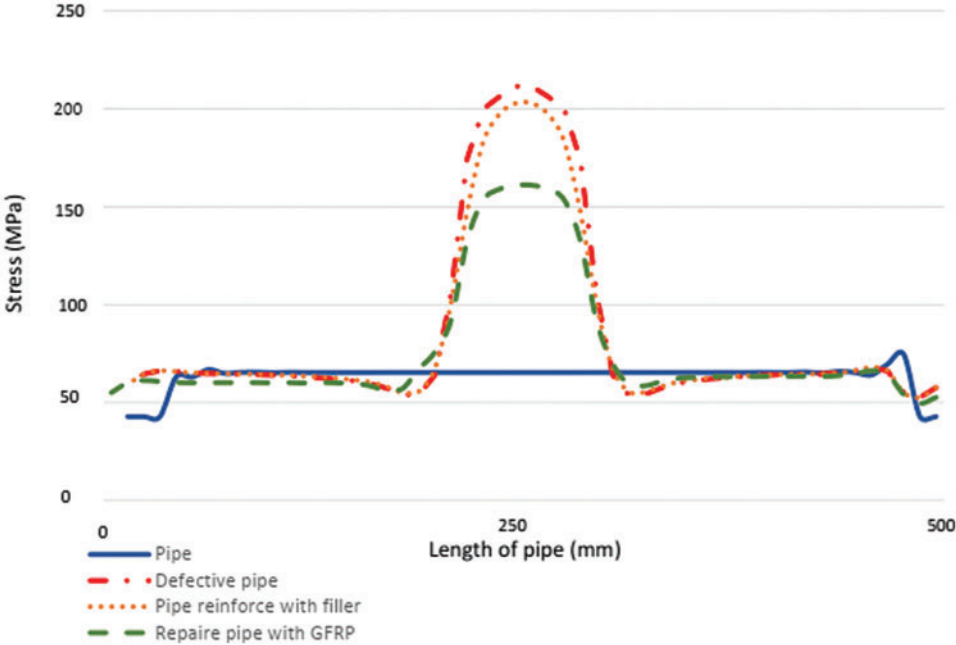
**Figure 21:** Comparison diagram of stress distribution in healthy, defective, filler-reinforced and composite-repaired pipe

The results of the finite element analyses demonstrate the substantial improvement in structural integrity achieved through the combined application of filler resin and GFRP composite fabric. As shown in Fig. 21, the stress pick is reduced by 4% due to the filler resin reinforcement. This reduction further increases to 22% following the GFRP composite fabric application. Fig. 22 further illustrates the effectiveness of the repair by showing a 62% reduction in circumferential strain compared to the unrepaired pipe.

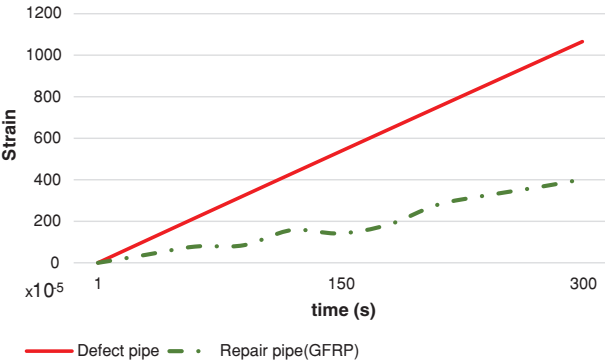
**Figure 22:** Peripheral strain diagram in the pipe before and after repair

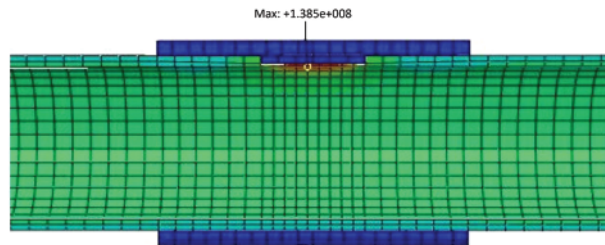
**Figure 23:** Stress in a pipe repaired with CFRP composite

In order to assess the effect caused by the use of a different woven composite fabric, it was created a numerical modelled of the pipe having an outer repair layer made of CFRP fibers instead of the GFRP one. The calculation of the minimum thickness of the layer required, performed as per Eq. (14), showed that the CFRP layer is more than 50% thinner than the GFRP layer. With the CFRP configuration, the simulation results showed a 12.5% reduction of the von Mises peak stress with respect to the GFRP one; in addition, also the circumferential strain presented a reduction of 25% in the supplementary configuration. The simulation image and its results can be seen in Figs. 23–27. In addition, a comparison of experimental and numerical strain of defective pipe and repaired pipe is shown in Table 6.

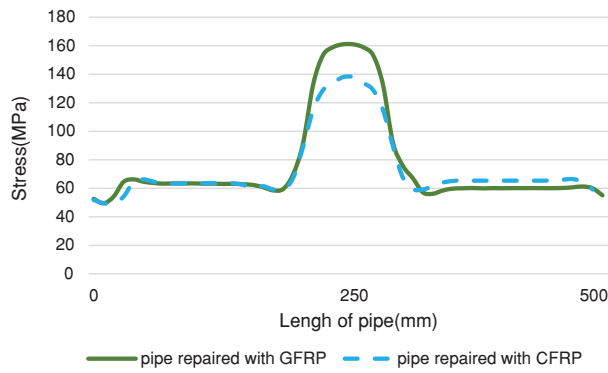
**Figure 24:** Comparison diagram of stress distribution in a pipe repaired by GFRP and CFRP composite fibers

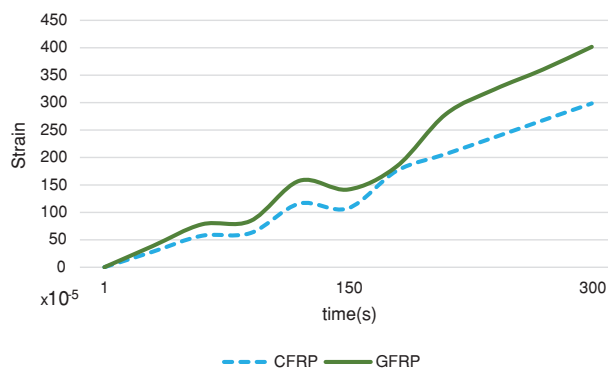
**Figure 25:** Comparison diagram of circumferential strain in a tank repaired with the help of composite with GFRP and CFRP fibers

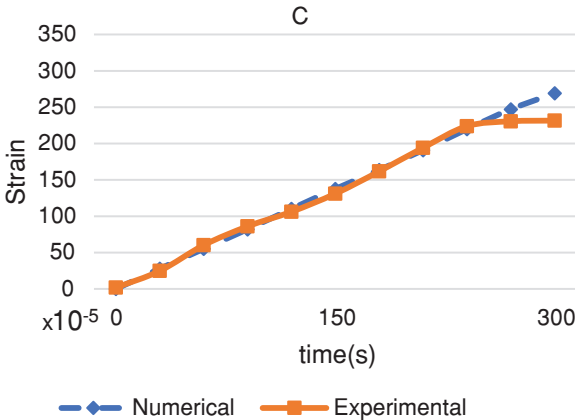
**Figure 27:** Comparison of experimental and numerical circumferential strain of defective pipe at point C

Figs. 26 and 27 report the axial and circumferential strain comparison between tests data and numerical results. Due to the defect's geometry, the axial gauge A and the circumferential one C detect a tensile and increasing trend during the experiment, whereas a compressive and downward trend occurs for the circumferential strain gauge B. The numerical analyses were able to reproduce the experiments both in terms of strain values and trend. The numerical-experimental agreement is complete in the initial part of the test whereas, during the second half of the experiment, a mismatch arises. The maximum error between experimental data and numerical results was detected by the circumferential strain gauge B, corresponding to a value of 17% as per Table 6. Also, in Fig. 26, the correspondence in the axial strain diagram, gauge B, between experiments and numerical analyses is spotless over the first 100 s of the test. According to the coordinates of the strain gauge in Fig. 27, it can be seen that the peripheral strain C is located at a distance of 70 mm from the center of the defect. As shown in Fig. 27, due to the distance of this strain gauge from the defect location-the peripheral strain C was

located at a distance of 70 mm from the center of the defect- the nonlinear effects and deformation are less evident. From the beginning to the time of 250 s, the two curves, experimental and numerical, match entirely, but in the end of the test, when the internal pressure was 90 bar, a maximum difference of 14% arises.

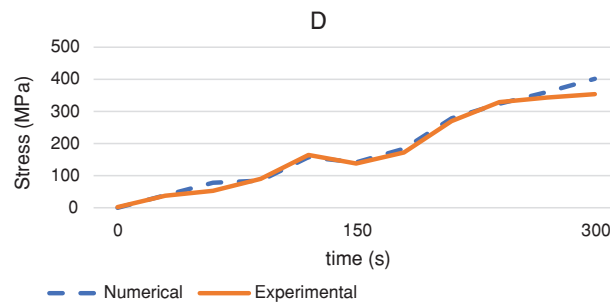
As can be observed from the diagram of Fig. 28, there is a very precise agreement between numerical and experimental results of the circumferential strain. In fact, the maximum difference detected, always at the highest-pressure levels, was 11.8%. This could be explained by the fact that the reparation reduces the non-linearities related to the sharp variation of the geometry and as a consequence attenuate the stress pick; this secondary effect is not detected by the FE-analysis of the numerical model. An other explanation is that the high level of the internal pressure caused a fluctuations in the strain gauges measurement.

**Figure 28:** Comparison of experimental and numerical stress of repaired pipe at point D
