Damage Assessment in Pultruded GFRP with AE

D. Crivelli¹, M. Guagliano² and A. Monici³

Abstract: Pultrusion is a process for manufacturing uniform section composite profiles, which allows to obtain structural elements of virtually any length. The use of E-glass fiber allows to obtain a material with a good rigidity-to-weight and strength-to-weight ratio; these features allowed to use these materials in civil structures, such as poles for anti-noise panels and public lighting, also thanks to their insulating properties. However, the knowledge on the damage development of these materials is still uncertain, and this is slowing down their development.

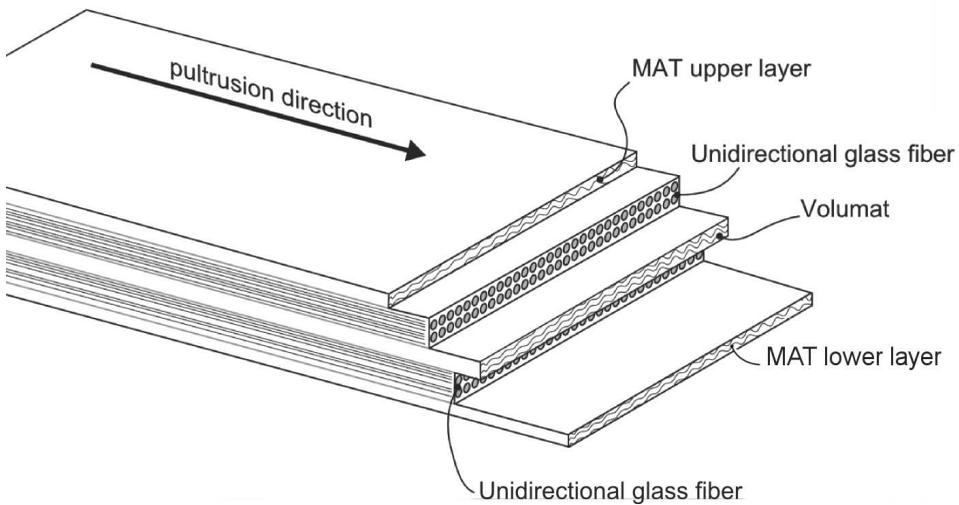
Figure 1: Schematic section of the pultruded MAT3

Two different configurations of such layers were tested, namely MAT2 and MAT3. The MAT2 type consisted of uniaxial glass fibers with a top and bottom random fiber layer; the MAT3 type included an additional layer in the middle of the specimen, named *volumat* (Figure 1).

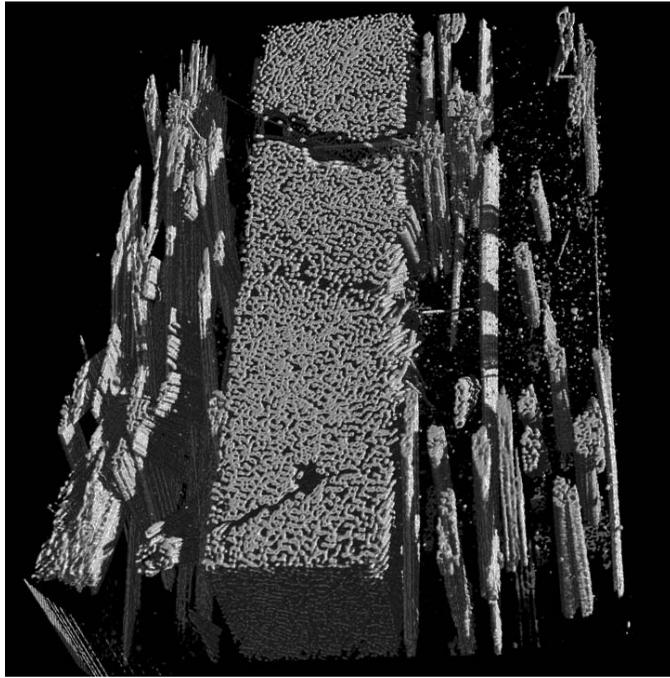
Figure 2: 3D tomography image of a MAT2 specimen cutout (the matrix is filtered)

In Figure 2 the glass-fibers layout can be seen in a 3D tomography image of a MAT2 specimen section, from a previous work of the authors [Crivelli et al. (2010)].

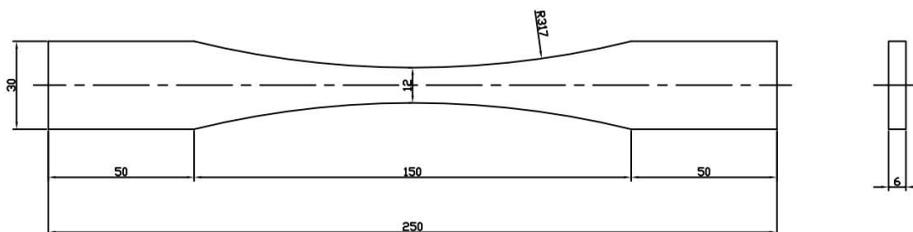
Figure 3: Dogbone specimen geometry (both MAT2 and MAT3)

In this work, 15 MAT3 and 19 MAT2 specimens are considered. The specimens were milled to a dog-bone shape (Figure 3). Such configuration allows to avoid the usage of tabs and the consequent stress intensification, and shows the best uniformity in failure mode, position, and avoids unwanted slipping of the tabs due to non-perfect bonding, as experienced by [Keller et al. (2005)]. Each specimen was measured in its smallest section prior to the tensile test.

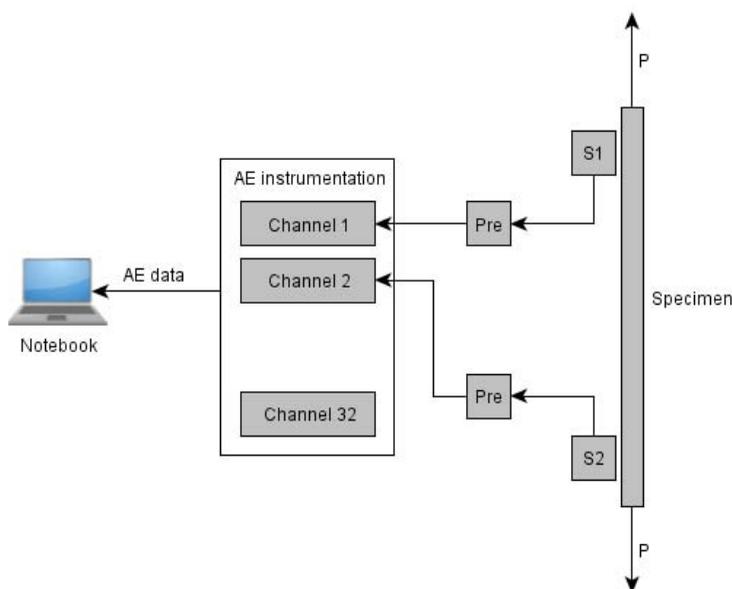
Figure 4: Acoustic Emission data acquisition chain

To monitor the specimens with AE, a commercial instrumentation (Valen AMSY-5) was used. This instrumentation includes the whole measurement chain involved in AE recording (Figure 4).

Two sensors were attached to each specimen with vacuum grease, according to [ASTM E976], at a distance of 120mm. Sensors were then connected to preamplifiers with short cables (less than 1000mm); each preamplifier was connected to one

channel of the AE master unit. The unit was connected to a laptop which recorded the AE “hits” waveforms and parameters (Figure 5). The noise threshold of the channels was set to 40dB AE.

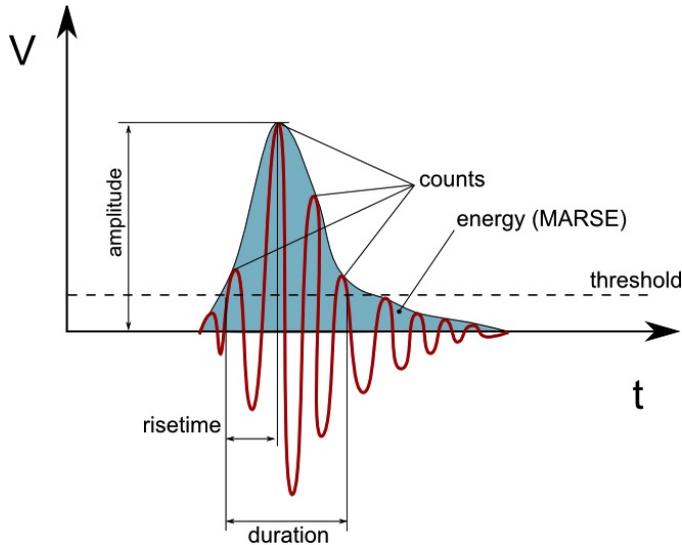
Figure 5: Acoustic Emission signal and parameters example

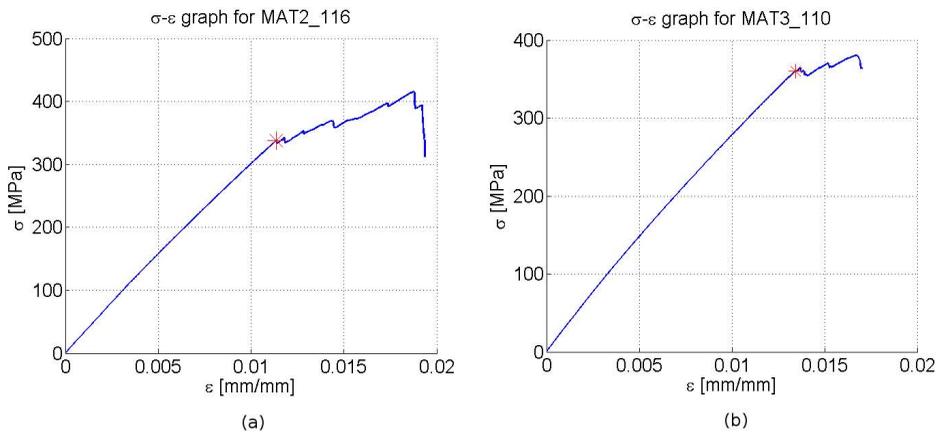
Figure 6: Stress-strain curves for a MAT2 and a MAT3 specimen

A typical stress-strain curve for a specimen is reported in Figure 6.

It can be seen that the test can be divided into 2 phases: the first, which is almost linear, and a second which presents an inelastic behavior (from a deformation value ε_i) and sudden load bearing drops. This is linked to visible damage development and a sensitive increase in AE activity.

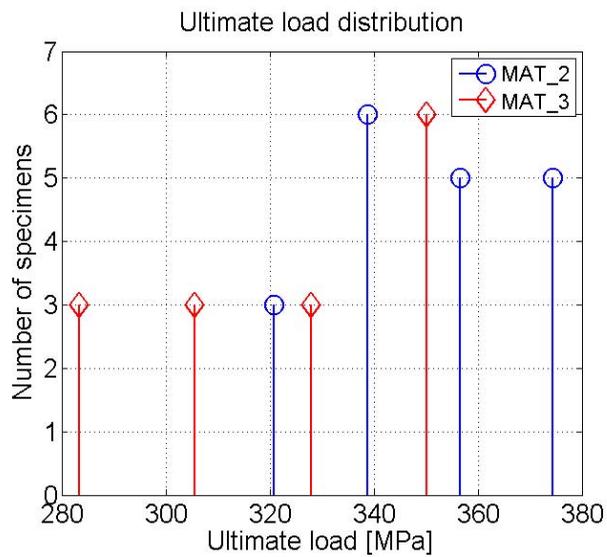
Figure 7: Ultimate load distribution

The two materials tested showed a quite uniform behavior, with a tensile strength measured at the first inelastic load drop, with a mean value of about 340 MPa and a standard deviation of 28 MPa (Figure 7). No significant difference between the

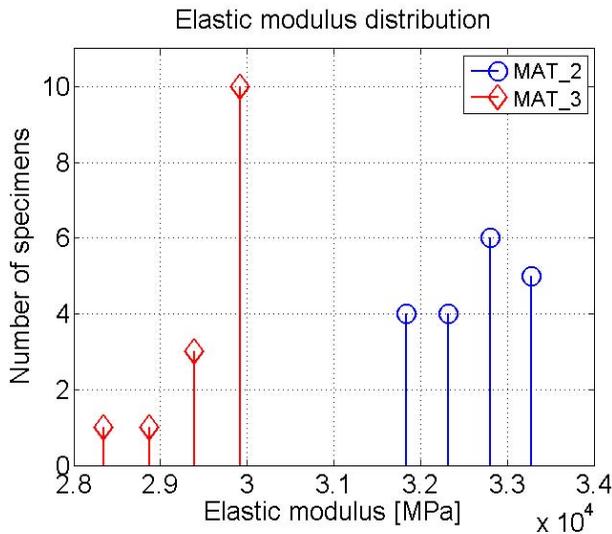
Figure 8: Elastic modulus distribution

The elastic modulus showed indeed a difference between the two materials, which can be explained by considering the presence of the Volumat (which contributes partially to the longitudinal rigidity). Thus, a lower elastic modulus is measured in MAT3 specimens (Figure 8). In particular, MAT2 specimens showed a mean elastic modulus of 32500 MPa, where MAT3 specimens showed a mean value of 29600 MPa.

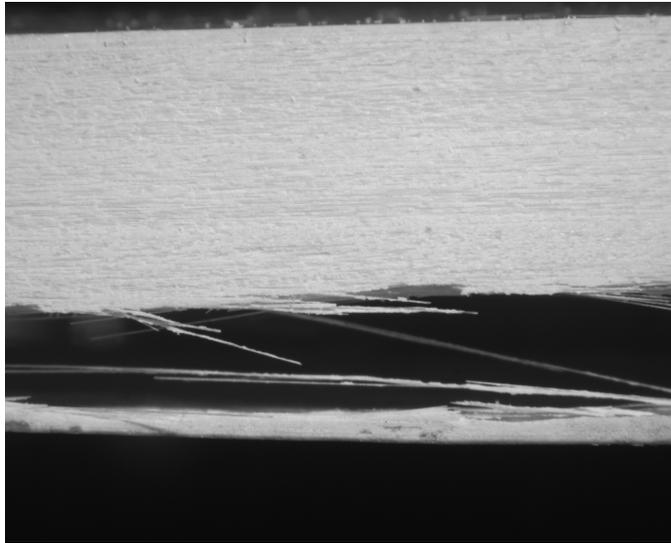
Figure 9: Delamination of a specimen (MAT2)

Broken specimens showed a uniform behavior, with an abrupt delamination failure mode which involves the MAT layer (Figure 9).

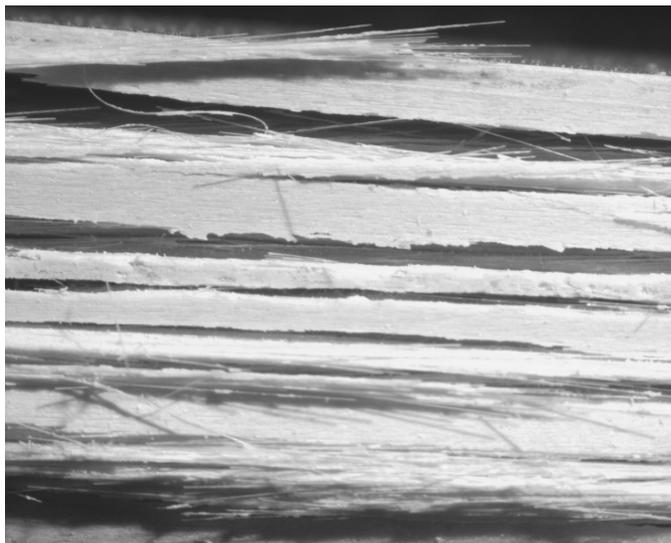
Figure 10: Delamination of a specimen (MAT3)

MAT3 specimens showed delaminations also extended to the inner MAT layer, which separated from the longitudinal fibers (Figure 10).

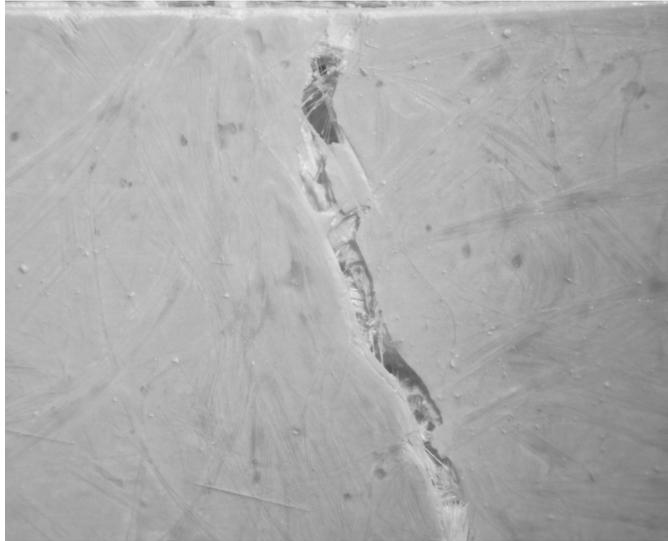
Figure 11: Longitudinal MAT cracking

All specimens also presented some form of longitudinal cracking of the upper and lower MAT layers, which developed during the test and not as a result of the delamination (Figure 11).

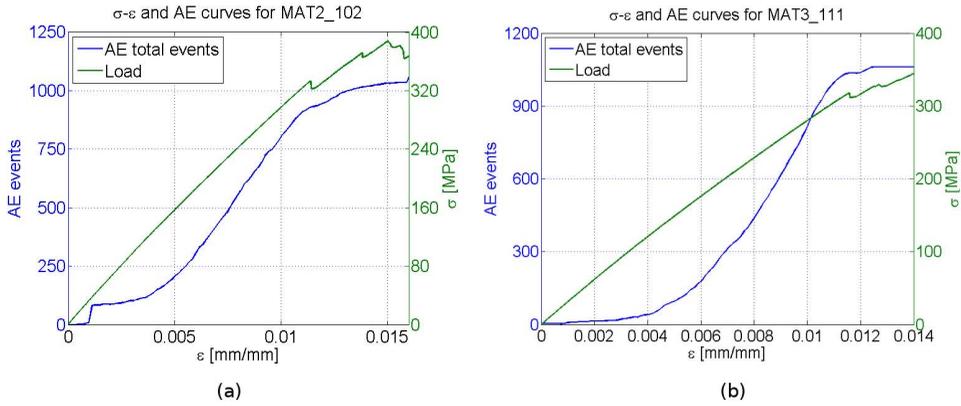
Figure 12: AE events and stress-strain curve for two specimens

AE activity and behavior is comparable throughout the specimen set. As can be seen in Figure 12, the activity is low (i.e. a low number of events in time) in the first part, then the AE rate increases steadily; finally (after the first load drop) the activity slows down, in a S-shaped curve similar to the one found in [Carpenter and Kumosa (2000)].

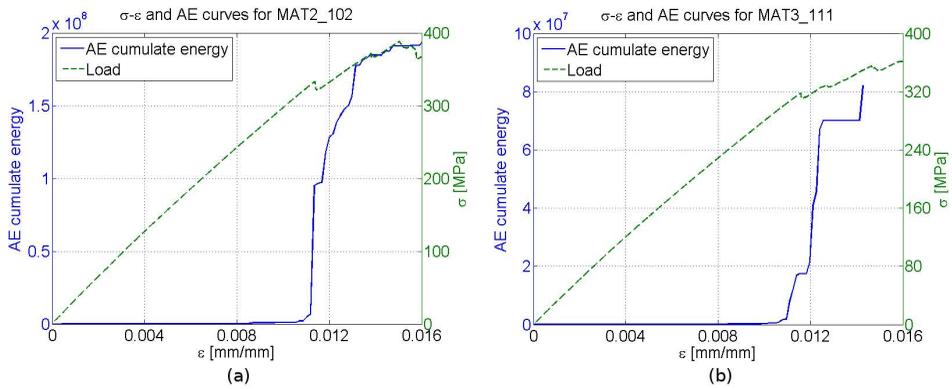
Figure 13: AE cumulated energy during two tests

AE cumulated energy parameter (Figure 13), on the other hand, shows a sudden increase prior to failure (the beginning of the inelastic regime). This is an indicator of catastrophic failure occurring in the specimen, with less events with an higher energy content.

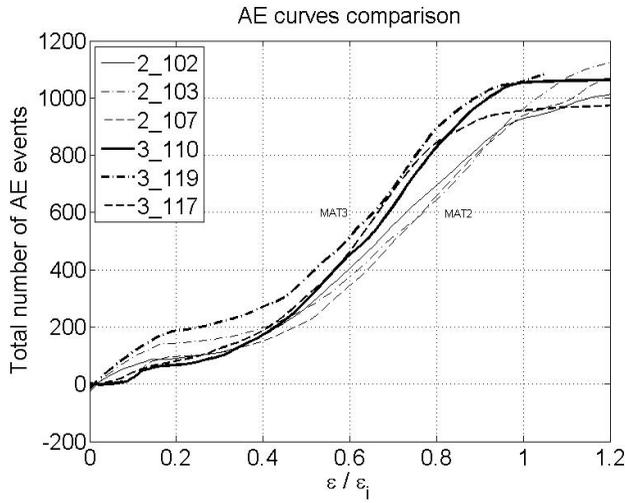
Figure 14: Comparison of AE curves of different specimens

The comparison between multiple AE events curves, normalized at the inelastic strain value ϵ_i , shows a different behavior between the two materials (Figure 14); in particular MAT3 seems to be more active than MAT2. This behavior is confirmed by the comparison of the first derivative (AE rate, Figure 15), which shows that the AE activity is not monotonically increasing but its derivative is also increasing, until it reaches a maximum before the breakage strain. This analysis shows also that MAT3 has its maximum AE rate (peak) at a strain which is lower than that of MAT2.

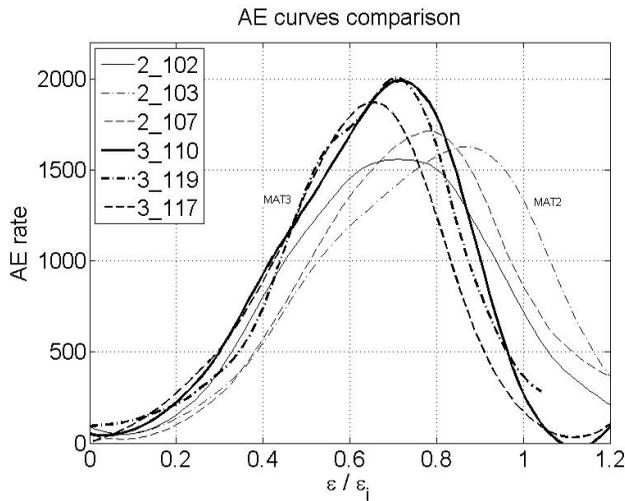
Figure 15: Comparison of the first derivative of AE activity of different specimens

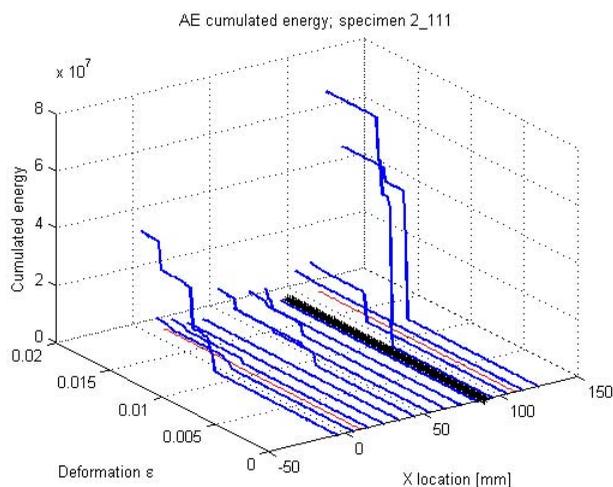
Figure 16: Progression in time of cumulated energy, divided by X location

be seen in Figure 16, that shows (in solid line) the AE cumulated energy for sections of 10mm width. In the case depicted, a MAT fracture was found at about 80mm (marked with a thick line in the xt plane), and confirmed by the energy released in that area.

The most appealing feature of AE is the possibility to locate the damage location. The most promising feature for failure detection is cumulated AE energy; this can
