Experimental and Numerical Study on Progressive Collapse Analysis of a Glulam Frame Structure: I. Side Column Exposed to Fire

Xiaowu Cheng, Xinyan Tao and Lu Wang*

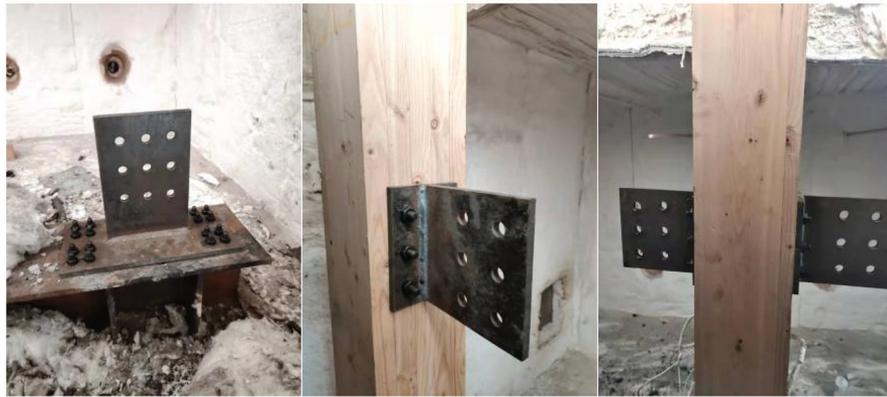
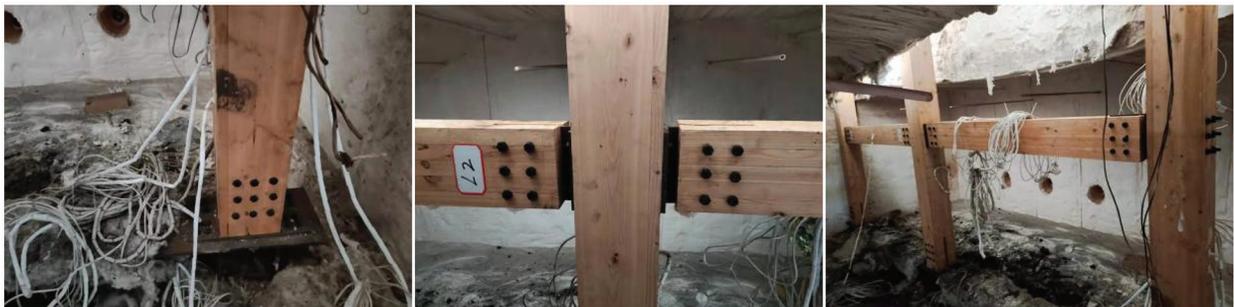
Figure 3: Assembly process of the frame. (a) Installation of wood-steel-wood bolted connections, (b) installation of columns, (c) installation of beams, (d) the entire frame

[30], a 2-storey and two-span plane frame is designed with reference to the actual office building. The scale ratio of the frame is 1:3. The column spacing is 1.42 m and floor height is 0.84 m. Douglas fir lumbers are used as the raw material to make five-layer glulam timber components. The material properties of Douglas fir were listed in Tables 1 and 2. The dimension of the section of beam is 100 mm × 150 mm, and the dimension of column is 150 mm × 150 mm. Wood-steel-wood bolted connections are used in this study, which are made of Q235 steel and 8.8 M10 high strength bolts. The columns are connected to the rigid foundation beam by bolts and T-shape steel plates. Detailed dimension of connections is shown in Fig. 1. The rigid foundation beam adopts I-shape cross section of 200 mm × 200 mm × 8 mm × 12 mm, as shown in Fig. 2. The frame is assembled in the furnace in Nanjing Tech University. The process is shown in Fig. 3.

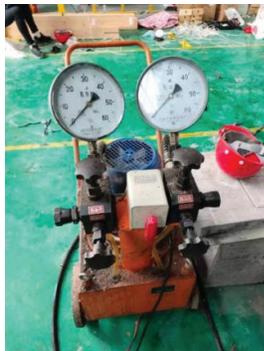
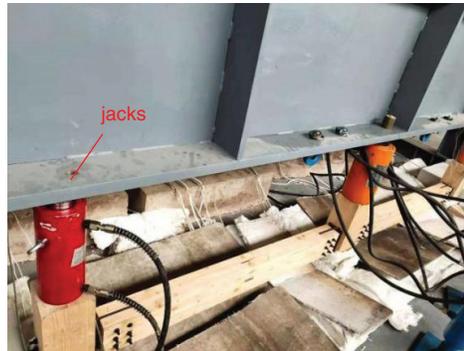
Figure 5: Loading of the frame. (a) The vertical load, (b) oil pump, (c) jacks

The fire test was carried out in the furnace of the fire engineering laboratory in Nanjing Tech University. The temperature-time curve in the furnace was consistent with ISO834 standard fire curve. The rock wool was used to wrap the unfired members for fire protection, as shown in Fig. 4. The vertical load was applied to the top of columns by means of hydraulic jacks, so that the effects of the weight of superstructure and pile load on beam could be taken into consideration. Meanwhile, the load was kept at 150 kN by adjusting the oil pump, as shown in Fig. 5.

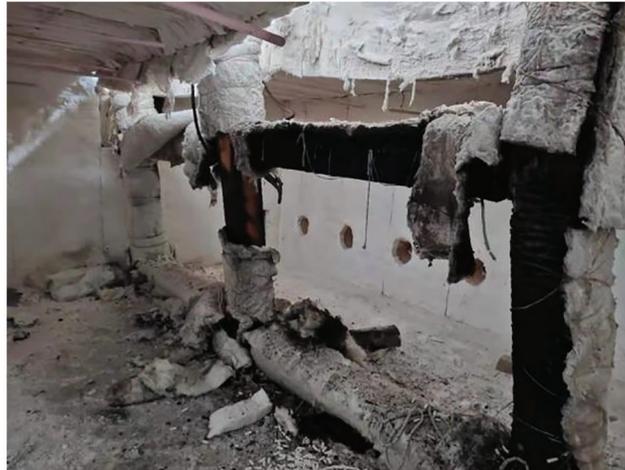
Figure 8: Overall deformation of the frame

Reaching the 26th min of fire exposure, the vertical displacement of the side column increased obviously. As shown in Fig. 8, the out-of-plane displacement of the frame occurred under the bias of the column and the structure was sprayed. The fire was extinguished at the 30th min.
