# Damage Detection in z-Fiber Reinforced, Co-Cured Composite Pi-Joint Using Pitch-Catch Ultrasonic Analysis and Scanning Laser Vibrometry

**Abstract:** Damage detection in constrained geometry structures like z-pinned, co-cured composite pi-joints is established using pitch-catch ultrasound and scanning laser vibrometry measurements. Ultrasonic pitch-catch measurements consisted of a network of PZT (Lead Zirconate Titanate) sensors placed on the specimen and sensing Lamb waves at each sensor location, where measurements were taken at symmetric top and bottom sensor locations for healthy and damaged pi-joint specimens. Results showed the presence of fatigue-induced bend damage of the joint as a reduced peak-to-peak amplitude response across the joint. Scanning laser vibrometry measurements were used to study the propagation of Lamb waves within the narrow, constrained geometry pi-joint structure, where the reflection and superposition of propagating Lamb waves was studied using time-resolved image analysis. The presence of delamination and hidden damage was visualized as changes in the propagating Lamb wave characteristics, where a reduction in propagating energy levels and dispers

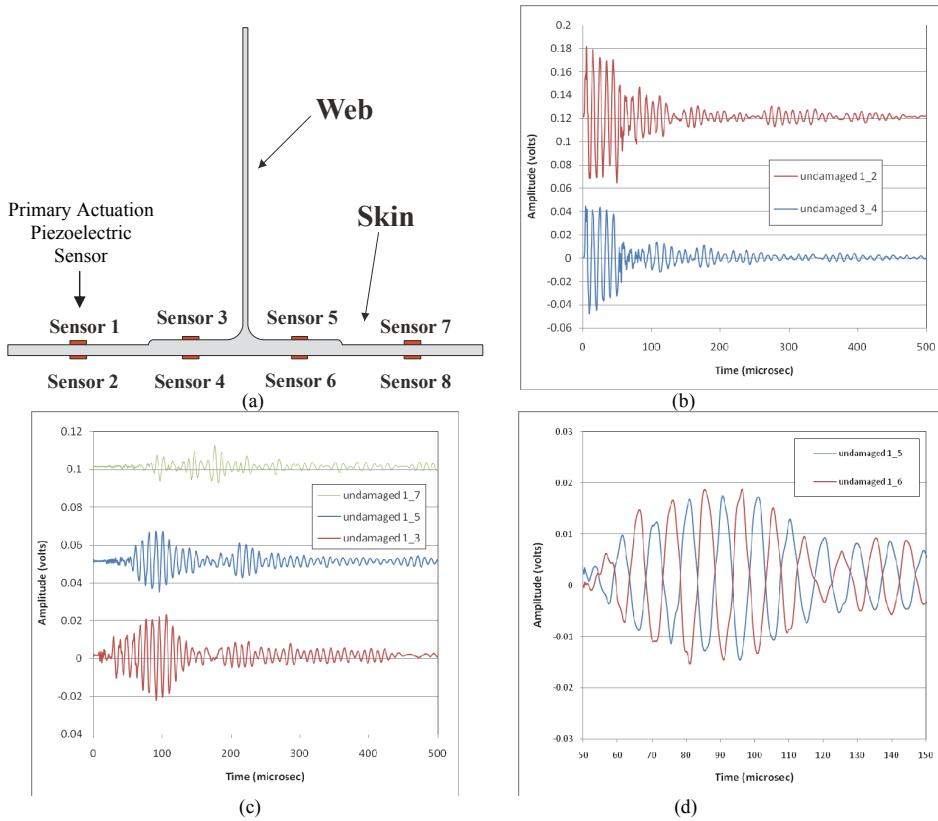
Figure 7: (a) Sensor positions locations on pi-joint sample in cross-section, (b) pitch-catch signals thru the thickness of the skin for sensor pairs 1 to 2 and 3 to 4, (c) Lamb wave signals detected along the length of the composite skin for pairs 1 to 3, 1 to 5, and 1 to 7, and (d) anti-symmetric motions detected by sensor pair from 1 to 5 and 1 to 6.

Pitch-catch measurement results for the bonded piezoelectric sensor disks on the undamaged pi-joint sample are provided in Figure 7, where sensor locations are indicated in Figure 7a. Specimen geometry dimensions and additional details were provided in Figure 2. In this set of experiments, measurements were targeted for the composite skin, where as described previously, 100 kHz toneburst signals were used to preferentially excite the  $A_0$  mode in the pi-joint sample. Pitch-catch measurements were made for sensor pairs on the top and bottom of the composite skin, and also for propagating Lamb waves along the length of the sample.

Figure 7b depicts the thru-transmission pitch-catch signal for sensor pairs 1-2 and 3-4. Similar results were also obtained for the 5-6 and 7-8 sensor pair combinations. The 1-2 sensor signal has been offset vertically by 0.12 volts to provide a better comparison of the signal content. For both waveforms, there is a nominal 5-cycle signal that arrives almost immediately, which represents the signal transmission from the sensors on the top of the sample to the corresponding bottom sensors. The arrival time of the 3-4 sensor pair signal (3.2 usec) was slightly longer than the 1-2 sensor pair signal (2.5 usec) due to a thickness change from 6.6 mm to 4.8 mm, respectively. Due to the restricted geometry, reflected energy from the sides and left end of the sample occur relatively quickly in time causing signals to overlap at the various receiving sensor positions. The excitation source duration time for the 100 kHz, 5-cycle toneburst signal was 50 microseconds, which is apparent in both of the waveforms. The reflected signals from the left edge of the sample were expected to occur at approximately 40 microseconds for the 1-2 sensor combination, and at approximately 106 microseconds for the 3-4 sensor combination, which is in reasonable agreement with the observed signals in Figure 7b, where the 3 to 4 sensor pair shows a more distinct separation of signal content in the 0 – 200 microsecond time frame. Reflected signals from the sides of the sample occur at approximately 36 microseconds for both sensor pair combinations causing distortions and apparent lengthening of the waveforms. The signal content also decays away rapidly, which is typical of the type of the composite materials used.

Figure 7c and 7d depict propagating Lamb wave signals excited using sensor 1 and receiving sensors along the length of the sample. Figure 7c provides a compari-

son of the signals obtained as the Lamb wave propagates at increasing distances from left to right according to the schematic diagram in Figure 7a. The 1-5 and 1-7 sensor signals have been offset vertically to provide a better comparison of the signal content. First arrival times of 33 usec, 60 usec, and 93 usec were estimated from the waveforms for the 1-3, 1-5, and 1-7 sensor pair combinations, which is in reasonable agreement with the  $A_0$  Lamb wave mode propagating at a speed of 1500 m/s. A noticeable reduction in signal amplitudes was observed as the wave propagated due to energy spreading effects and attenuation occurring in the composite material. Reasonably consolidated toneburst signals were observed for the

1-3 and 1-5 sensor pair combinations, where the trailing toneburst signal occurring at 200 microseconds is attributed to reflected energy from the left edge of the sample. A more complex and less consolidated signal occurred for the 1-7 sensor pair combination. Similar results were observed for the 1-4, 1-6, and 1-8 pitch-catch sensor pairs. A verification of frequency-tuned  $A_0$  Lamb wave excitation can be seen in Figure 7d, where a comparison of the 1-5 and 1-6 sensor pairs are provided showing anti-symmetric motions for the top and bottom of the sample.
