# Structural Response of Composite Panels with a Bonded Patch Repair Using Full-Field Measurement

**Abstract:** This paper presents an experimental/analytical evaluation of patch repair of solid laminated composites. The experimental program was focused on destructive evaluation of full-scale repaired panels under static tension loading conditions using speckle test full-field image recording technology. The speckle test results were used to validate a finite element analytical model. Based on the evaluation performed in this study, the finite element model and the speckle imaging technology provide major enhancements in understanding the performance of the scarf repairs.

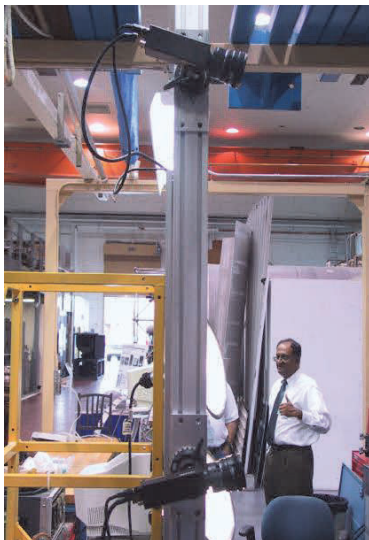
Figure 3: The speckle test and the recording set-up.

(a) The digital stereo camera setup

(b) The camera calibration target

The arrangement of the VIC-3D set-up used to obtain full-field displacement measurements of the composite test panel is shown in Fig. 3. As the load is applied, the 3-D measurements of speckle were recorded at regular intervals (once in 5 seconds). From the measured displacements, the complete full field mapping was completed using the software VIC-3D. Fig. 4 shows the front and back views of the panel after the ultimate load was reached. The failure initiated at the top edges of the patch near gage #33. Then, the failure progressed toward the mid-section to reach the ultimate failure between the patch and the parent panel.

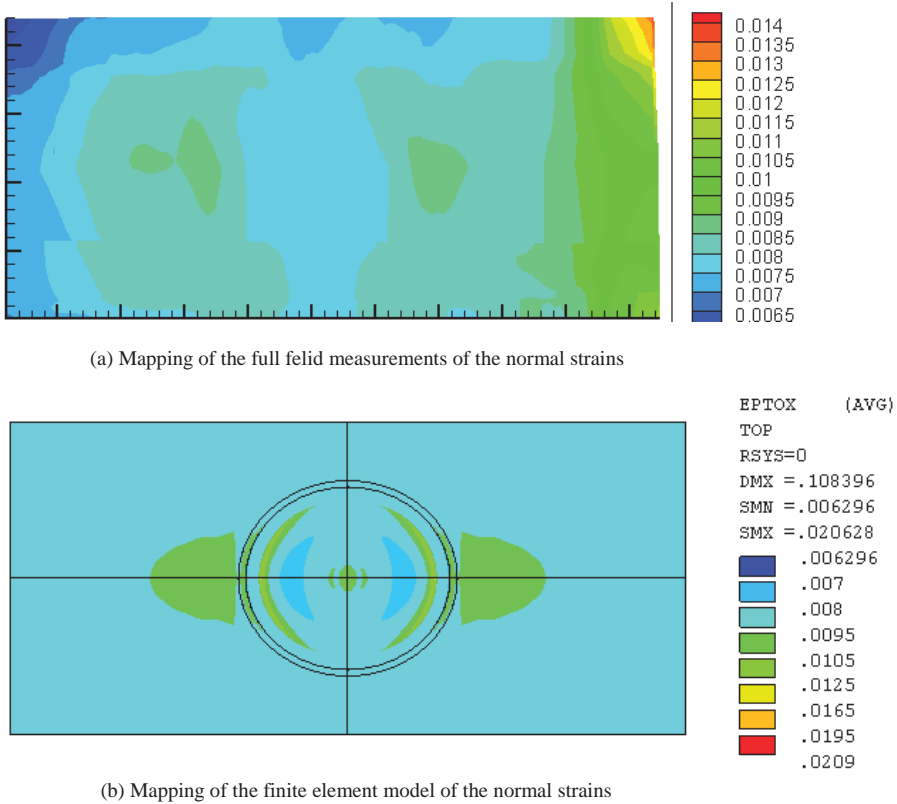
Fig. 7 presents mapped comparison between the full field measurements and the out put of the numerical model. It appears that the two results shown relatively matching data which indicates the accuracy of techniques, the numerical model and the full field measurements.

Figure 7: Full field comparisons of normal strains between the VIC 3-D and FE model.
